SI B61 31 14  
General Electrical Systems

## **SB-10057537-8656**

**Service Action: Replace Convenience Charging Electronics (KLE)**

I01 (i3 and i3 REx)

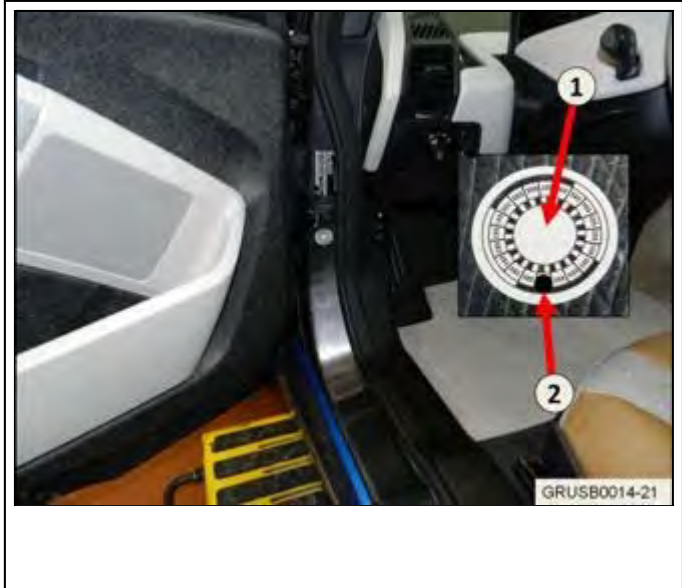
### LABEL INSTRUCTIONS

<p>This Service Action has been assigned code number <b>717</b>. After the vehicle has been checked and/or corrected, obtain a label (SD 92-453) and:</p> <ul style="list-style-type: none"> <li>A. Emboss your BMW center warranty number in the middle of the label (1);</li> <li>B. Punch out code number <b>717</b> (2), printed on the label; and</li> <li>C. Affix the label to the A-pillar as shown.</li> </ul>
---	---

If the vehicle already has a label from a previous Service Action/Recall Campaign, affix the new label next to the old one. Do not affix one label on top of another one because a number from an underlying label could appear in the punched-out hole of the new label.
