HYUNDAI NEW THINKING. NEW POSSIBILITIES.	GROUP CAMPAIGN	NUMBER 14-01-054
	DATE DECEMBER 2014	MODEL(S) SANTA FE (CM)
Technical Service Bulletin		
SUBJECT:	ECM UPDATE – P0638, LIMITED POWER MODE AND ETC MOTOR CLEANING (SERVICE CAMPAIGN TV5)

SUBJECT: ECM UPDATE – P0638, LIMITED POWER MODE AND ETC MOTOR CLEANING (SERVICE CAMPAIGN TV5)

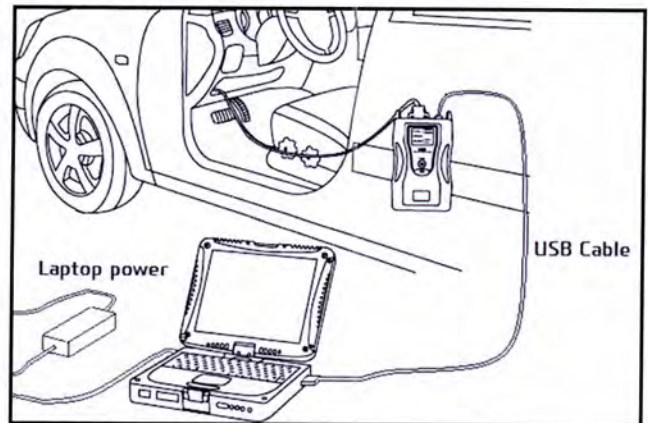
- Connect the USB cable between the GDS and the VCI.
- Connect the 16-pin DLC connector from the VCI into the DLC located under the driver's side dash.

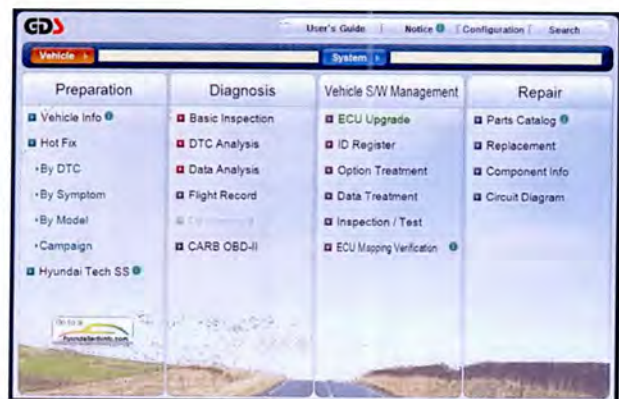
1. From the GDS home page, select **Inspection / Test**. If necessary, select the VIN.

Select **Engine** as the system and then select **OK**.

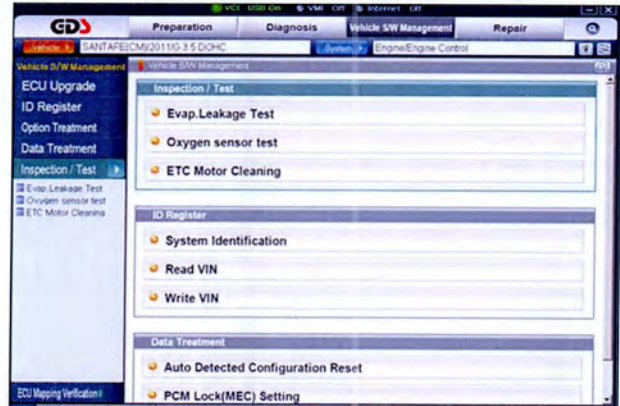
2. Select **ETC Motor Cleaning**.

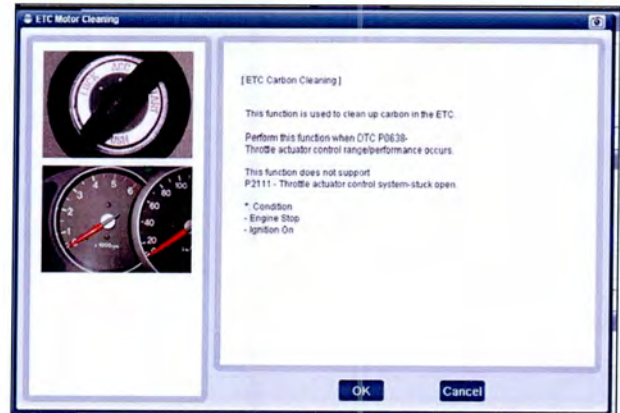
3. Select **OK** to continue if the conditions are met.

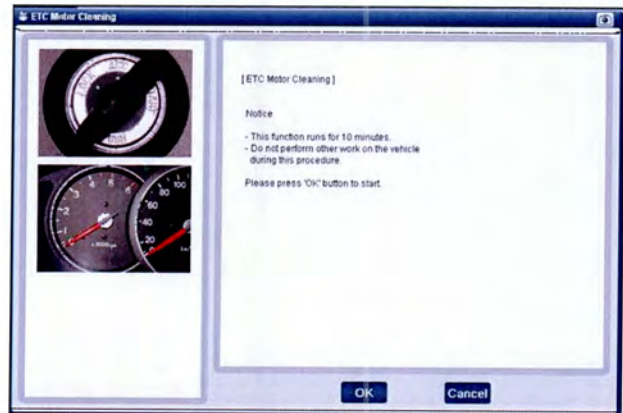
4. The ETC Motor Cleaning will take approximately 10 minutes. Select **OK** to continue.

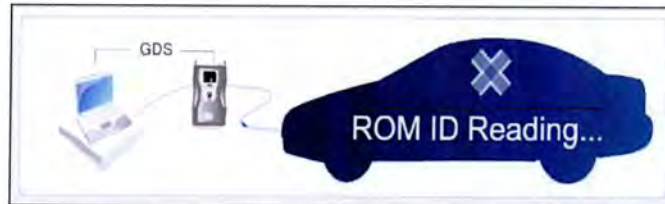
1. From the GDS home page, select **ECU Upgrade**. If necessary, select the VIN.
2. Select **Engine** as the system and then select **OK**.
3. Select **Auto Mode** and then select **Next**.
4. From the **System** tab, select **Engine** and then select **OK**. The GDS will read the ROM ID. Confirm the ROM is applicable as shown on Page 2, "ECM ROM ID Information".
NOTE: Record the ECM ROM ID in case the auto update fails and a manual update is needed.

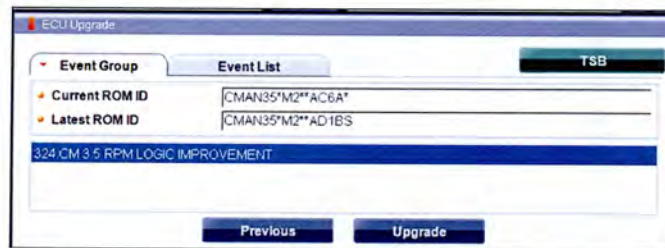
5. Update event "**324.CM 3.5 RPM LOGIC IMPROVEMENT**" will display. Select **Upgrade**.
