HYUNDAI NEW THINKING. NEW POSSIBILITIES. Technical Service Bulletin	GROUP FUEL SYSTEM	NUMBER 14-FL-007
	DATE DECEMBER 2014	MODEL(S) TUCSON (LM)
SUBJECT: ECM UPDATE – TUCSON 2.4L MIL ON (DTC P0300-P0304)

This bulletin provides information related to the ECM software update on certain 10~11MY TUCSON (LM) 2.4L vehicles which may experience a check engine light with any of the following DTC's:

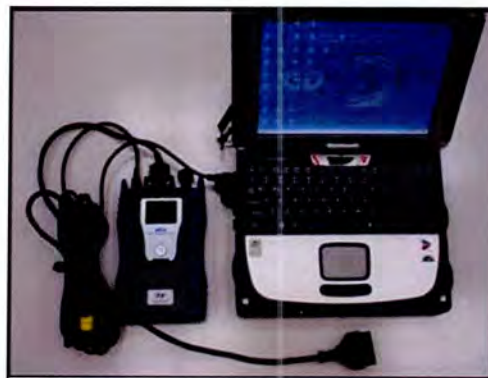
- Connect the USB cable between the GDS and the VCI.
- Connect the 16-pin DLC connector from the VCI into the DLC located under the driver’s side dash.
