HYUNDAI NEW THINKING. NEW POSSIBILITIES.	GROUP CAMPAIGN	NUMBER 14-01-060
	DATE DECEMBER 2014	MODEL(S) ACCENT (RB)
Technical Service Bulletin		
SUBJECT: ECM UPDATE – 15MY ACCENT (RB) 1.6L GDI CHECK ENGINE LIGHT ON WITHOUT ENGINE DTC STORED (SERVICE CAMPAIGN TW0)

SUBJECT ECM UPDATE – 15MY ACCENT (RB) 1.6L GDI CHECK ENGINE LIGHT ON W/O ENGINE DTC STORED

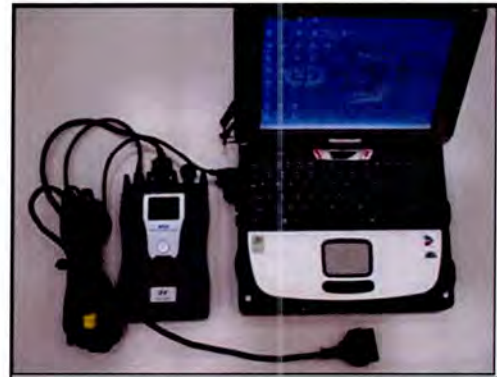
- Connect the USB cable between the GDS and the VCI.
- Connect the 16-pin DLC connector from the VCI into the DLC located under the driver's side dash.
