**HYUNDAI**NEW THINKING.  
NEW POSSIBILITIES.

## Technical Service Bulletin

GROUP	NUMBER
CAMPAIGN	14-01-008
DATE	MODEL
JANUARY 2014	ELANTRA (MD)

**SUBJECT:** 2013 MY ELANTRA (MD) ECM & TCM UPDATE (SERVICE CAMPAIGN TS4)

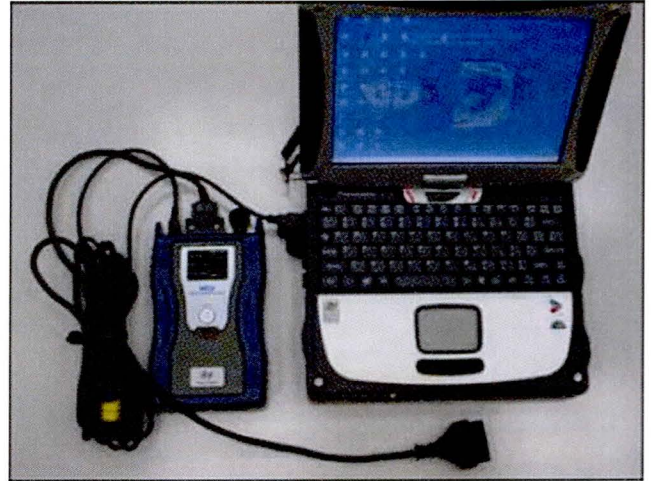
- Connect the USB cable between the GDS and the VCI.
- Connect the 16-pin DLC connector from the VCI into the DLC located under the driver's side dash.
