Service Bulletin

CHECK ENGINE LIGHT AND AUTOMATIC TRANSAXLE WARNING LIGHT ON WITH DTC P0842, P0847, P0872 AND/OR P0877 STORED IN TCM MEMORY

Bulletin No: 05-005/14

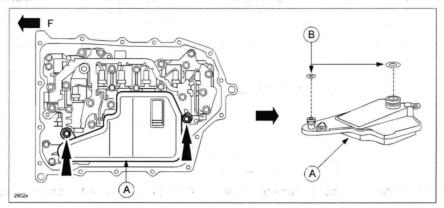
4. Remove the oil strainer (A) and the oil strainer O-rings (B) from the transaxle. F=Front of vehicle

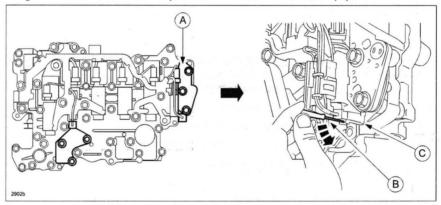
- 5. Remove oil pressure switch A.
 - a. At oil pressure switch A, insert a precision flathead screwdriver (B) and move it in the direction of the arrow in the figure to disconnect the oil pressure switch A connector (C).

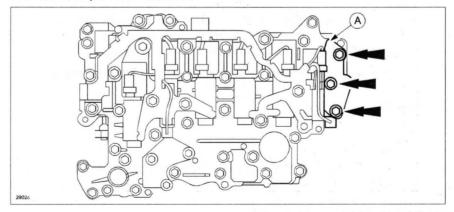
b. Remove the bolts for oil pressure switch A.

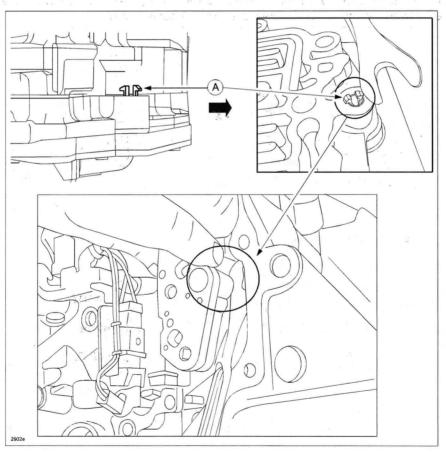
- c. Detach the tab shown and remove oil pressure switch A from the control valve body.
 - 1. Using an appropriate tool (such as a fastener remover), push the tab (A) of oil pressure switch A.

CAUTION: If the tab is broken during removal, make sure to remove the broken pieces.

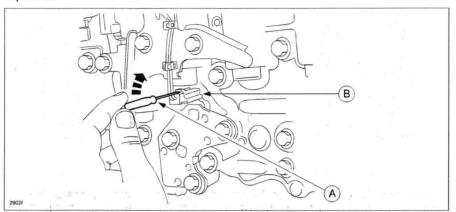
- 6. Remove oil pressure switch B.
 - a. Insert a precision flathead screwdriver (A) and move it in the direction of the arrow as shown to disconnect the oil pressure switch B connector.

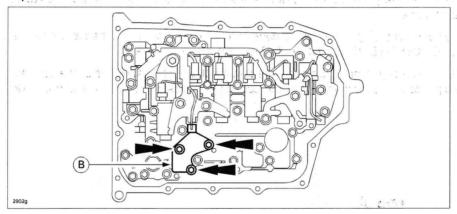
b., Remove oil pressure switch B.

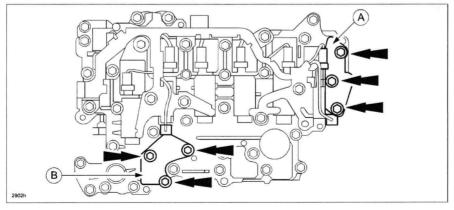
- 8. Verify that the tab of each oil pressure switch A and B is attached correctly.
- Install the bolts for oil pressure switches A and B.
 Tightening torque: 9-10 N•m {92-101 khf•cm, 80-88 in•lbf}

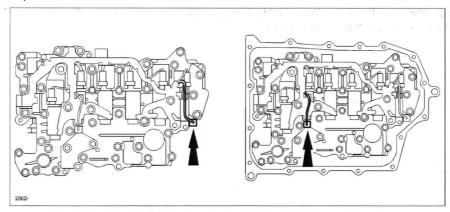
10. Connect the oil pressure switches A and B connectors.

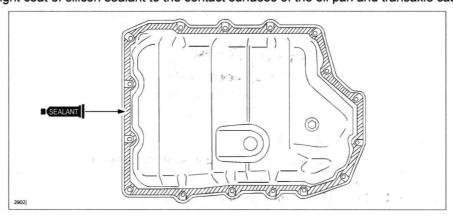
CAUTION: Clean any remaining silicone sealant off the contact surfaces of the transaxle case and oil pan. a. Apply a light coat of silicon sealant to the contact surfaces of the oil pan and transaxle case.

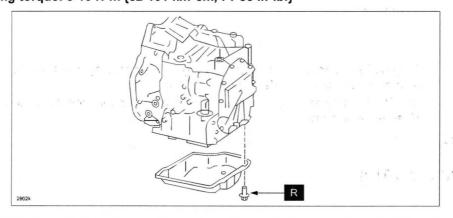
b. Install the oil pan with new bolts before the applied sealant starts to harden.

Tightening torque: 8-10 N•m {82-101 khf•cm, 71-88 in•lbf}
