MODEL
2014MY Sorento (XMa)
w/Base Audio
2013MY Rio (UB)
w/Base Audio

NUMBER
076

TECHNICAL SERVICE BULLETIN

SUBJECT: AUDIO SOFTWARE UPGRADE - BLUETOOTH® CALL CUTS OFF

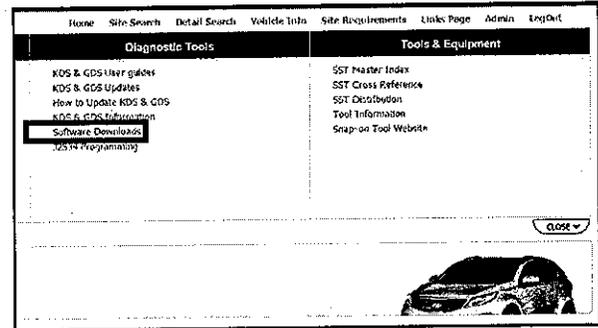
1. Log onto www.kdealer.com > KGIS and click on Diagnostic Tools > Software Downloads from the navigation menu.

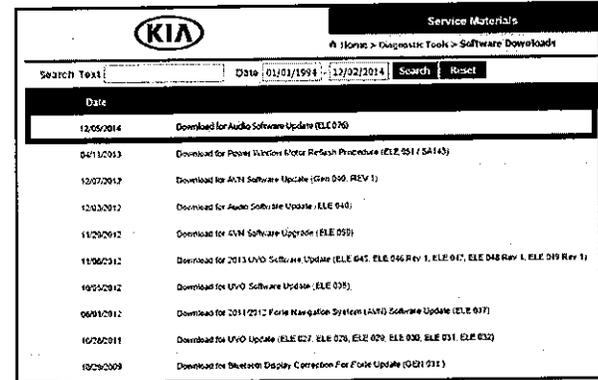
2. Click on "Download for Audio Software Update (ELE 076)".

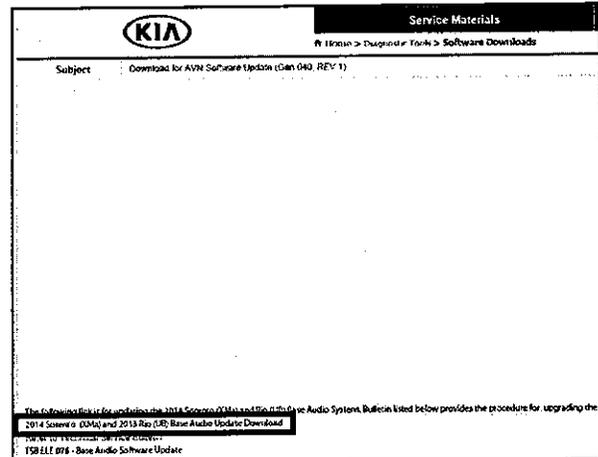
3. Click on "2014 Sorento (XMa) and 2013 Rio (UB) Base Audio Update Download".

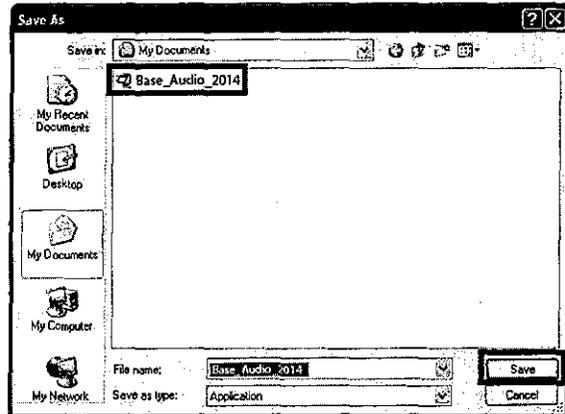
- 4a. Save file onto computer by clicking "Save".
- 4b. Navigate to saved location and double click on file to open it. The file name is Base_Audio_2014.

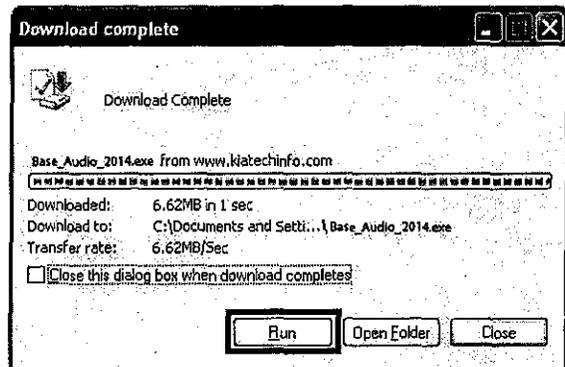
5. Click "Run."

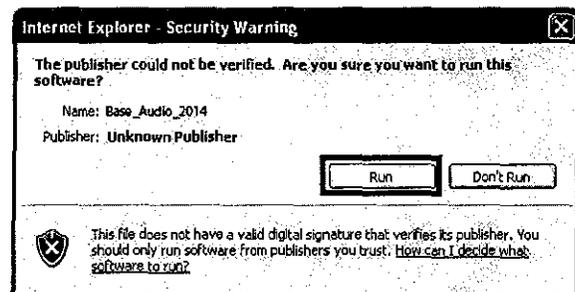
6. Click "Run."

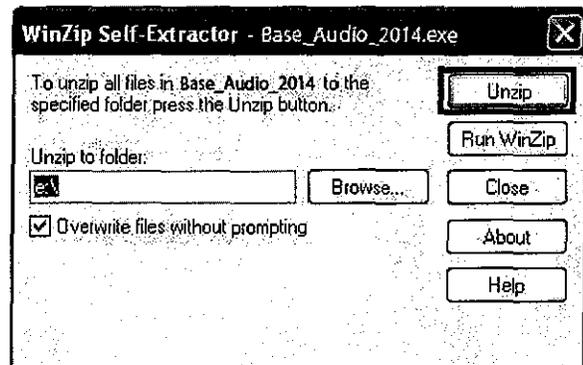
7. Insert a flash drive into USB port on your computer, select the port where the USB is connected to and click "Unzip". The files will be downloaded to the USB flash drive.

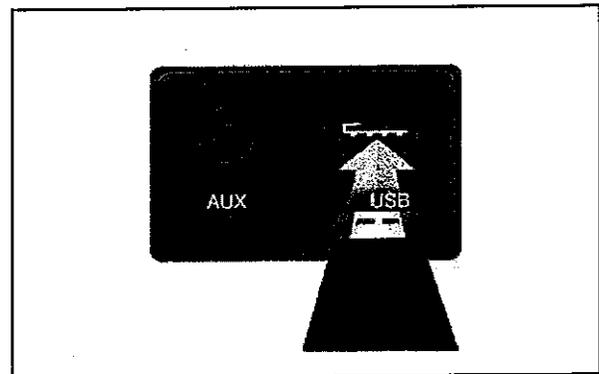
10. Insert the USB flash drive into the vehicle's USB port and allow the music file to play for one (1) second.

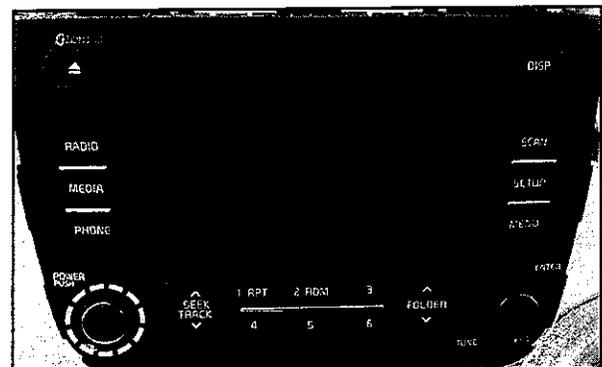
11. Press the "POWER" button to turn the audio system OFF.

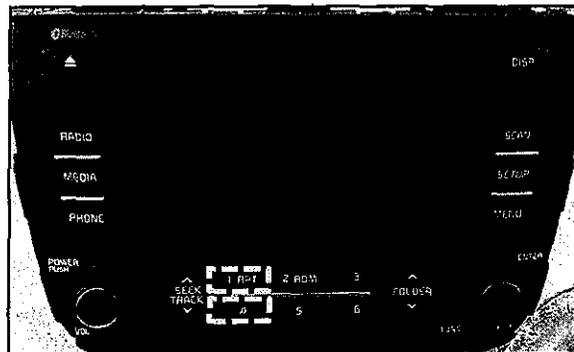
12. To access the Engineering Mode on Sorento (XMa) vehicles: Press and hold buttons 1 and 4 simultaneously for 2 seconds, then, press the button 1 four times in quick succession.

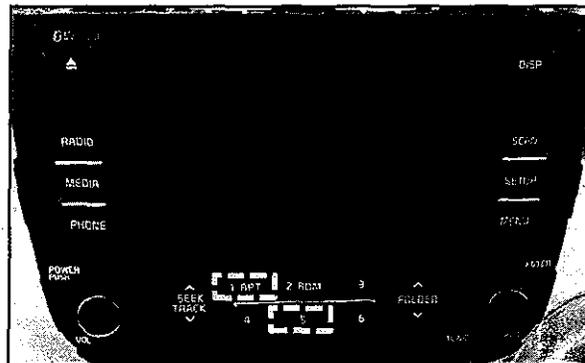
13. To access the Engineering Mode on Rio (UB) vehicles: Press and hold buttons 1 and 5 simultaneously for 2 seconds, then, press the button 1 four times in quick succession.

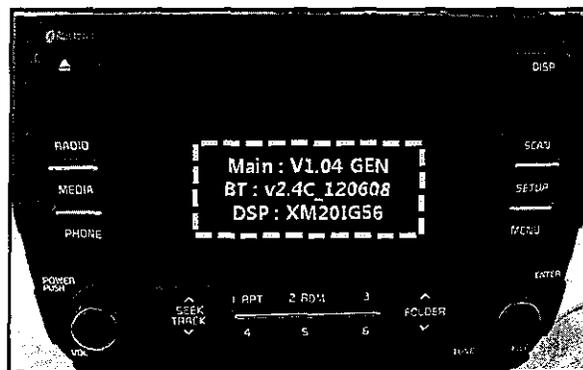
14. Once in engineering Mode, the system will display the software version on the screen. Confirm the original software version matches the information shown in the table below.

Original S/W Version
BT : v2.4C

If the original software version is BT: v2.4D, No further action is required.

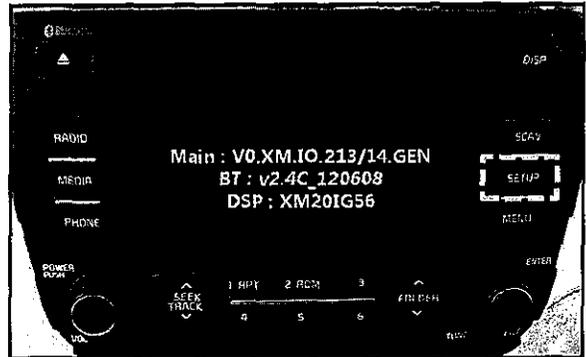
- 15. Press the "SETUP" button.

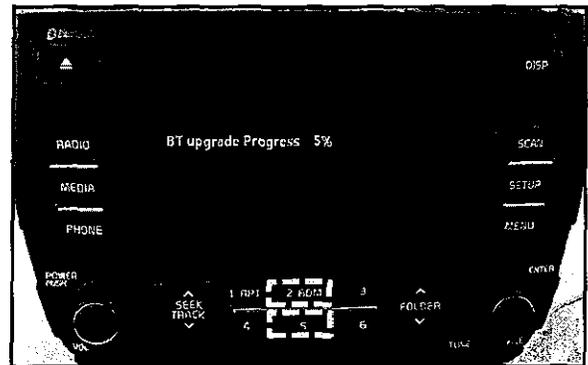
- 16. Press button 5, then, press button 2 to access "BT Upgrade". The upgrade progress will be shown on the screen.
