# Entune Audio Head Unit Software Update (Panasonic)

Service  
Category    Audio/Visual/Telematics

Section     Audio/Video

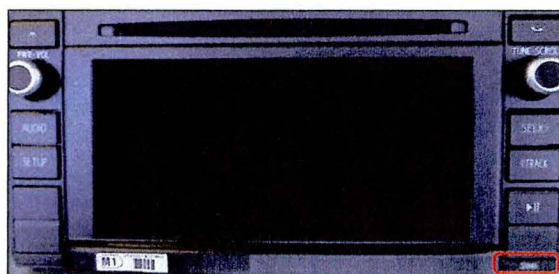
Figure 1. Highlander, Sequoia, Tacoma, & Tundra

1. Confirm the audio system type by checking the Panel ID printed on the bottom-right or bottom-center of the machine.

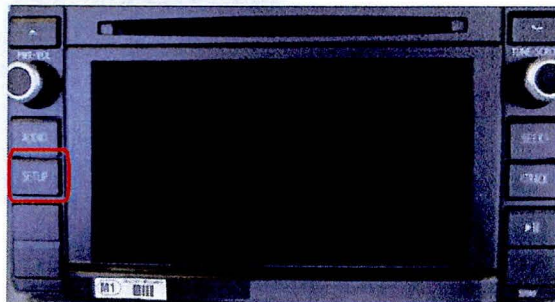
**Figure 3. Tacoma, Sequoia**

**A. For Entune™ Audio:**

Press the *SETUP* button on the panel.

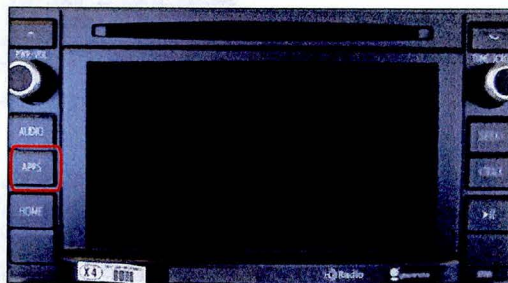
**Figure 5. 4Runner, Highlander, Highlander HV, Sequoia, Tacoma and Tundra**

**B. For Entune™ Audio Plus / Entune™ Premium Audio:**

(1) Press the *APPS* button on the panel.

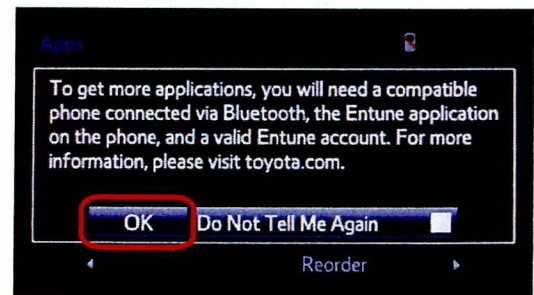
**Figure 7.**

If Entune™ pop-up displays, select *OK*.

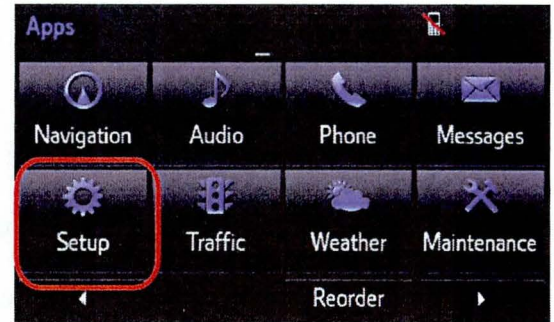
**Figure 8.**

- (2) Select *Setup* on the *Apps* screen.

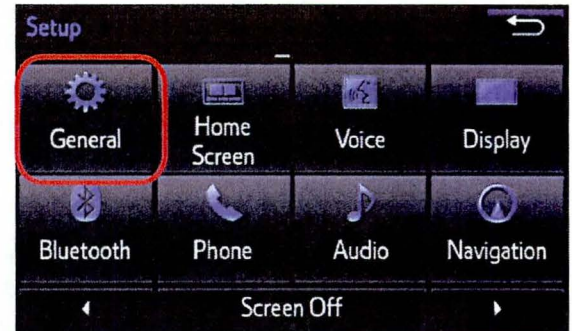
**Figure 9.**

5. Select *General* on the *Setup* screen.

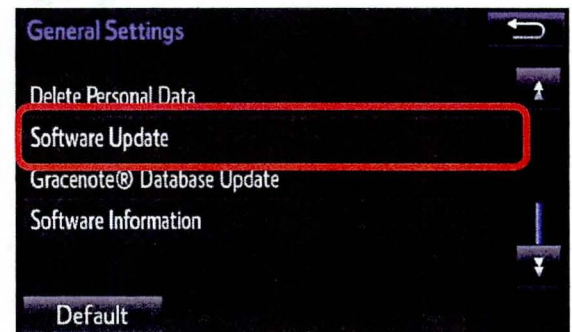
**Figure 10.**

6. Select *Software Update* from the list on the *General Settings* screen.

Scroll down the list until *Software Update* is displayed.

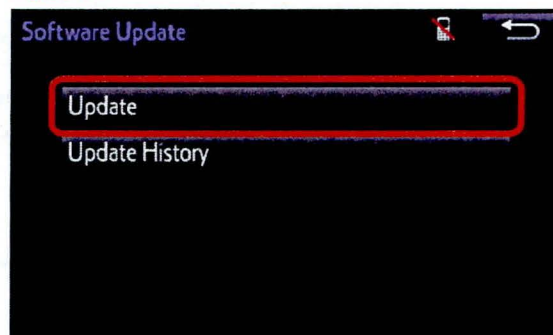
Figure 11.

7. Select *Update* on the *Software Update* screen.

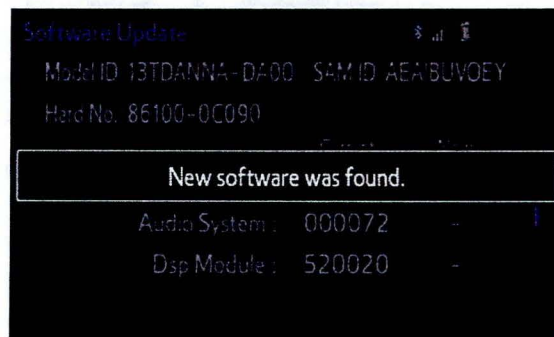
Figure 12.

If software has been detected properly, a "New software was found." pop-up will be displayed.

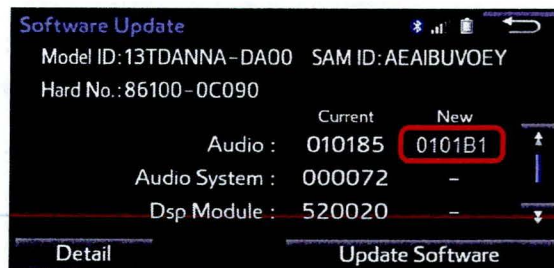
Figure 13.

8. Verify that the new software is up-to-date on the *Software Update* screen.

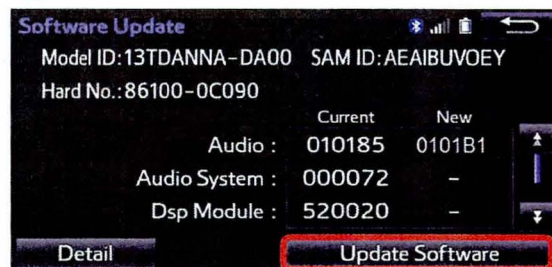
Figure 14.

9. Select *Update Software* on the *Software Update* screen.

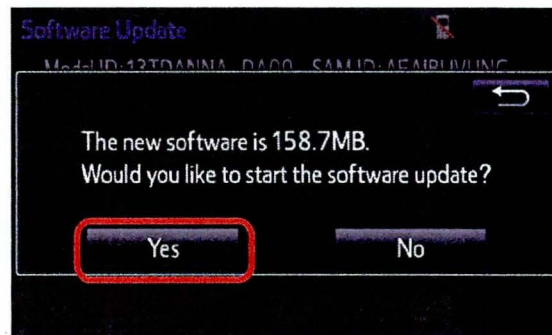
Figure 15.

10. Select *Yes* on the “Would you like to start the software update?” pop-up.

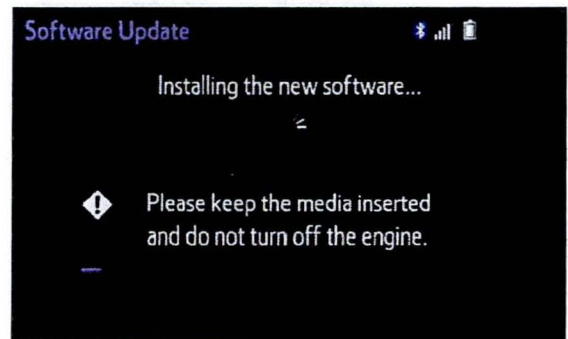
Figure 16.

11. The unit begins installation. The update will take about 10 minutes.

- Do NOT turn off the engine or ACC before the software is ready for updating.
- Do NOT pull the USB Drive SST out of the vehicle USB port.

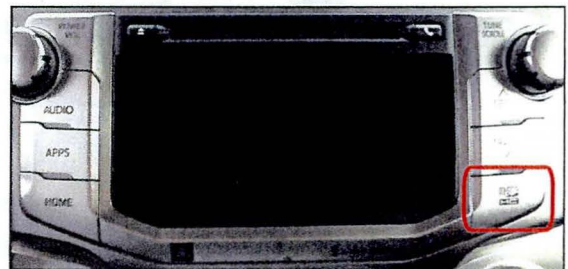
Figure 17.

If update fails and the error message "New software is not compatible with the system." displays, cycle the ignition OFF, remove the Map Micro SD Card from the head unit, and repeat steps 2 – 11.

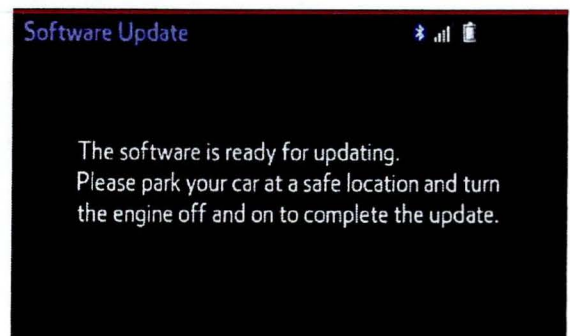
Figure 18.

12. When "The software is ready for updating." displays, cycle the ignition OFF.

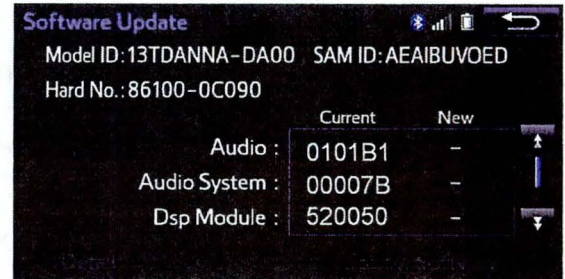
1. Perform steps 3 – 7 of the Software Update procedure to re-enter the *Software Update* screen.
2. Verify that the software information is updated on the *Software Update* screen.
