Entune Audio Head Unit Software Update (Panasonic)

YEAR(S)	MODEL(S)	ADDITIONAL INFORMATION
2014	4Runner, Highlander, Sequoia, Tacoma, Tundra

Updated system software is now available to address these conditions. Follow the repair procedure in this bulletin to install the latest software version.

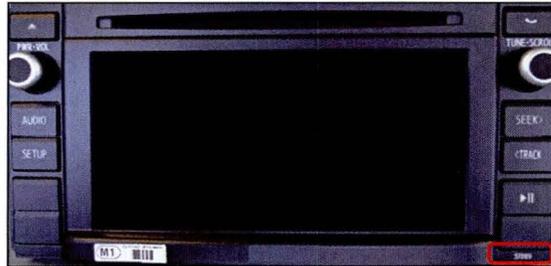
Figure 1. Highlander, Sequoia, Tacoma, & Tundra

1. Confirm the audio system type by checking the Panel ID printed on the bottom-right or bottom-center of the machine.

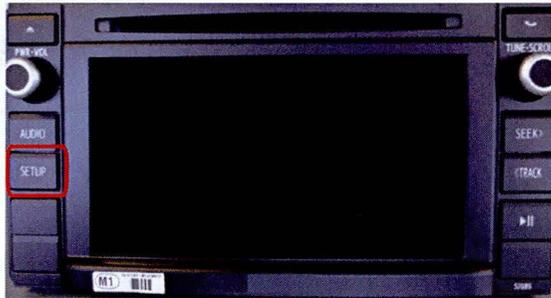
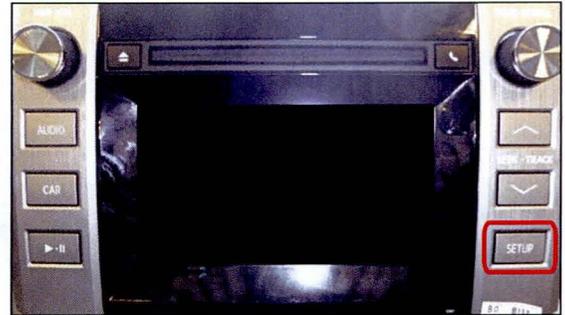
A. For Entune™:

Press the *SETUP* button on the panel.

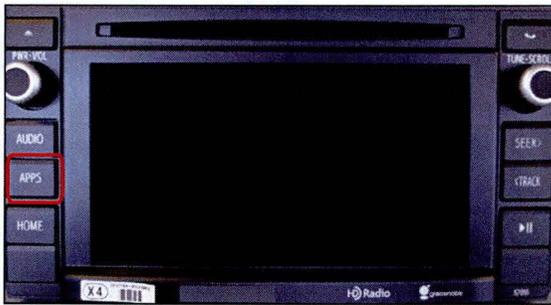
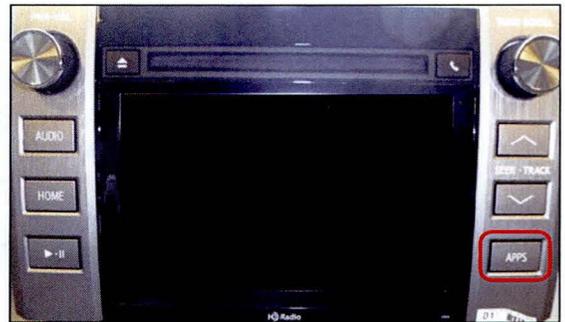
B. For Entune™ Plus / Entune™ Premium:

Press the *APPS* button on the panel.

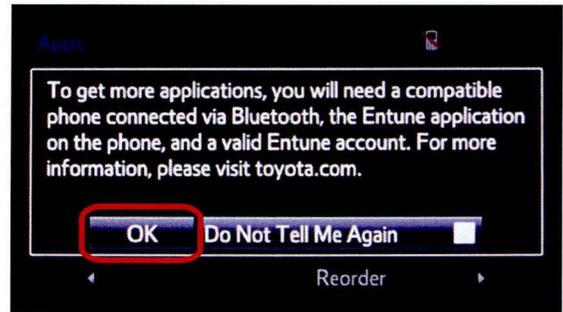
Figure 7.

If Entune™ pop-up displays, select *OK*.

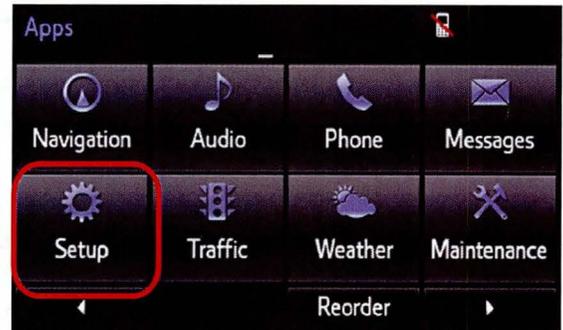
Figure 8.

Select *Setup* on the *Apps* screen.

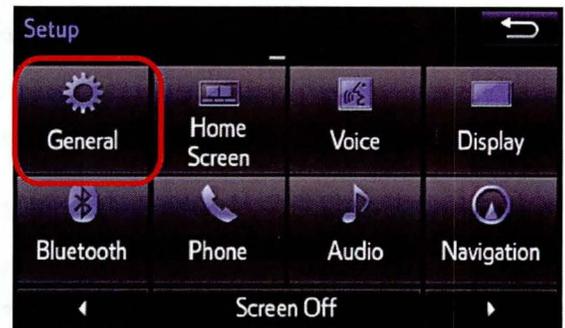
Figure 9.

5. Select *General* on the *Setup* screen.

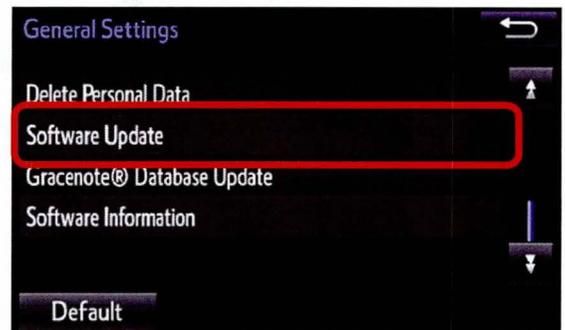
Figure 10.

6. Select *Software Update* from the list on the *General Settings* screen.

Scroll down the list until *Software Update* is displayed.

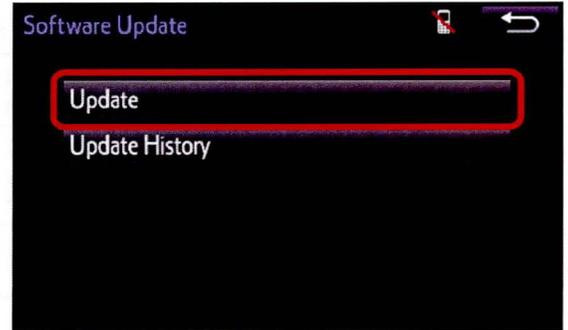
Figure 11.

7. Select *Update* on the *Software Update* screen.

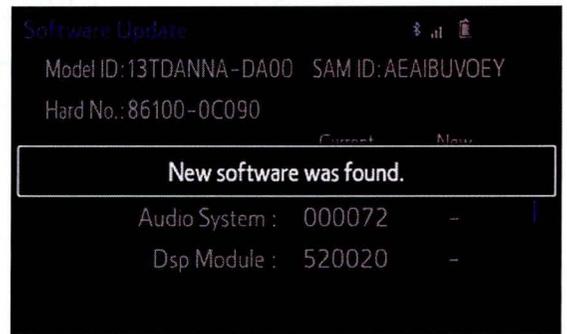
Figure 12.

If software has been detected properly, a "New software was found." pop-up will be displayed.

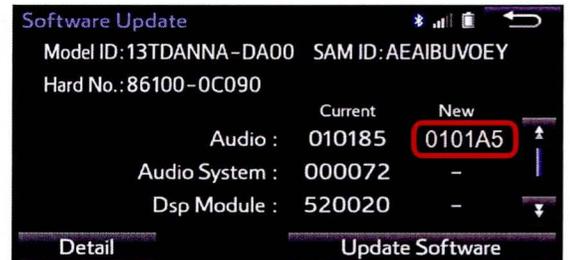
Figure 13.

8. Verify that the new software is up-to-date on the *Software Update* screen.

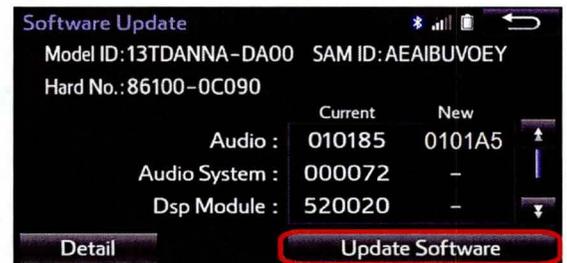
Figure 14.

9. Select *Update Software* on the *Software Update* screen.

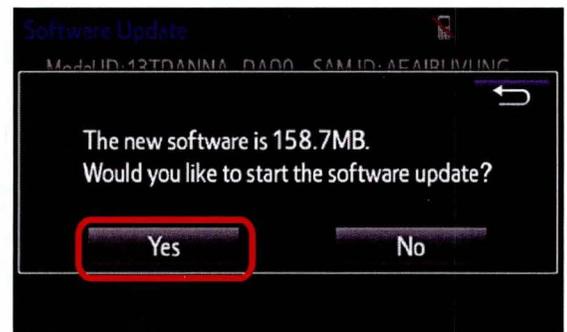
Figure 15.

10. Select *Yes* on the “*Would you like to start the software update?*” pop-up.

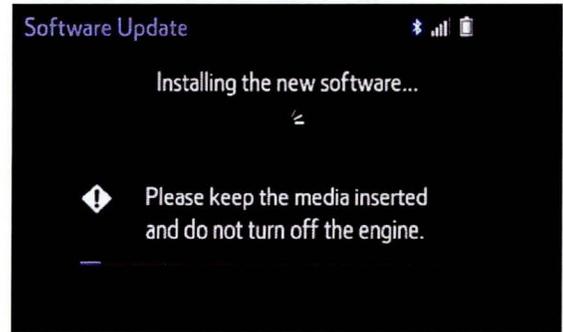
Figure 16.

11. The unit begins installation. The update will take about 10 minutes.

- Do NOT turn off the engine or ACC before the software is ready for updating.
- Do NOT pull the USB Drive SST out of the vehicle USB port.

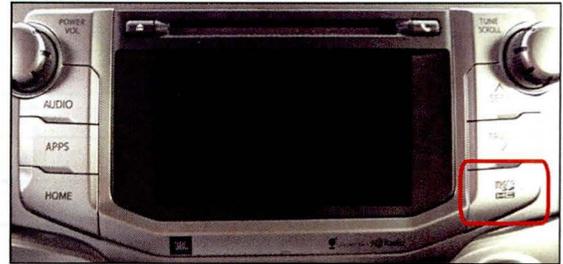
Figure 17.

If update fails and the error message "New software is not compatible with the system." displays, cycle the ignition OFF, remove the Map Micro SD Card from the head unit, and repeat steps 2 – 11.

Software update error is more likely to occur in areas with more traffic information.

Once update is complete, reinsert the Map Micro SD card into the head unit, cycle the ignition OFF, and proceed to step 13.

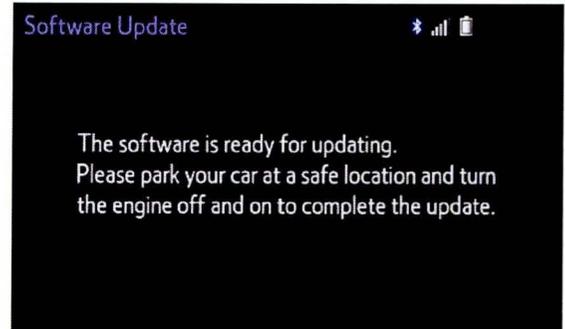
12. When "The software is ready for updating." displays, cycle the ignition OFF.

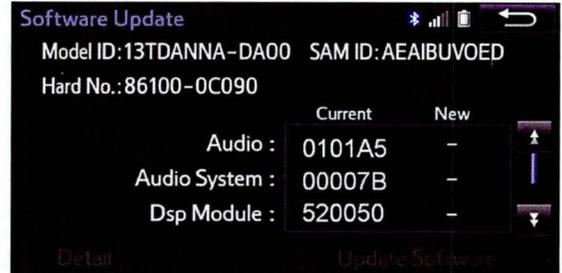
Figure 19.

1. Perform steps 2 – 6 of the Software Update procedure to re-enter the *Software Update* screen.
2. Verify that the software information is updated on the *Software Update* screen.
