S-SB-0015-14

Techstream ECU Flash Reprogramming Procedure

Service Category Engine/Hybrid System

Section Engine Control

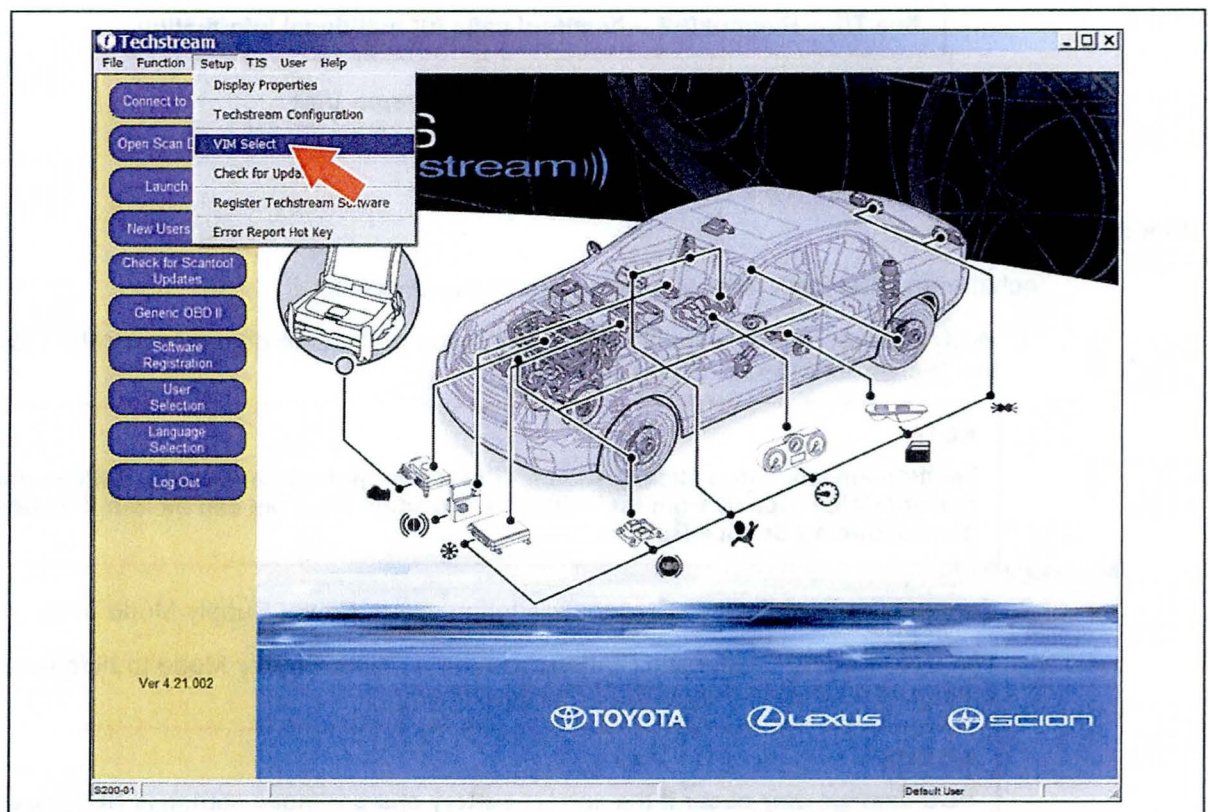
Figure 1.

1. Select *Setup* from the Techstream Main Menu screen.
2. Select *VIM Select* from the Setup drop down menu.

3. Select the correct Interface Setup from the drop down list.
 - If using Techstream 2.0, select *MongoosePro MFC*.
 - If using Techstream Lite, select *Mongoose MFC* or *MongoosePro MFC* (depending on the cable being used).

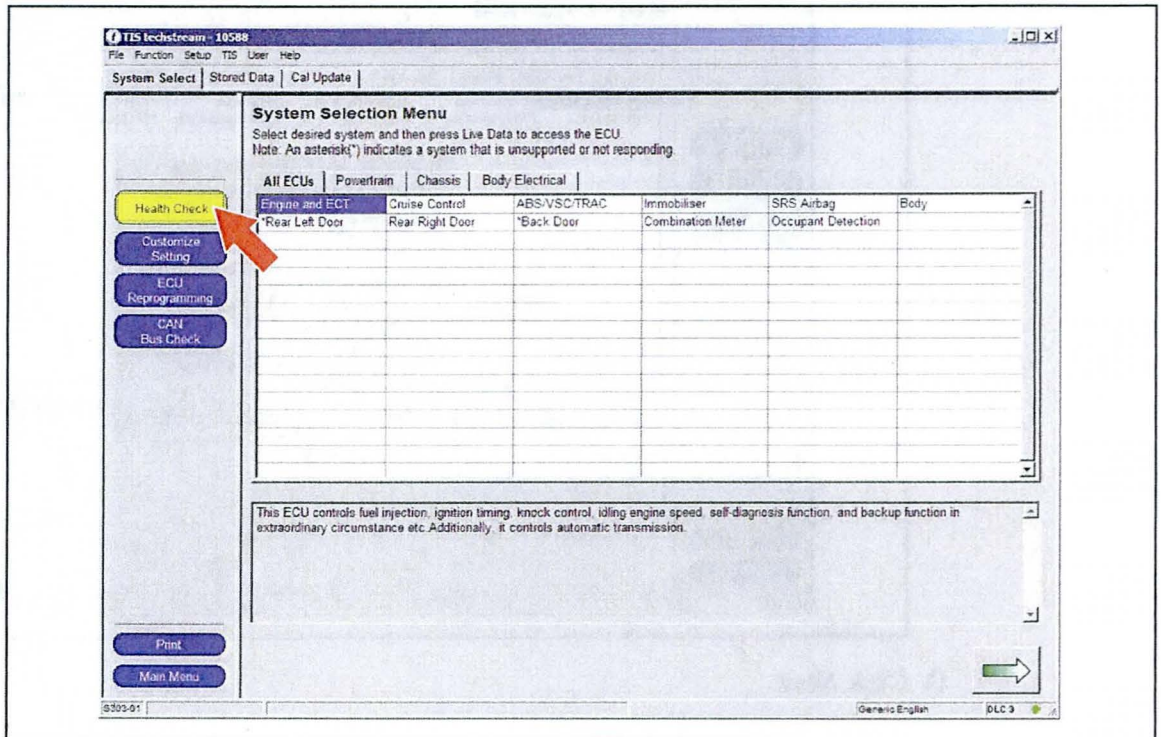
Figure 2.

1. Verify the vehicle's applicability for recalibration and locate desired calibration file.
 - A. Connect Techstream and establish a vehicle connection.
 - B. Click the *Health Check* button on the *System Select* tab.

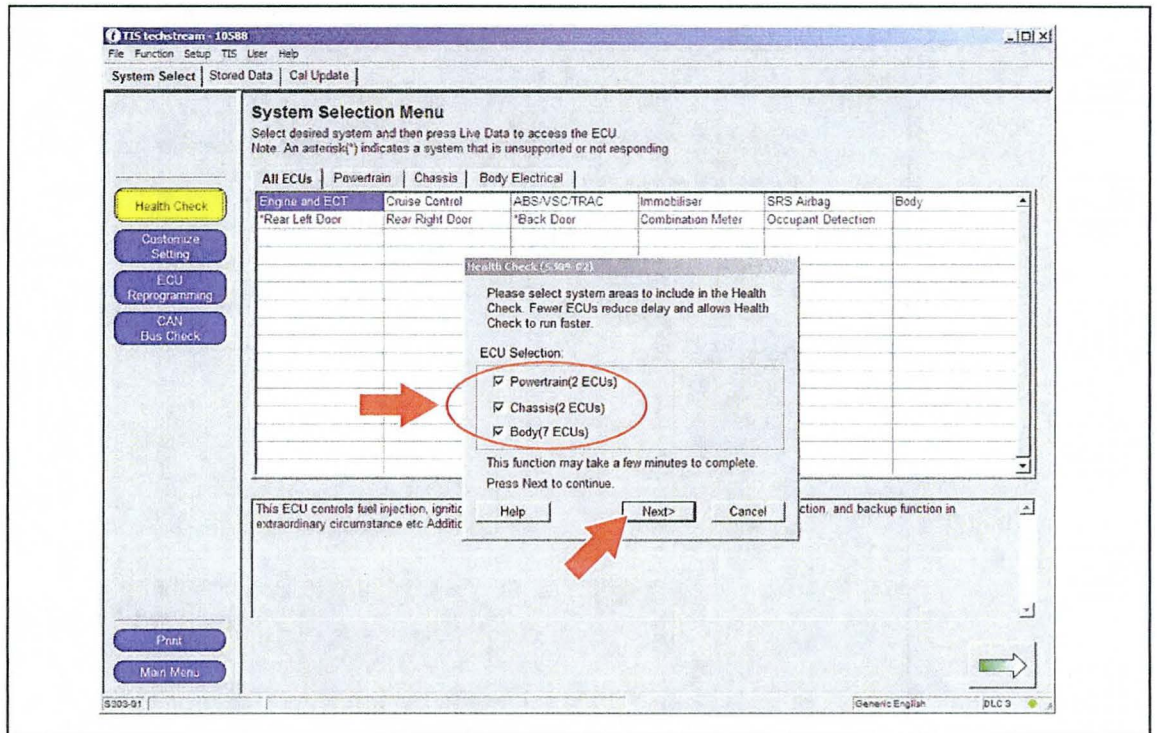
Figure 3.

C. Choose desired ECU group(s) in the *Health Check* dialog box.

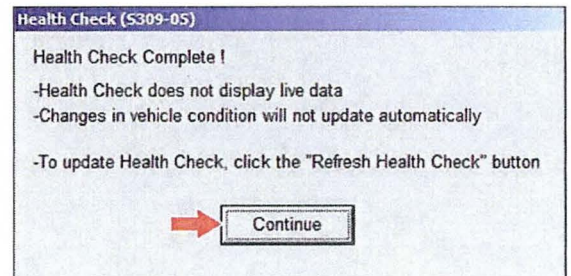
Figure 4.

E. Click *Continue* to view Health Check results.

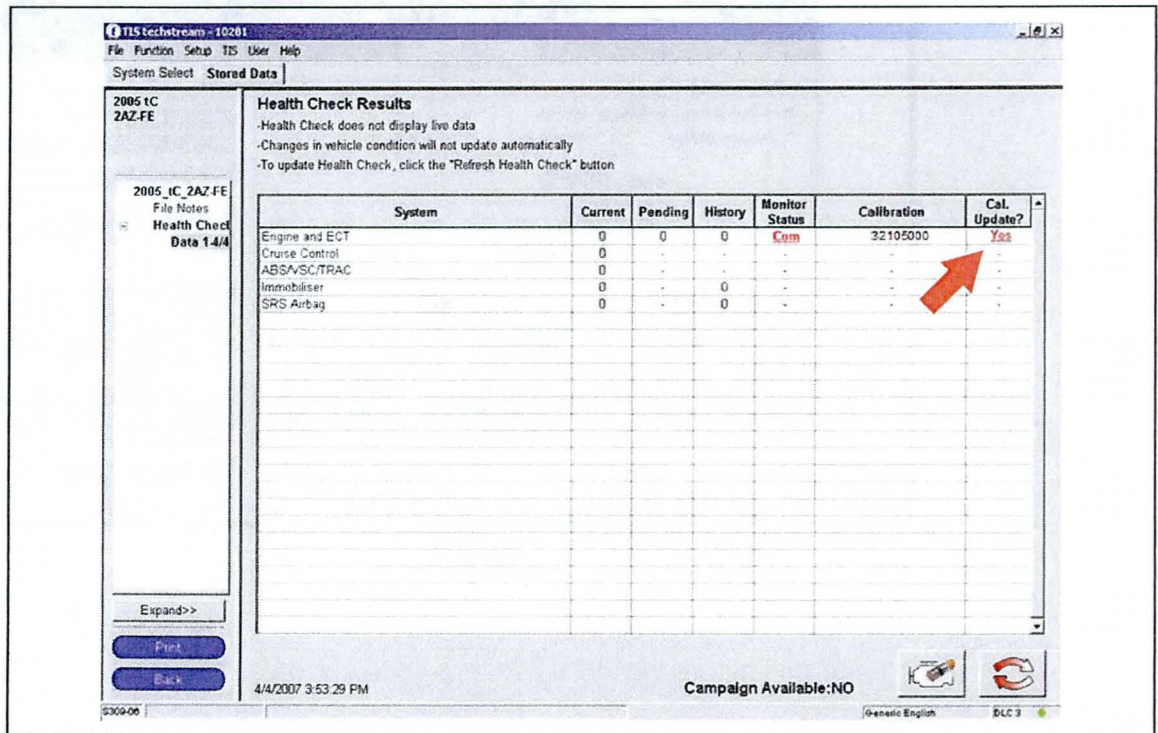
Figure 5.

- F. Available calibration updates are indicated by a **Yes** link in the *Cal. Update?* column. Click the **Yes** link to access the appropriate Service Bulletin on TIS.

- Note any DTCs stored in systems that will be flash reprogrammed.
- Clicking the **Yes** link will automatically launch TIS and perform a calibration search.

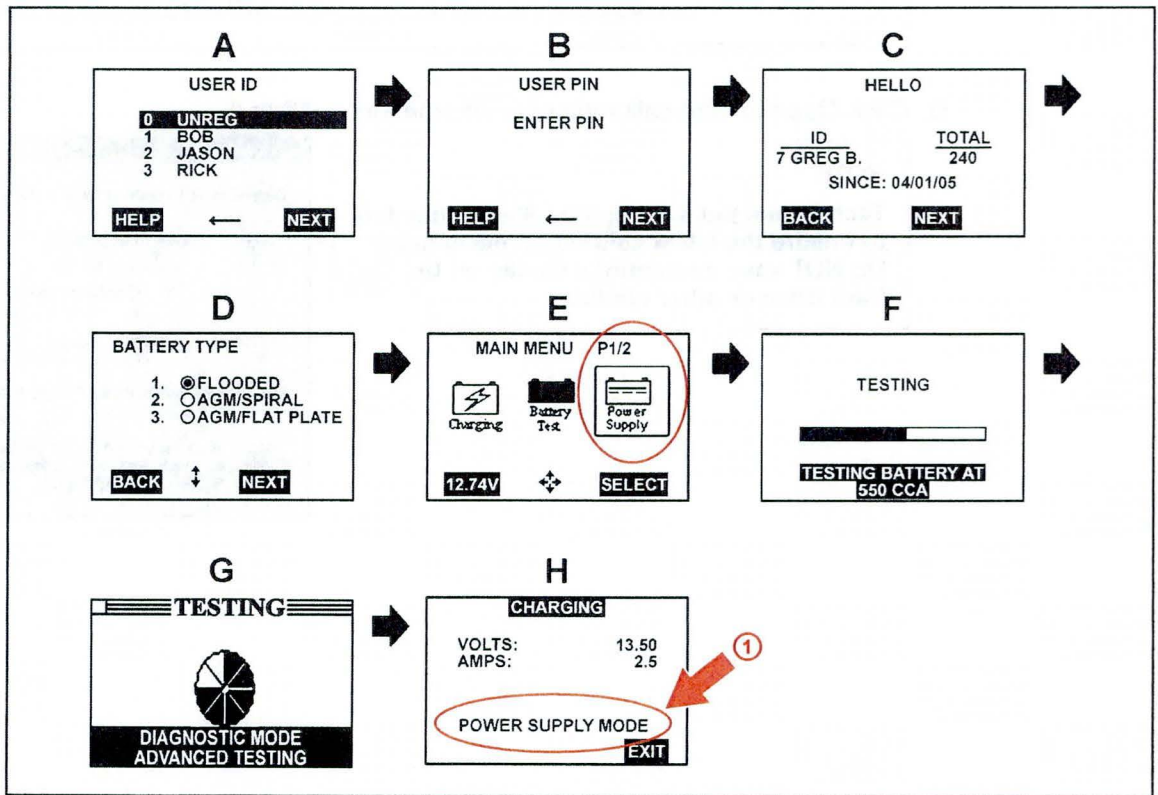
Figure 7.

2. Connect the GR8 Battery Diagnostic Station.
 - A. Connect the GR8 Battery Diagnostic Station to the vehicle and turn it ON.
 - B. Select Power Supply Mode by following the screen flow below.

- ECU damage may occur if the correct battery charger and mode setting are NOT used.
- Power Supply Mode is used to maintain battery voltage at 13.5 volts while flash reprogramming the vehicle.
- For details on how to use the GR8 Battery Diagnostic Station, refer to the [GR8 Instruction Manual](#) located on TIS, *Diagnostics – Tools & Equipment – Battery Diagnostics*.

1 Confirm Power Supply Mode Is Selected

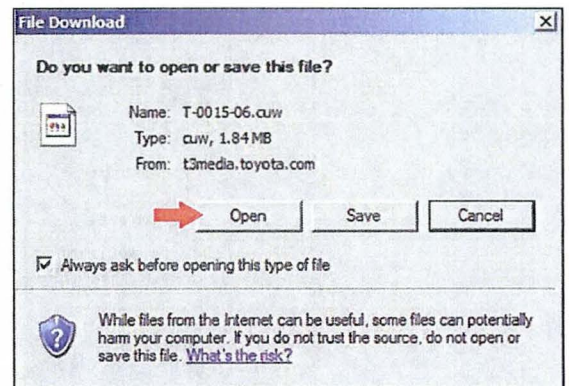
Figure 9.

- B. Click *Open* to load calibration file information.

Techstream pulls calibration files as needed to ensure the latest calibration file is used. Do NOT save calibrations locally on the hard drive or other media.

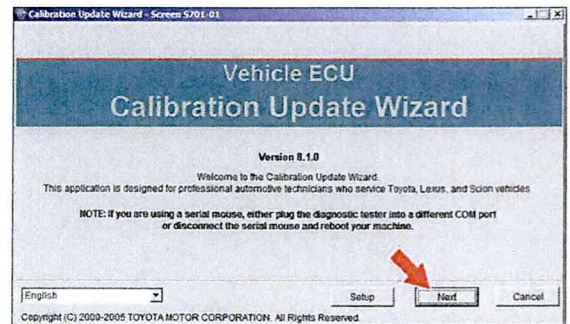
Figure 10.

- C. Click *Next* to start the calibration update process.

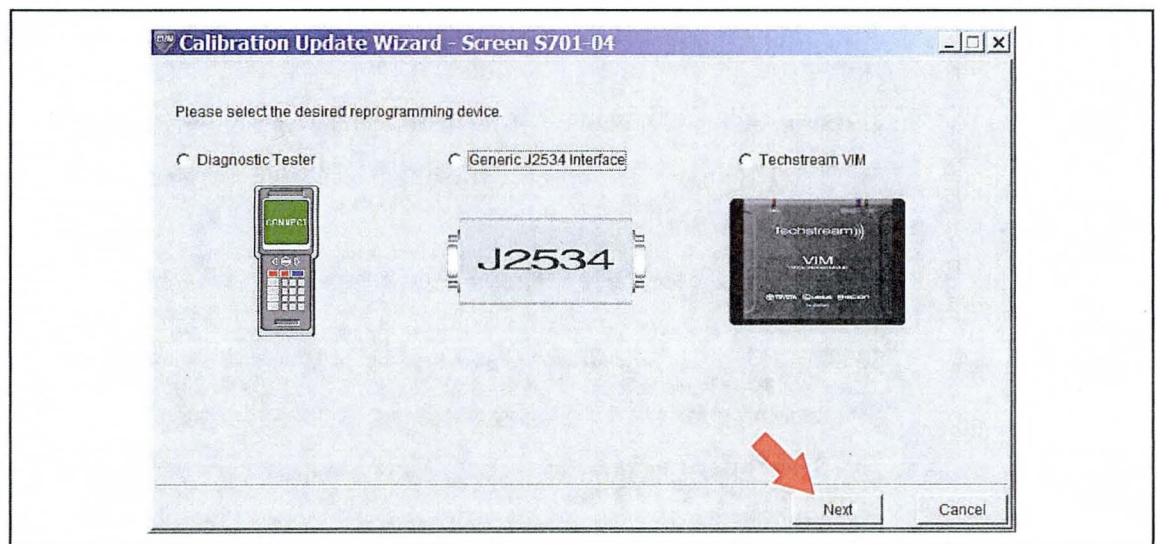
Figure 11.

D. Select the correct reprogramming device.

Then click *Next*.

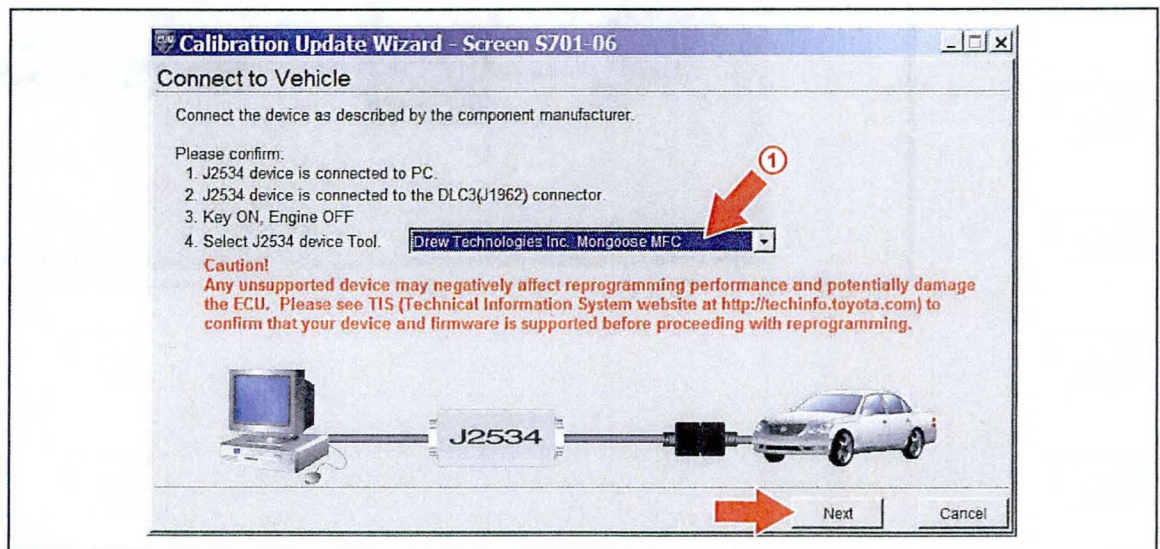
Figure 12. Using Techstream 2.0 or Techstream Lite

1 Select Correct Device Tool ("Mongoose MFC" or "MongoosePro MFC")

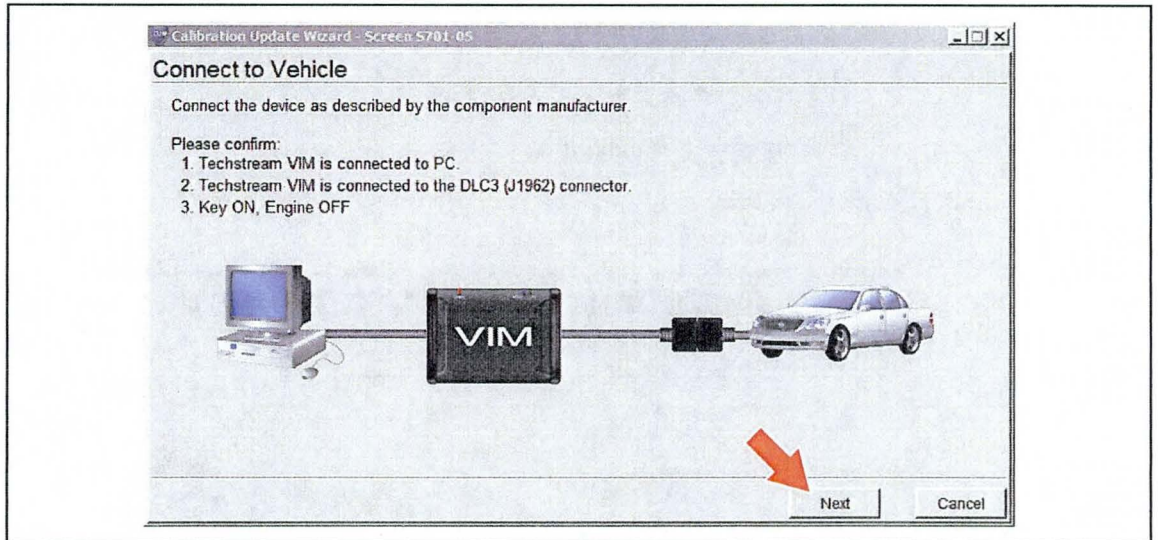
Figure 13. Using TIS Techstream

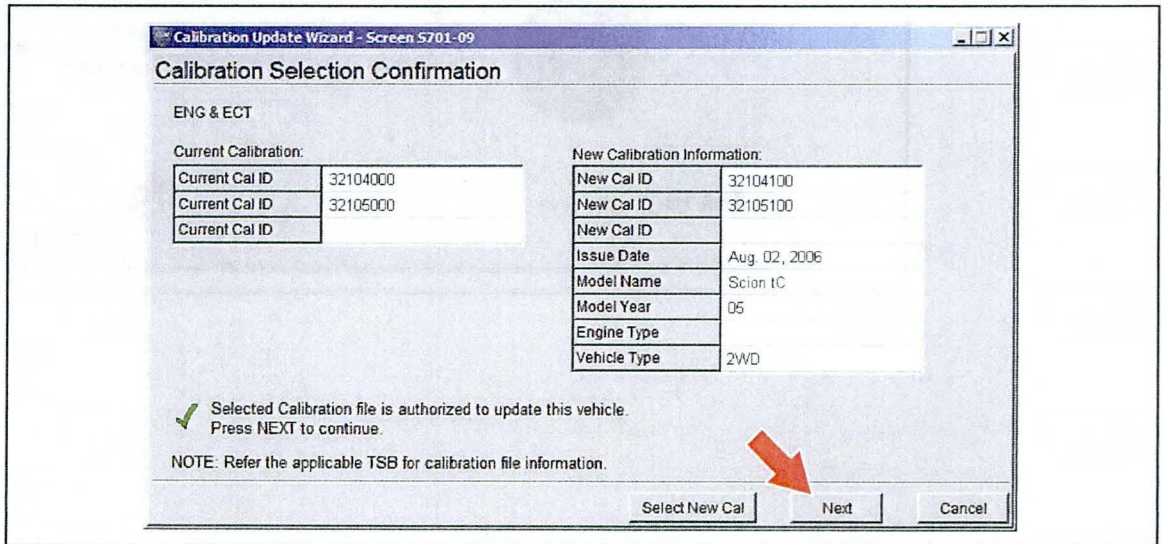
Figure 14.

- The total number of calibration IDs in the calibration file corresponds to the number of reprogrammable processors in the ECU.
- Each calibration file may contain up to three separate calibrations.
- Figure 14 shows an example of the update procedure for a two-processor ECU.

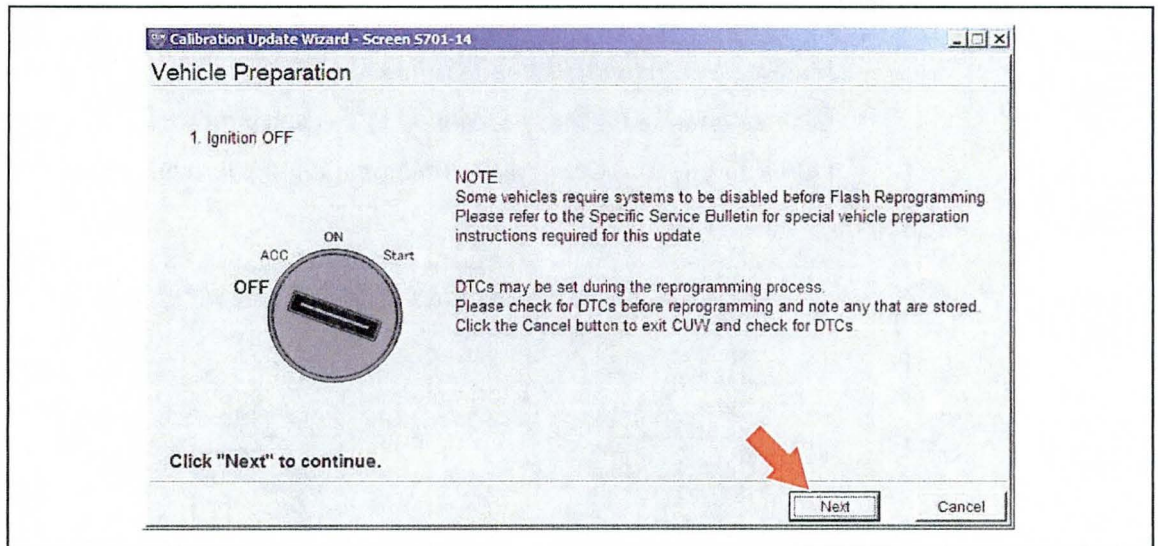
Figure 15.

G. Turn ignition OFF. Then click *Next*.

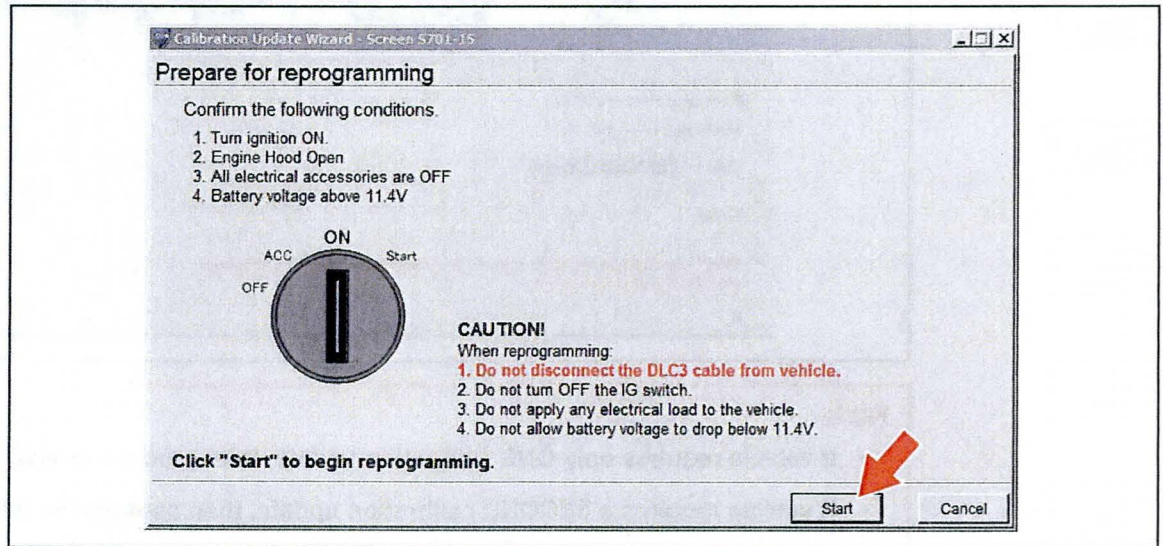
Figure 16.

Verify the vehicle is connected to a battery charger before continuing — If battery voltage falls below 11.4 volts, ECU damage may occur.

Then click *Start*.

If key cycle is NOT done properly, reprogramming will stop at 10% and Cal 1 will fail to load.

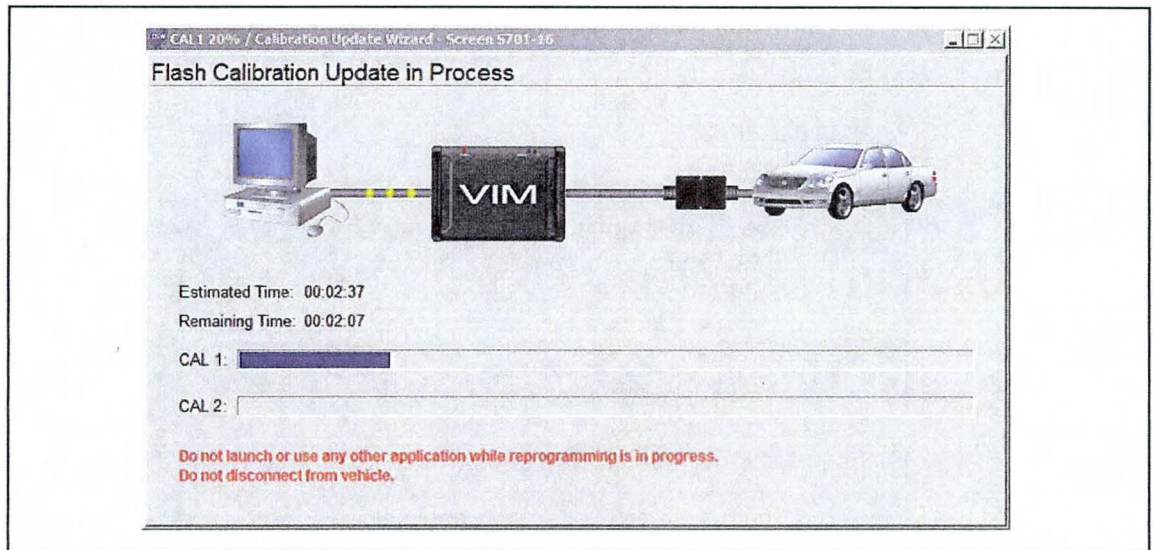
Figure 17.

- ECU flash reprogramming may take anywhere from 3 – 30 minutes per calibration file.
- Reprogramming time will vary depending on model and ECU communication protocol. Vehicles using CAN communication protocol will reprogram much faster (2 – 7 minutes).

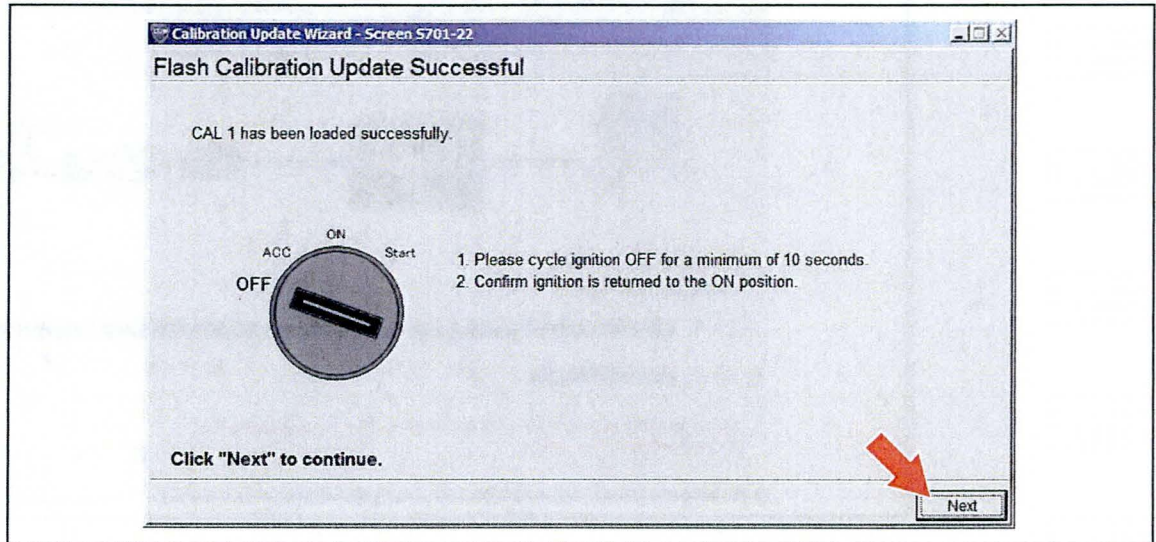
Figure 18.

- J. When Cal 1 has completed the update process, turn ignition OFF for a minimum of 10 seconds. Then click *Next*.

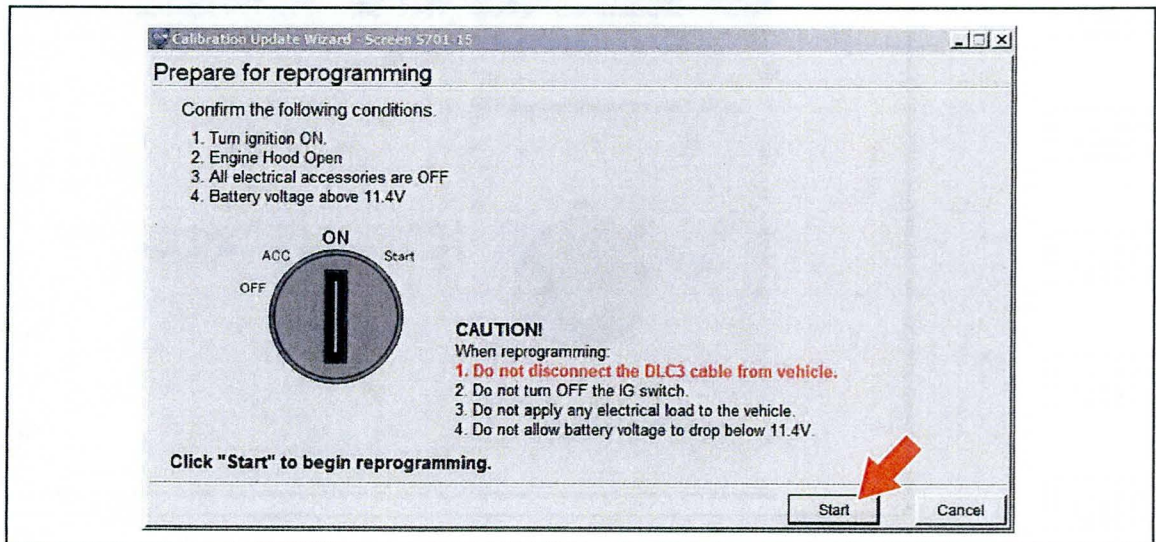
Figure 19.

- K. Turn ignition to the ON position. Then click *Start*.

If key cycle is NOT done properly, reprogramming will stop at 10% and Cal 2 will fail to load.

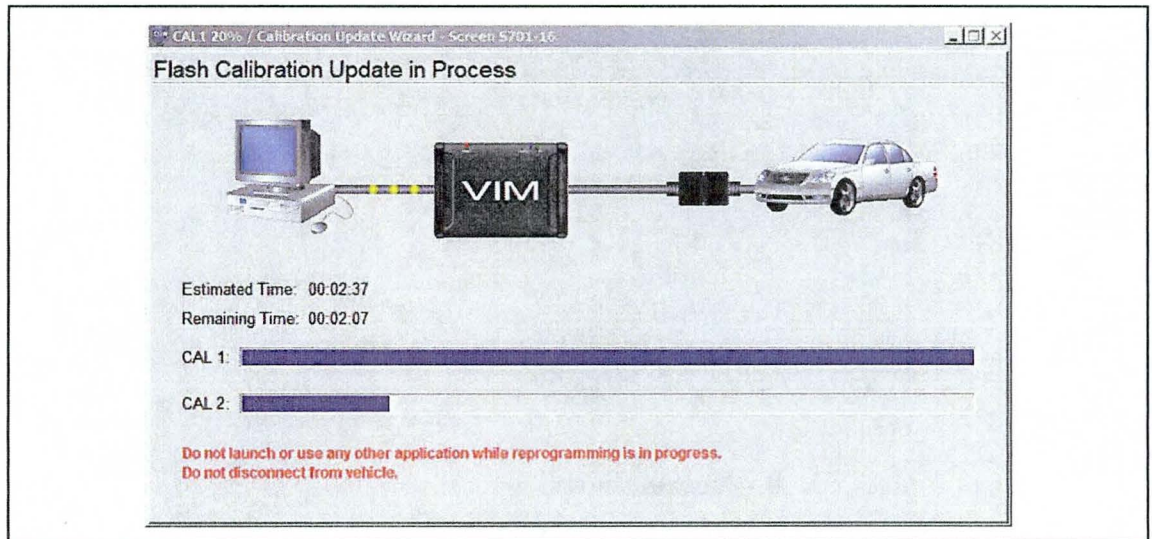
Figure 20.

- L. Do NOT disturb the vehicle during flash reprogramming.

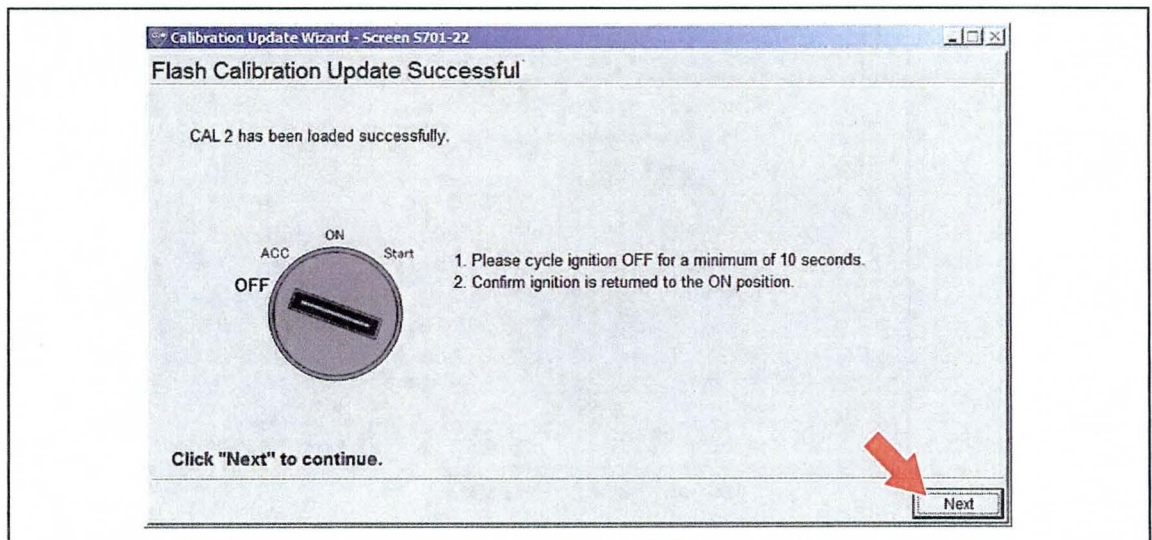
Figure 21.

- M. Turn ignition OFF for a minimum of 10 seconds. Then click *Next*.

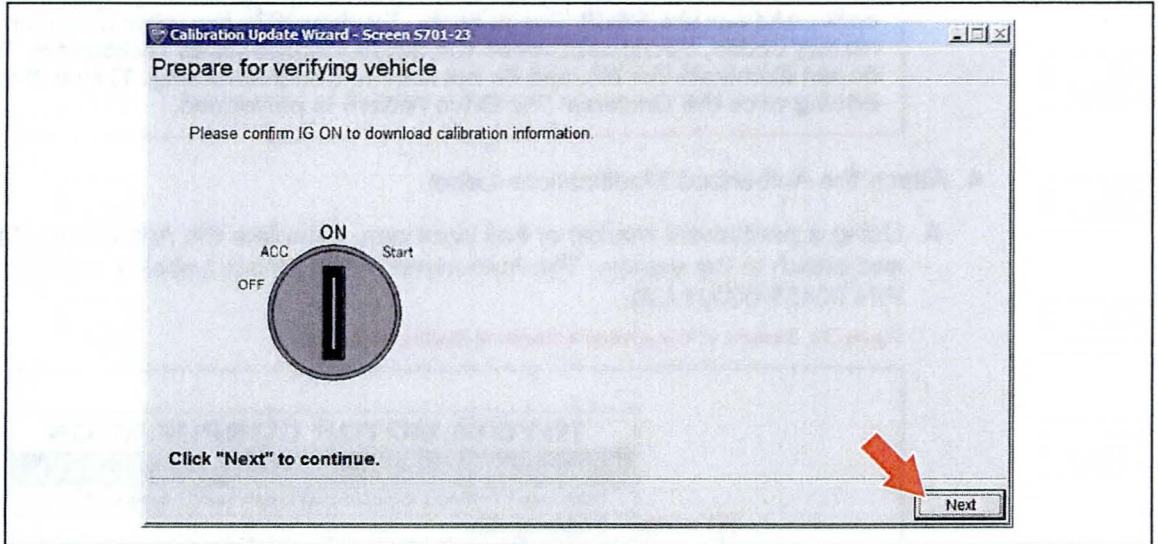
Figure 22.

N. Turn ignition to the ON position. Then click *Next*.

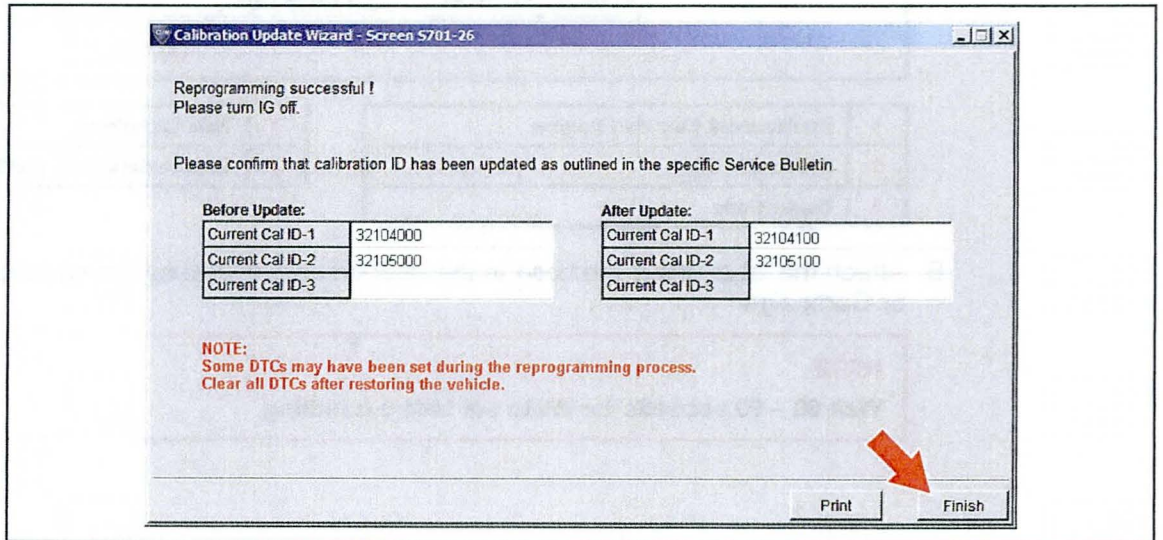
Figure 23.

O. Confirm all calibrations were updated as specified in the Service Bulletin. Then click *Finish*.
