HYUNDAI NEW THINKING. NEW POSSIBILITIES. Technical Service Bulletin	GROUP	NUMBER
	CAMPAIGN	14-01-063
	DATE	MODEL(S)
	DECEMBER 2014	ELANTRA (MD/UD)
SUBJECT:	ECM UPDATE – DTC P2096 (SERVICE CAMPAIGN TW3)

Description: This bulletin provides an ECM update for some 2013MY Elantra vehicles to update the diagnostic logic for DTC P2096 [Post Catalyst Fuel Trim System too Lean (Bank1)].

SUBJECT: ECM UPDATE – DTC P2096 (SERVICE CAMPAIGN TW3)

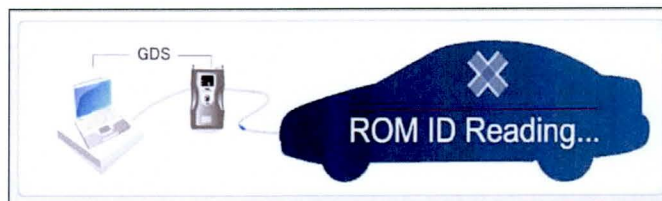
- From the **System** tab, select **Engine** and then select **OK**. The GDS will read the ROM ID. Confirm the ROM is applicable as shown on Page 2-3, "ECM ROM ID Information".
NOTE: Record the ECM ROM ID in case the auto update fails and a manual update is needed.
