<b>HYUNDAI</b>   NEW THINKING. NEW POSSIBILITIES. <b>Technical Service Bulletin</b>	GROUP <b>FUEL SYSTEM</b>	NUMBER <b>14-FL-004</b>
	DATE <b>SEPTEMBER, 2014</b>	MODEL(S) <b>SANTA FE (AN)</b>
SUBJECT: ECM UPDATE – AN 2.0L TURBO COLD START MISFIRE LOGIC

## **ECU Update**

**Description:** This bulletin provides information related to an ECM software update on certain 2013-2014MY SANTA FE (AN) 2.0L TURBO vehicles to update the cold start misfire logic for the following DTCs: P0300, P0301, P0302, P0303 and P0304.

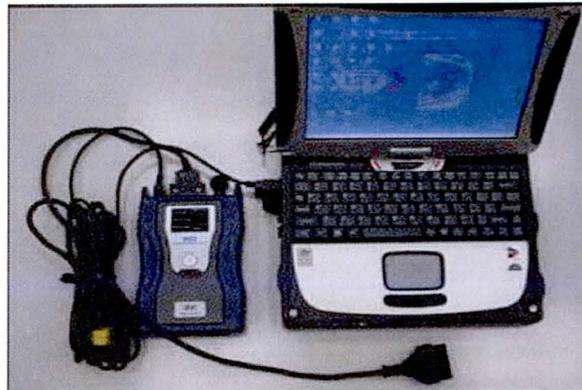
- Connect the USB cable between the GDS and the VCI.
- Connect the 16-pin DLC connector from the VCI into the DLC located under the driver's side dash.

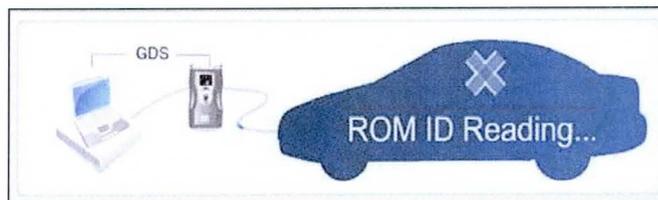
- From the **System** tab, select **Engine** and then select **OK**. The GDS will read the ROM ID. Confirm the ROM is applicable as shown on Page 2, “ECM ROM ID Information”.  
**NOTE:** Record the ECM ROM ID in case the auto update fails and a manual update is needed.

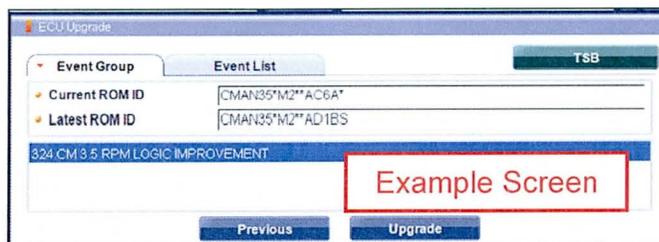
- Update event "**323.AN 2.0L TURBO COLD START LOGIC** " will display. Select **Upgrade**.
