Entune Audio Head Unit Software Update (Panasonic)

Service Category Audio/Visual/Telematics

Section Audio/Video

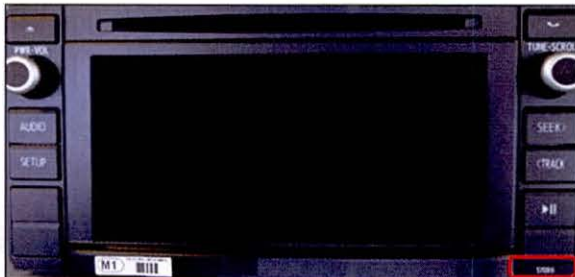
Figure 1. Highlander, Highlander HV, Sequoia, Tacoma, & Tundra

1. Confirm the audio system type by checking the Panel ID printed on the bottom-right or bottom-center of the machine.

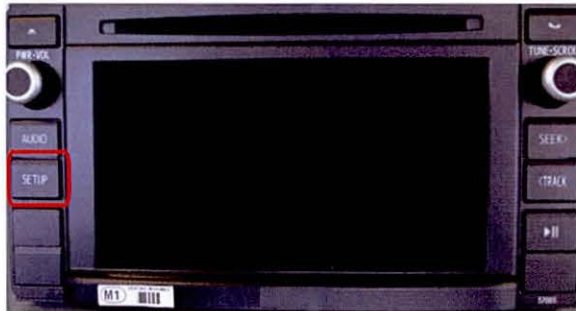
Figure 3. Tacoma, Sequoia

A. For Entune™ Audio:

Press the *SETUP* button on the panel.

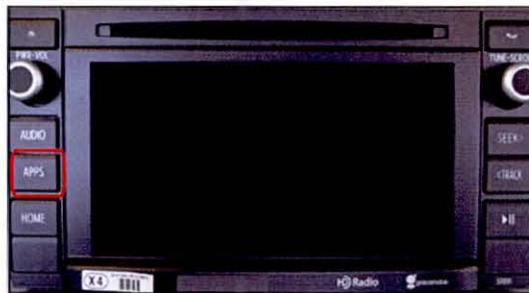
Figure 5. 4Runner, Highlander, Highlander HV, Sequoia, Tacoma & Tundra

B. For Entune™ Audio Plus / Entune™ Premium Audio:

(1) Press the *APPS* button on the panel.

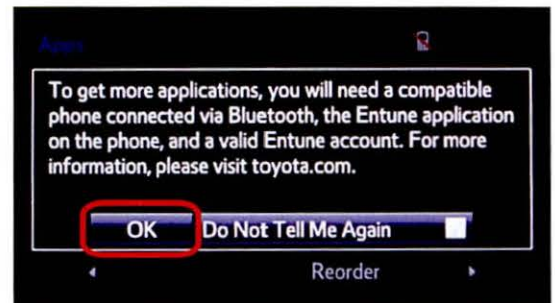
Figure 7.

NOTE
If Entune™ pop-up displays, select *OK*.

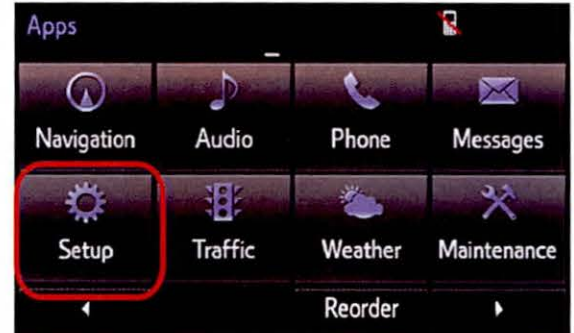
Figure 8.

- (2) Select *Setup* on the *Apps* screen.

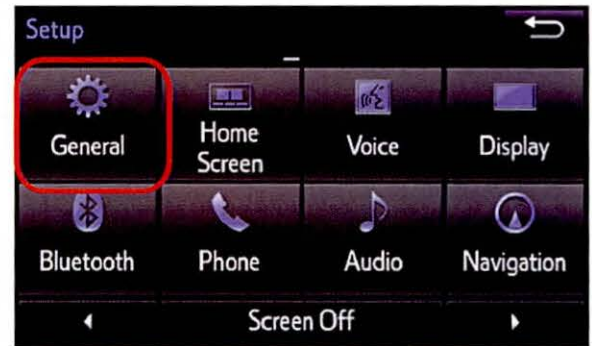
Figure 9.

5. Select *General* on the *Setup* screen.

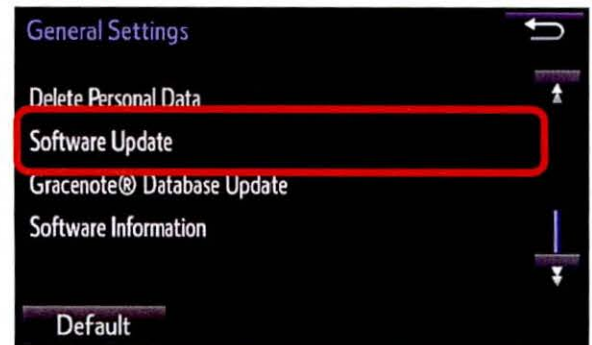
Figure 10.

6. Select *Software Update* from the list on the *General Settings* screen.

Scroll down the list until *Software Update* is displayed.

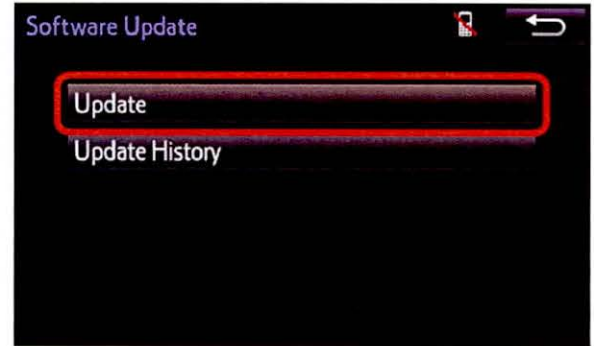
Figure 11.

7. Select *Update* on the *Software Update* screen.

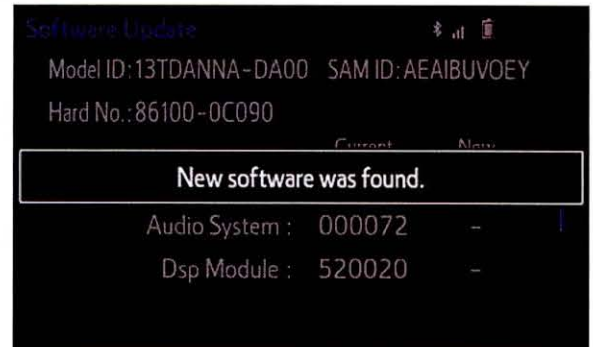
Figure 12.

If software has been detected properly, a "New software was found." pop-up will be displayed.

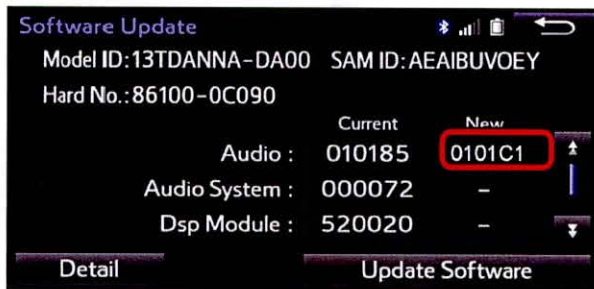
Figure 13.

8. Verify that the new software is up-to-date on the *Software Update* screen.

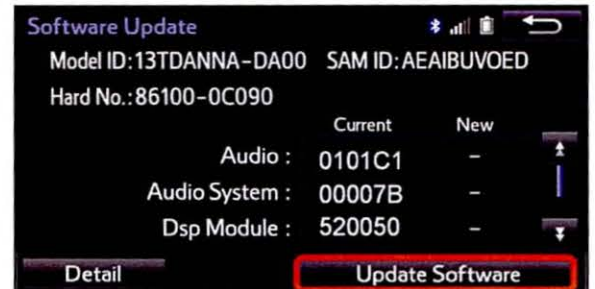
Figure 14.

9. Select *Update Software* on the *Software Update* screen.

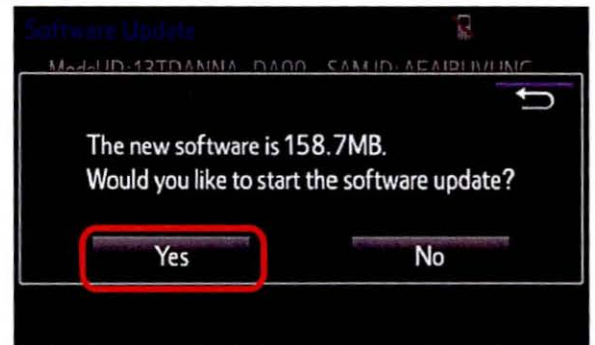
Figure 15.

10. Select *Yes* on the "Would you like to start the software update?" pop-up.

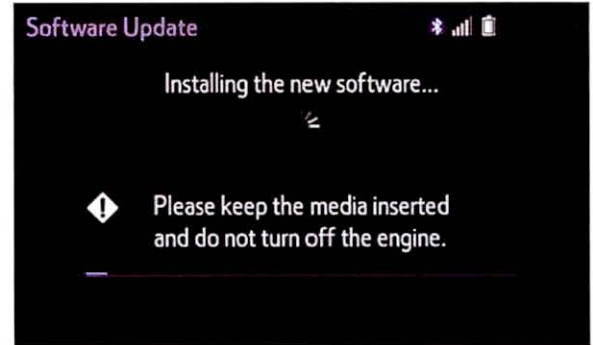
Figure 16.

11. The unit begins installation. The update will take about 10 minutes.

- Do NOT turn off the engine or ACC before the software is ready for updating.
- Do NOT pull the USB Drive SST out of the vehicle USB port.

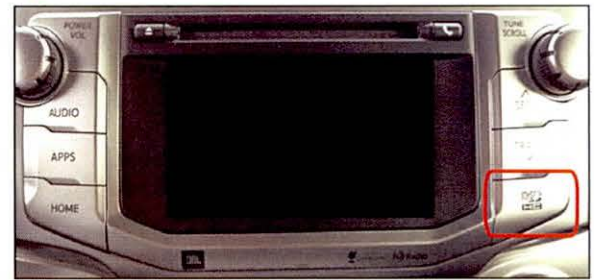
Figure 17.

If update fails and the error message "New software is not compatible with the system." displays, cycle the ignition OFF, remove the Map Micro SD Card from the head unit, and repeat steps 2 – 11.

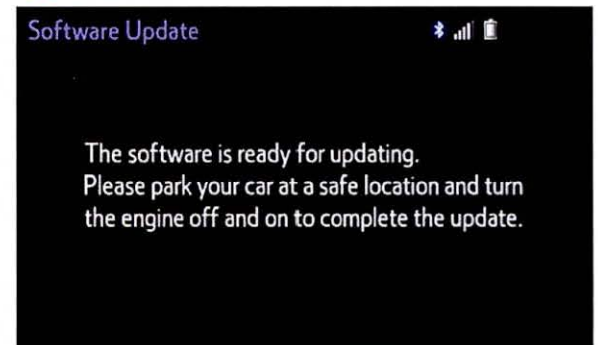
Figure 18.

12. When "The software is ready for updating." displays, cycle the ignition OFF.

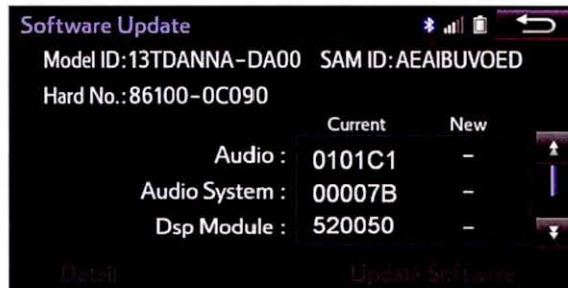
1. Perform steps 3 – 7 of the Software Update procedure to re-enter the *Software Update* screen.
2. Verify that the software information is updated on the *Software Update* screen. **Figure 19.**
