SERVICE BULLETIN

APPLICABILITY: 2015MY Impreza WRX 2.0L DIT **NUMBER:** 11-144-14
SUBJECT: Reprogramming Files for DTCs P0420, P2610 and P0134 **DATE:** 08/27/14

This bulletin announces availability of ECM reprogramming files to address DTCs P0420, P2610 and P0134 on 2015MY WRX 2.0L DIT vehicles.

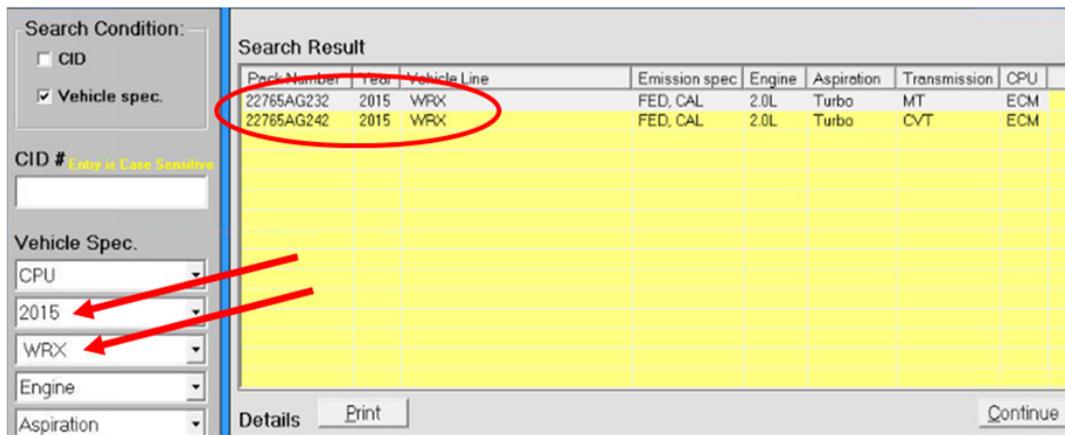
IMPORTANT: When searching in Flashwrite for these pack files, keep in mind that starting with 2015MY, the WRX is now its own model, separate from the Impreza. When searching by Vehicle spec. for applicable pack files, select the WRX from the drop-down list as shown in the screen below.
