TECHNICAL BULLETIN
LTB00679NAS2
26 SEP 2014

SECTION: 415-01

Loss Of Global Positioning System (GPS) Signal

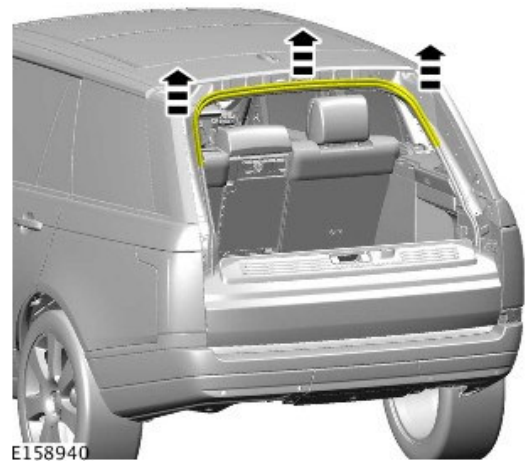
**NOTE: Note the orientation of the seal prior to detaching.**

Reposition the tailgate seal.

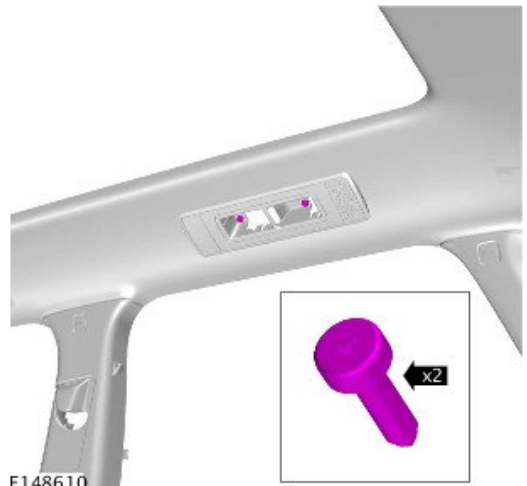
13.

**NOTE: This procedure must be carried out on both sides If equipped.**

Remove the roof air vent fixings.

- Torque: 6 Nm.

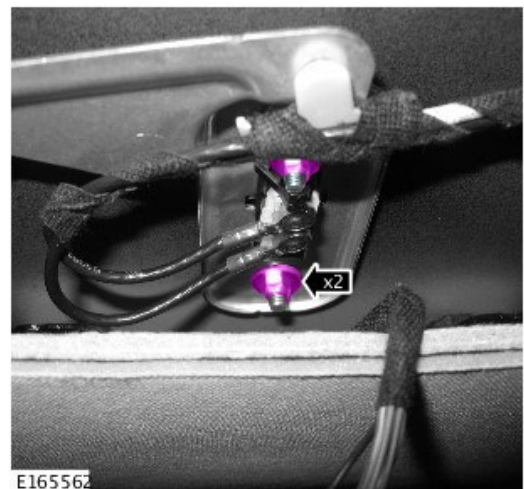
18. Remove the roof pod retaining nuts.
