| GROUP ELE | MODEL 2014MY Sorento (XMa) |

TECHNICAL SERVICE BULLETIN

SUBJECT: BCM UPGRADE - IPM LOGIC IMPROVEMENT

This bulletin provides information related to a software upgrade for the Instrument Panel Module (IPM) of some 2014MY Sorento (XMa) vehicles, produced from January 22, 2013 to November 15, 2013, and equipped with a Power Tail Gate (PTG) which may exhibit an intermittent parasitic draw of up to 400mA. To correct this condition, the BCM should be reprogrammed using the GDS download, as described in this bulletin. For confirmation that the latest reflash has been done to a vehicle you are working on, verify ROM ID using the tables in this TSB.

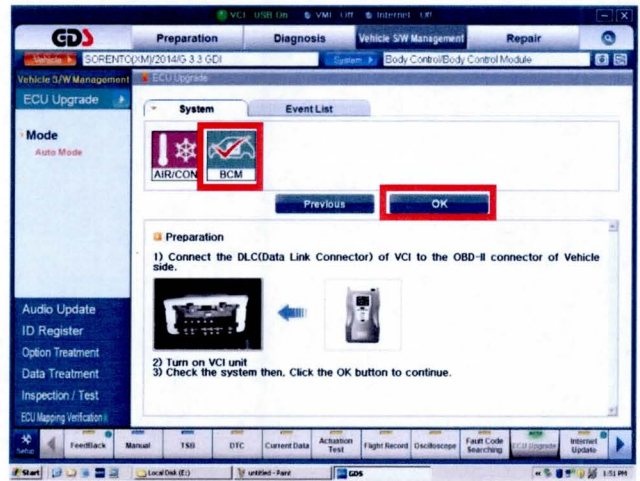
- 10. Select **BCM** and Click **OK**.

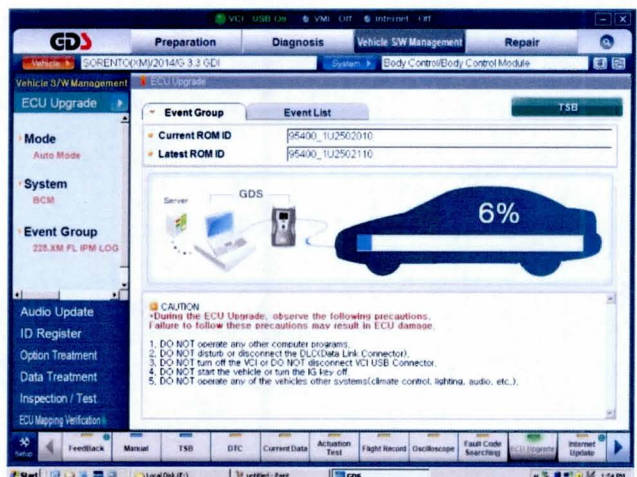
14. The upgrade will begin and the progress of the upgrade will appear on the bar graph.

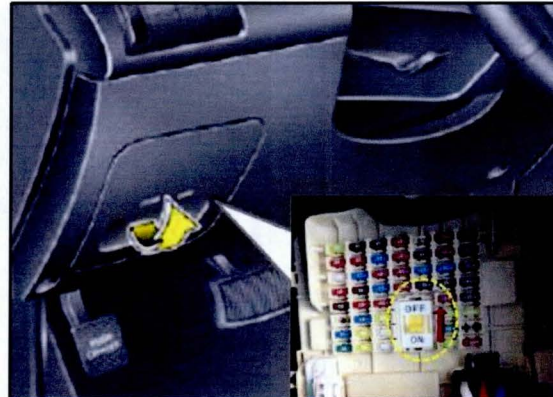
1. Within the ECU Upgrade screen, select **Manual Mode** in the left column, select **BCM** and then select **Upgrade Event 225**. Select the appropriate control unit part number by referring to the ROM ID Information Table on Page 2, and click **OK**.
2. Enter the appropriate password from the table above, and click **OK**.
3. Cycle the ignition ON and OFF once and open the driver's door, when prompted. Then, click **OK**.
4. Upgrade will begin and the progress of the upgrade will appear on the bar graph.
5. Click OK on the final screen. Upgrade event 225 is now complete.
6. Reconnect the hood switch
7. Operate the tailgate to confirm proper operation.
