MODEL  
2014MY  
Cadenza (VG)  
2014MY  
Optima (QF/TF)

NUMBER  
062 (REV 1, 10/03/2014)

## TECHNICAL SERVICE BULLETIN

SUBJECT: NAVIGATION UNIT SOFTWARE UPGRADE

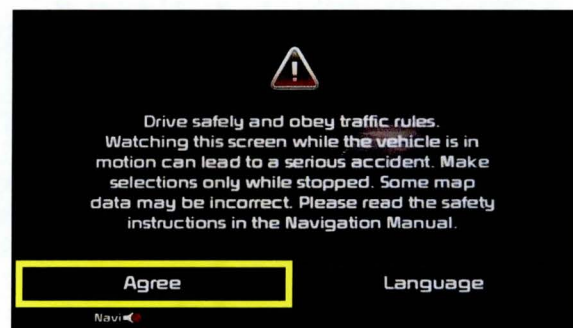
3. Press the

button and then touch the **Setup** icon on the screen.

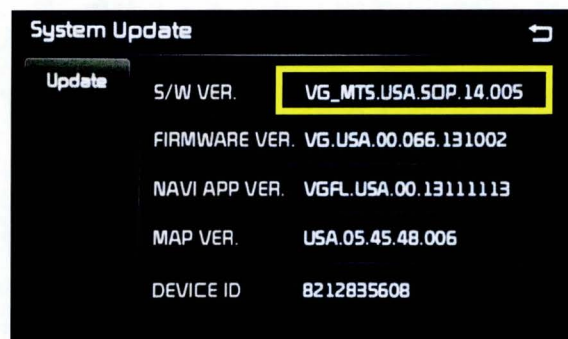
6. Remove the map SD Card from the slot and insert the upgrade SD Card. The AVN system will be restarted automatically after five (5) seconds.

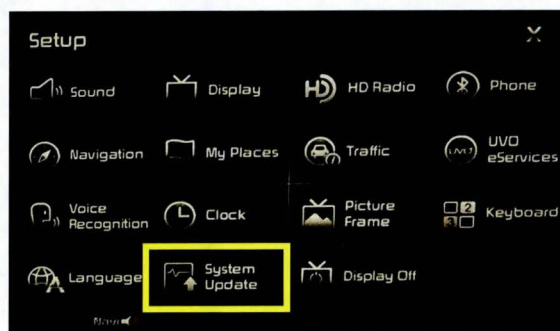
11. Confirm the upgraded software version matches the applicable information shown in the table below:
