GROUP TRA	MODEL 2015MY K900 (KH)
	NUMBER 054	DATE September 2014
<b>TECHNICAL SERVICE BULLETIN</b>		
SUBJECT: K900 (KH) SHIFT LOGIC IMPROVEMENT - TCM UPGRADE

**SUBJECT: K900 (KH) SHIFT LOGIC IMPROVEMENT - TCM UPGRADE**

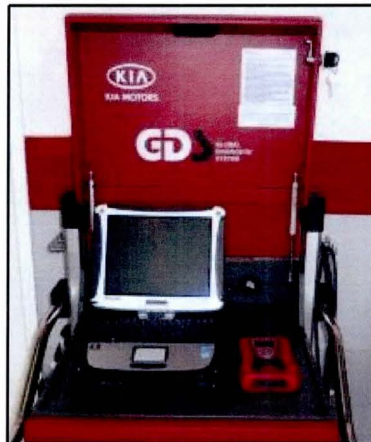
Global Diagnostic System (GDS)

This bulletin provides information related to an upgrade of the TCM software for 2015MY K900 vehicles, produced prior to April 15, 2014, which may exhibit a “rough shift feeling” concern, particularly when downshifting from third to second gear. To correct this concern, reflash the TCM (Transmission Control Module) as described in this TSB. For confirmation that the latest reflash has been done to a vehicle you are working on, verify ROM ID using the tables in this TSB.

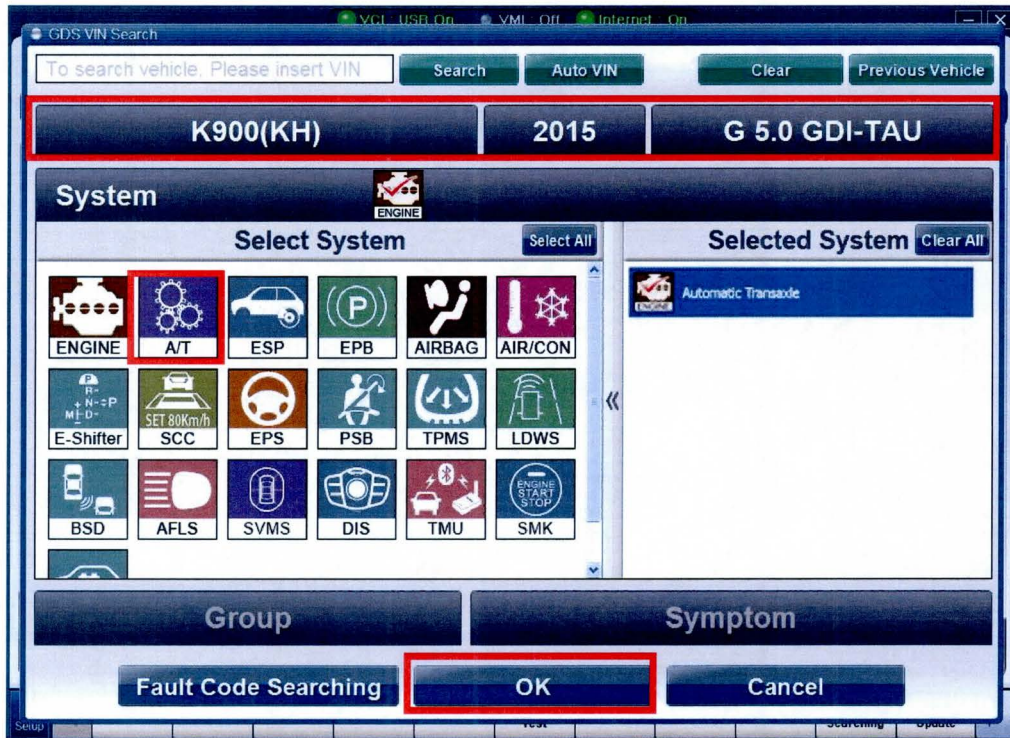
5. With the ignition key ON, turn ON the VCI and GDS. Access the GDS vehicle identification number (VIN) screen and configure the vehicle using the **VIN AUTO DETECT** Function.
6. Select **A/T** system and click **OK**.

7. Select **ECU Upgrade** from the bottom right-hand corner. Next select **Auto Mode**, and then **Engine**. Perform the ECM upgrade in accordance with normal GDS ECM upgrade procedures.
