**SERVICE BULLETIN**

**APPLICABILITY:** 2013MY Legacy and Outback with Subaru STARLINK™ / Aha™ with Fujitsu-Ten (F10) Audio /Navigation System  
**NUMBER:** 15-169-13  
**DATE:** 01/02/14

**SUBJECT:** Customer Satisfaction - Navigation SD Card Update Program

This Bulletin provides the procedure for reprogramming the F10 SD Card Navigation System with the latest software version.

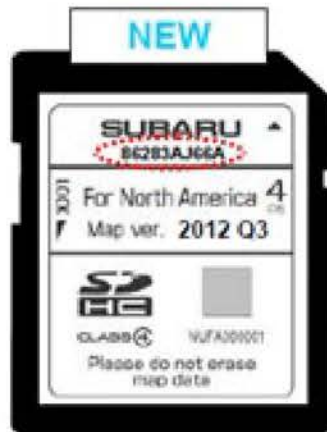
Once you have obtained the proper Update Kit for your application, proceed with the software installation procedure outlined below.

MODEL	PART NUMBER ON SD CARD	“UPDATE KIT” PART NUMBER
Legacy / Outback	86283AJ66A	MSA5M1321K

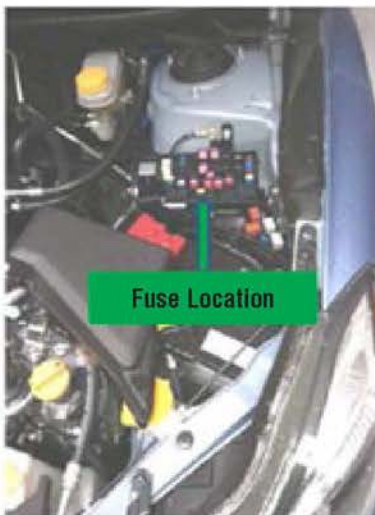
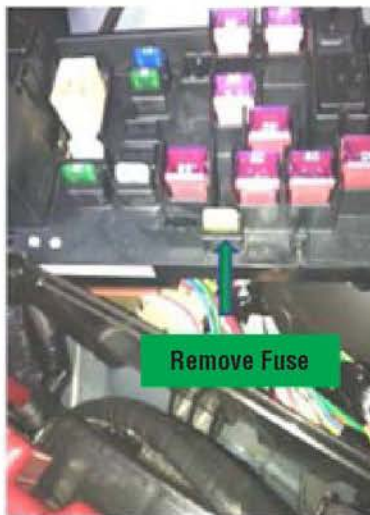
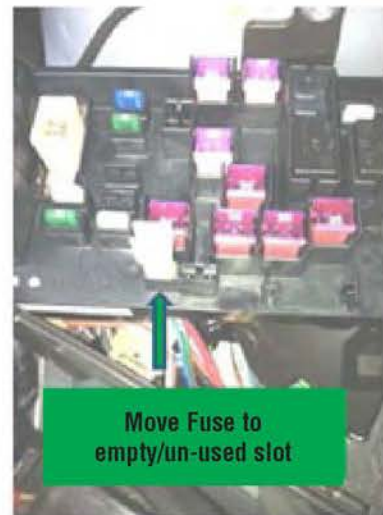
1. Confirm the Push Start Switch (or ignition key) is in the “OFF” position.
2. Remove the Back-Up fuse from the Main Box (M/B, under-hood fuse box).

**NOTE:** the Back-Up fuse locations may vary by model. See pg. 12-12 in the Owner Manual.

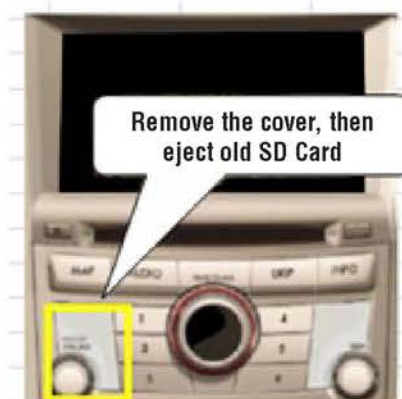
3. Once the fuse is removed, eject the current (old) SD card from the audio / navigation unit.

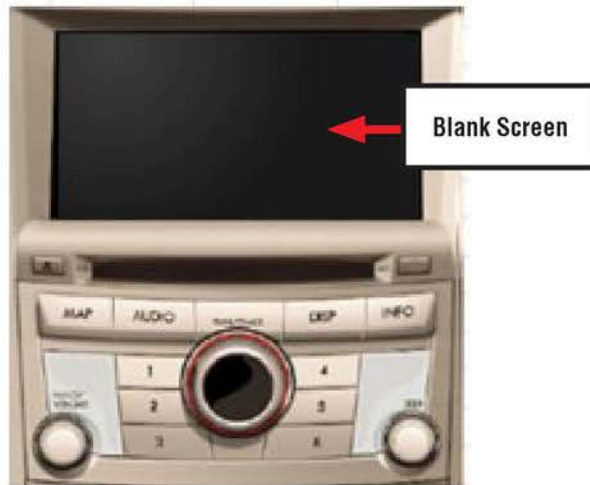
8. After the Push Start Button (or key) has been switched to “ACC”, reprogramming will start automatically and continue for approximately one minute. During this time, the display screen will be blank.

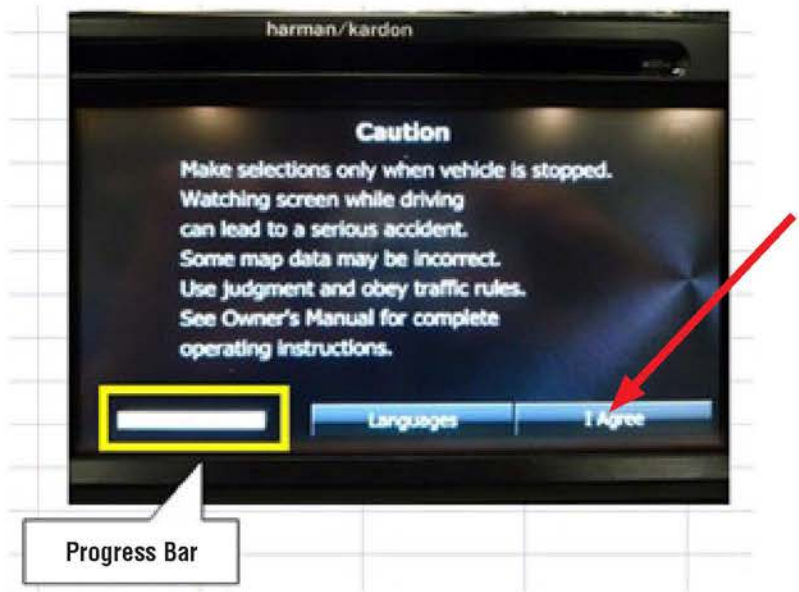
10. Next, press the “I Agree” button on the screen and confirm the progress bar proceeds to full as shown below.

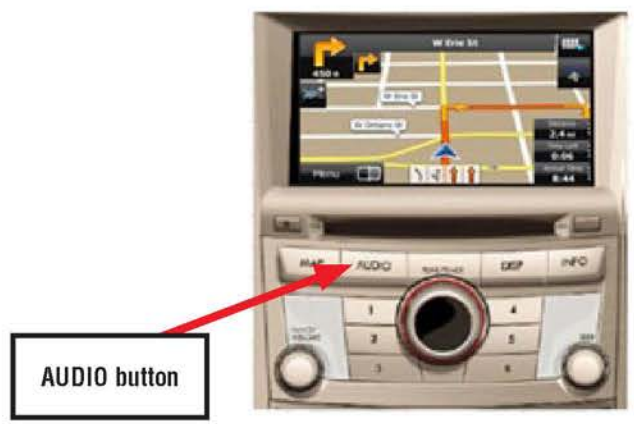
11. Press the “AUDIO” button once.

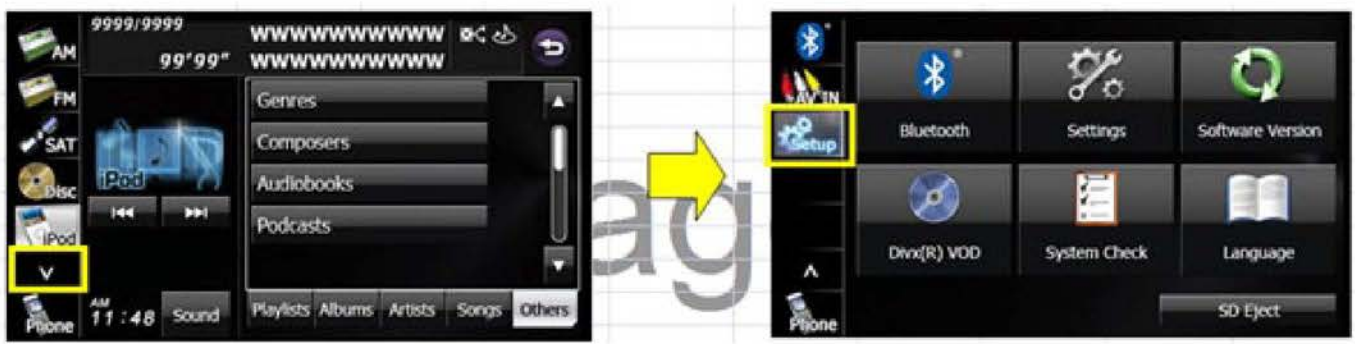
12. Next, press the “V” (down arrow) button then press the “Setup” button.
