Mack Trucks, Inc.
Greensboro, NC USA

ECM and ACM Software Updates
OBD2013, MP7, MP8, MP10
CHU, CXU, GU, LEU, MRU, TD

PI0826, ECM and ACM Software Updates

Software updates with enhancements are available for the engine control module (ECM) and aftertreatment control module (ACM) **for vehicles built from the start of OBD2013 production to May 29, 2013.**

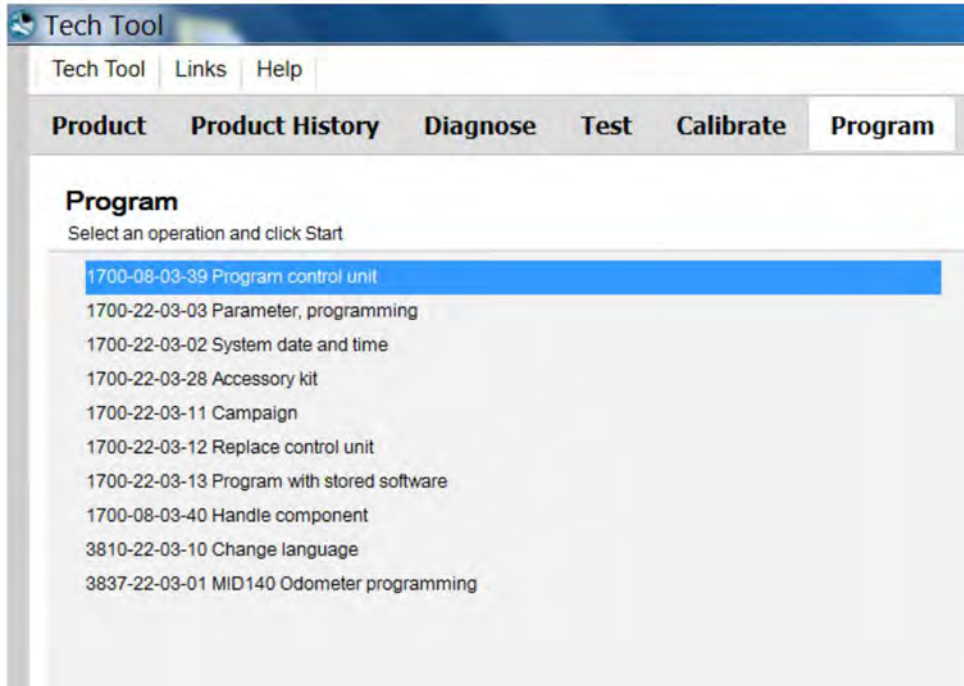
W2085457

- 7 From the Main Menu select Program and **then** Program Control Unit 1700-08-03-39. Then click Start.

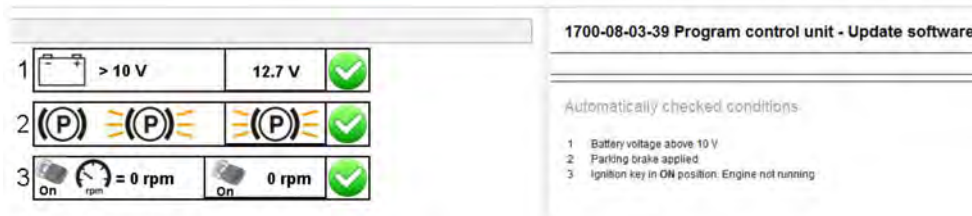
W2080113

10 Certain conditions must be met to continue with programming: battery voltage above 10v, parking brake applied, and ignition key in ON position with engine not running. When all conditions have been met, click Continue to proceed with programming.

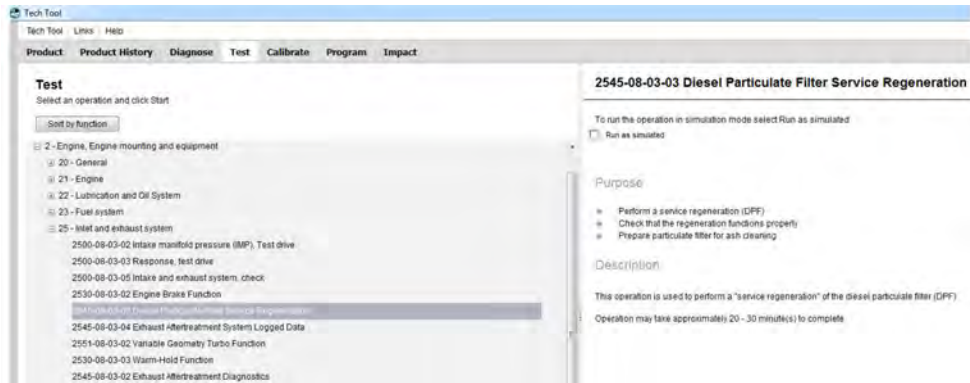
W2080634

13 When programming is complete, select Test from the Main Menu. Select 2545-08-03-03 Diesel Particulate Filter Service Regeneration and click on Start.

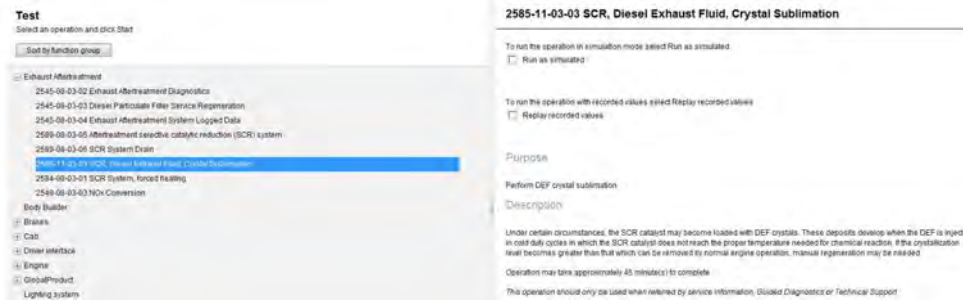
W2083561

17 When the HEST light goes off, select Test from the Main Menu. Select 2585-11-03-03 SCR, Diesel Exhaust Fluid, Crystal Sublimation and click on Start.

Note: Start the Crystal Sublimation process within 2 minutes of engine coming back to idle.
