Service Program Trucks

ECM and ACM Software Updates
OBD2013, MP7, MP8, MP10
CHU, CXU, GU, LEU, MRU, TD

PI0831, ECM and ACM Software Updates

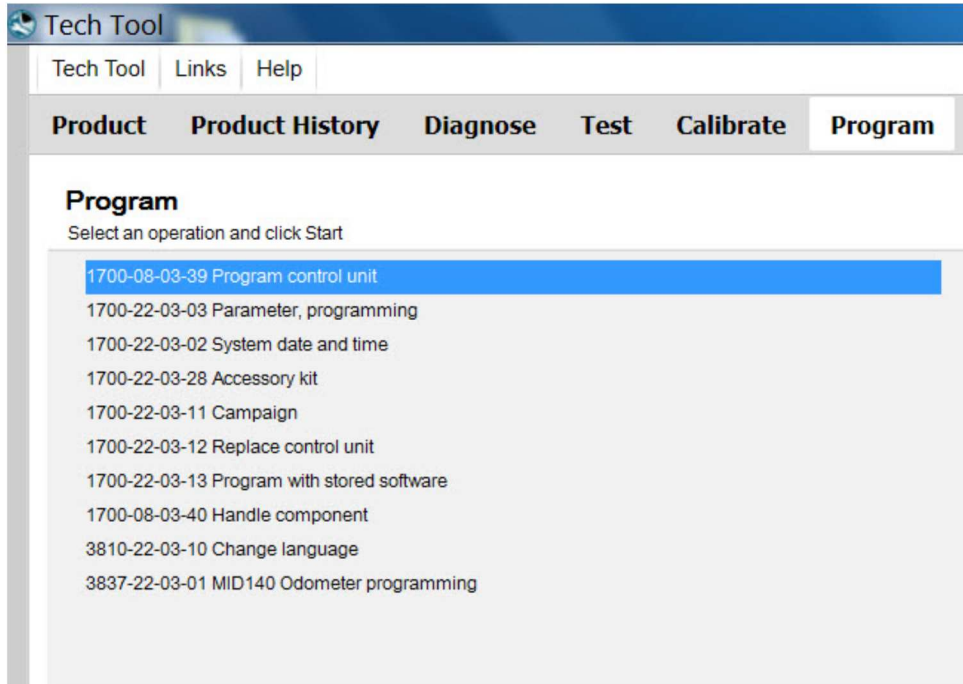
W2079940

- 7 From the Main Menu select Program and **then** Program Control Unit 1700-08-03-39. Then click Start.
