GROUP ELE	MODEL 2015MY Sedona (YP) (L, LX <u>ONLY</u>)
	NUMBER 073 (REV 3, 12/22/2014)	DATE November 2014
TECHNICAL SERVICE BULLETIN		
SUBJECT: SERVICE ACTION: INSTRUMENT CLUSTER LOGIC IMPROVEMENT (SA176)

SERVICE ACTION: INSTRUMENT CLUSTER LOGIC IMPROVEMENT (SA176)

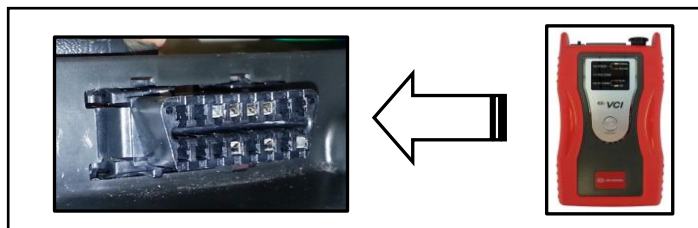
3. Connect the Main 16-pin DLC cable (GHDM – 241000) to the VCI.

4. Connect the Main 16-pin DLC cable (GHDM – 241000) to the OBD-II connector, located under the driver's side of the instrument panel.

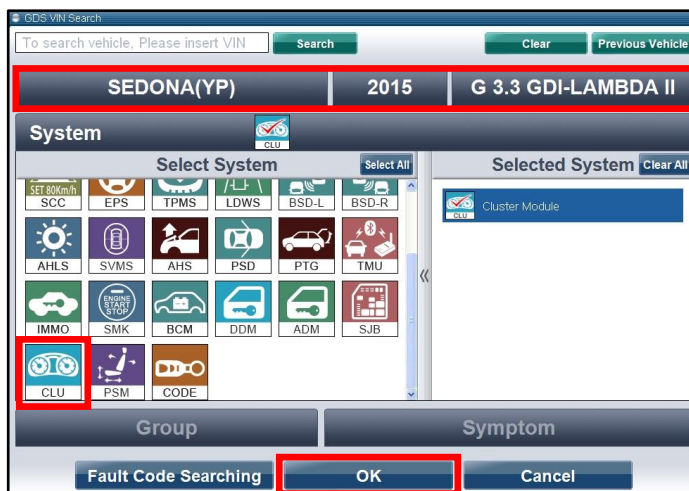
5. With the ignition key ON, turn ON the VCI and GDS. Access the GDS vehicle identification number (VIN) screen and configure the vehicle using the **VIN AUTO DETECT** Function.

6. Select **CLUSTER** system and click **OK**.
