REVISION B: THIS WARRANTY BULLETIN SUPERSEDES PREVIOUS VERSION.

**EMS & ACM SOFTWARE UPDATE
9700 (B13R)**

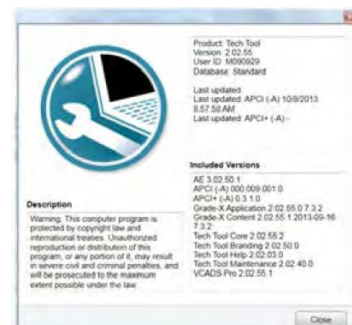
Check Premium Tech Tool version by clicking on Help tab and then click on "About TechTool".

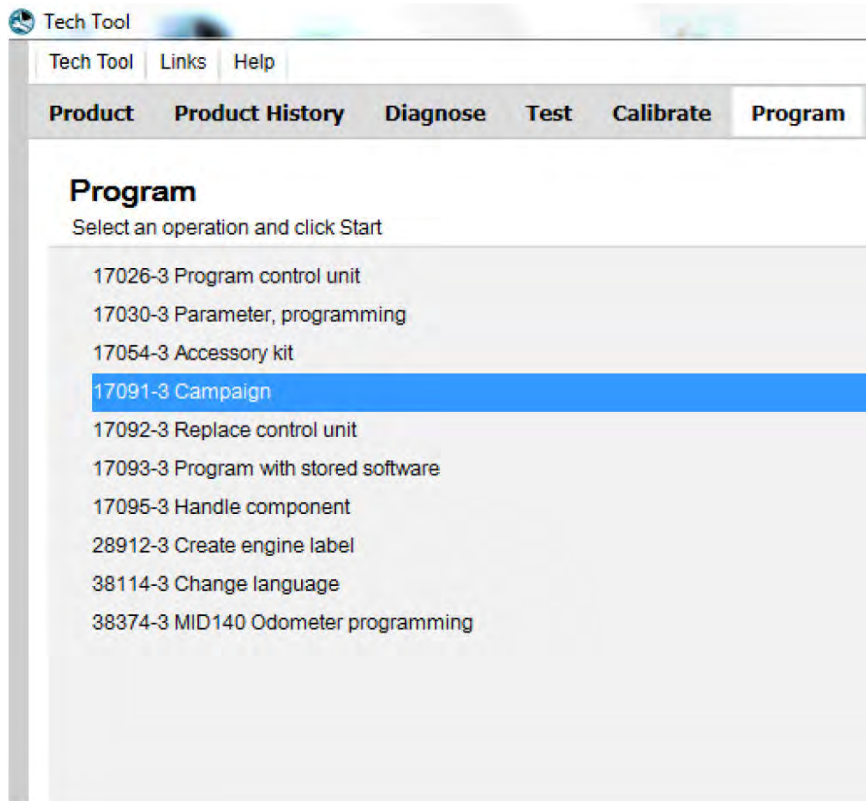
1. Secure the vehicle for service by parking it on a flat level surface, applying the parking brake, chocking the rear wheels, and placing the transmission in neutral.
2. Connect Premium Tech Tool (PTT) to the vehicle diagnostics connector using the 16 pin OBD cable 88890304 and Communication Interface 88890300. Connect the PC to a functional LAN or modem connection and a 120 Volt AC source.
3. Turn the ignition switch "ON".
4. Log in to PTT and Identify Vehicle is displayed.
5. Once the vehicle has been identified, enter the Work Order Number information, then click Start Work
6. From the Main Menu select Program and then Program Control Unit 1700-08-03-39. Then click Start.

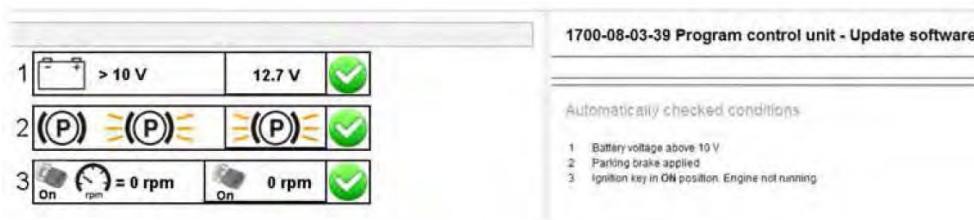
8. Select Campaign to update the control unit with the latest software.
9. Certain conditions must be met to continue with programming: battery voltage above 10v, parking brake applied, and ignition key in ON position with engine not running. When all conditions have been met, click Continue to proceed with programming.

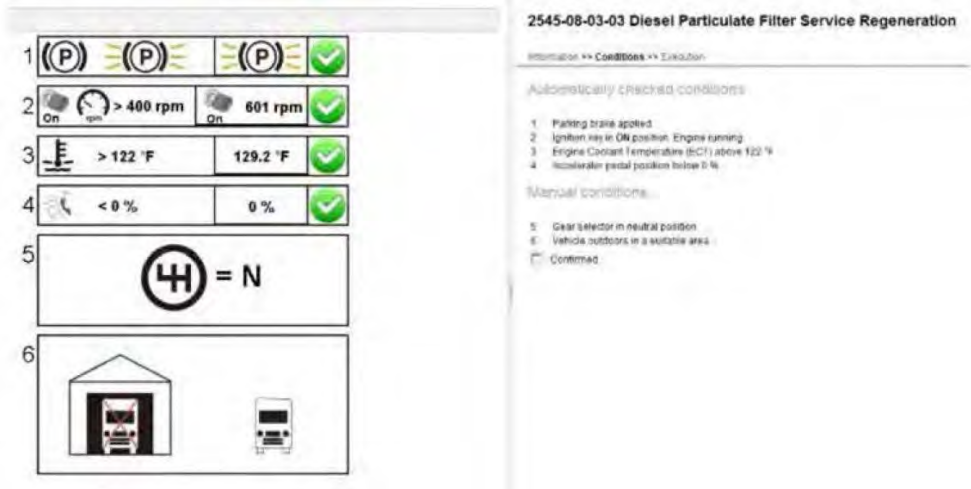
14. When all conditions are met, check the confirmed box and click on Continue.

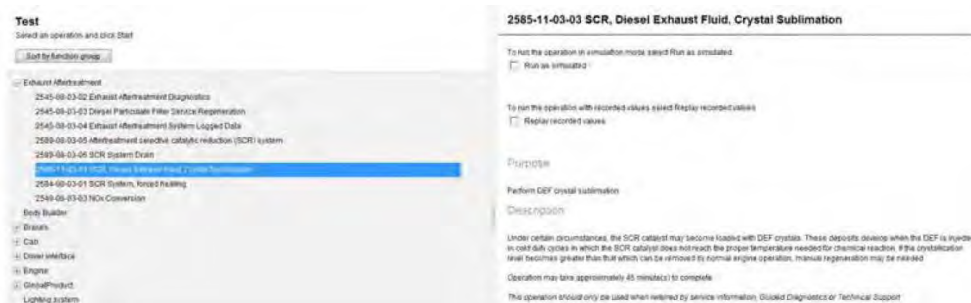
16. When the HEST light goes off, select Test from the Main Menu. Select 2585-11-03-03 SCR, Diesel Exhaust Fluid, Crystal Sublimation and click on Start.

Note: Start the Crystal Sublimation process within 2 minutes of engine coming back to idle.
