Technical Service Bulletin

GROUP NUMBER 14-FL-003 **FUEL SYSTEM** MODEL(S) DATE **VELOSTER (FS)** JULY, 2014

2012 VELOSTER ECM UPDATE

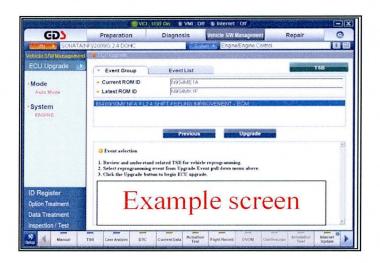
5. Select update event as listed on the GDS Event list of page-1. Select Upgrade.

- 6. If the screen indicates "Voltage is OK" (voltage > 12volts), select OK. If not, select CANCEL and charge the vehicle battery by running the engine for 10 minutes.
- 7. Updating will occur until 100% is reached on the bar graph. At the prompt, turn the ignition key off for 10 seconds then turn it on and select **OK**.
- 8. The GDS will confirm that ECM reprogramming is successfully finished. Select **OK**.
- 9. If the ECM update was not successful, go to GDS Manual Mode <u>ECM</u> update Procedure.
- 10. Check for DTC in all systems and Erase All DTC that stored due to loss of CAN communication during the ECM Update.
- 11. Turn **Off ignition 10 seconds** then turn **On** before going to engine start
- 12. Start the engine to confirm proper operation.
- 13. Clear DTC in the BlueLink system per instructions of TSB 12-BE-005-2.
