Control Module Software Updates
MP7 US2014
LEU, MRU

PI0857, Control Module Software Updates

(January 2015)

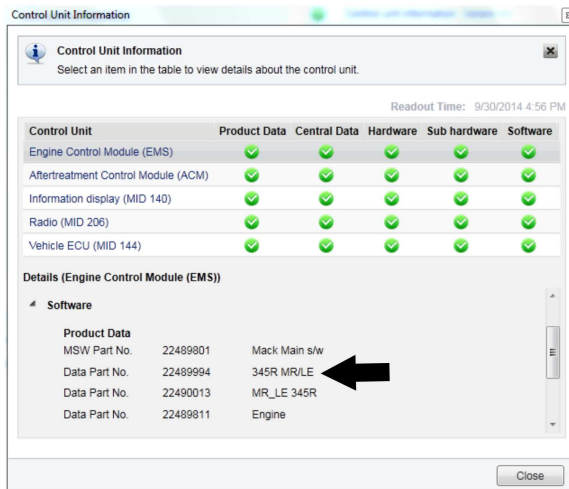
W2095986

Only vehicles that have the following engine ECM software dataset part numbers are affected

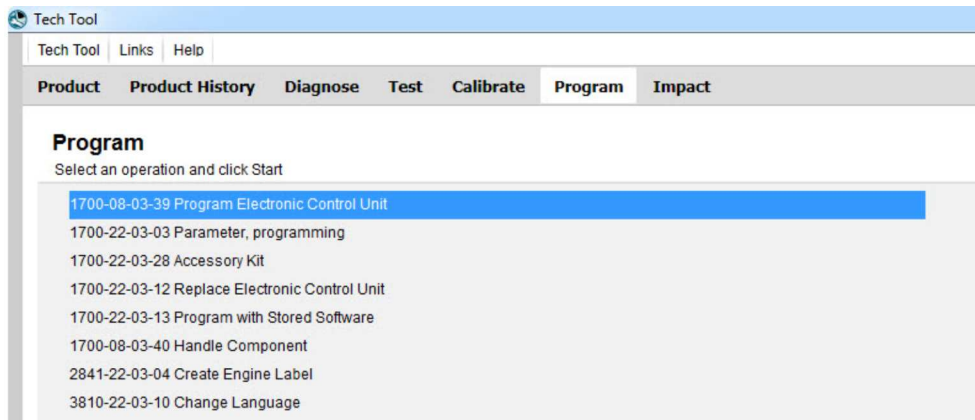
W2079941

- 7 From the Main Menu select Program and **then** Program Electronic Control Unit 1700-08-03-39. Then click Start.
