REFERENCE:	Nova Bus Manuals
SECTION:	18: Articulation system
RS N°:	MQR 7621-661& 7621-730
EFFECTIVE IN PROD.:	L898 (2015JN)

SUBJECT:	Hübner articulation with ACU III control unit
JUSTIFICATION:	The red articulation tell tale lights: 1- for an «Error 2 Plausibility 2» code generated for no reason, 2- when no code is logged in the ACU (ghost code).

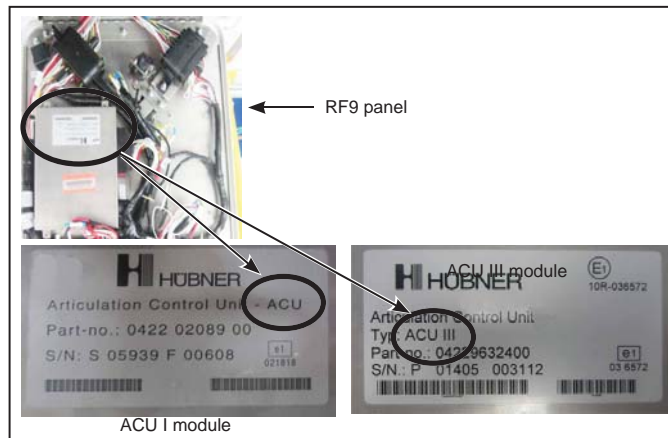
- 1.1. Open the RF9 panel door located at the rear interior of the vehicle.
- 1.2. Locate and identify the Hübner Articulation Control Unit (ACU). See Figure 1.

Figure 1 - Location and Identification of the Hübner Articulation Control Unit (ACU) in the RF9 Panel

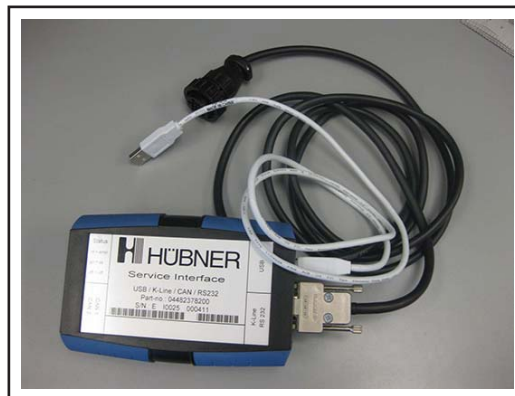
- 1.3. You will have to use the Hübner Service Interface to connect your computer to the vehicle's ACU. See Figure 2.

Figure 2 - Hübner Service Interface (Part N° N8900610)

Connect the Hübner service interface to the ACU's 9-pin connector in the RF9 panel. See Figures 2 and 3.

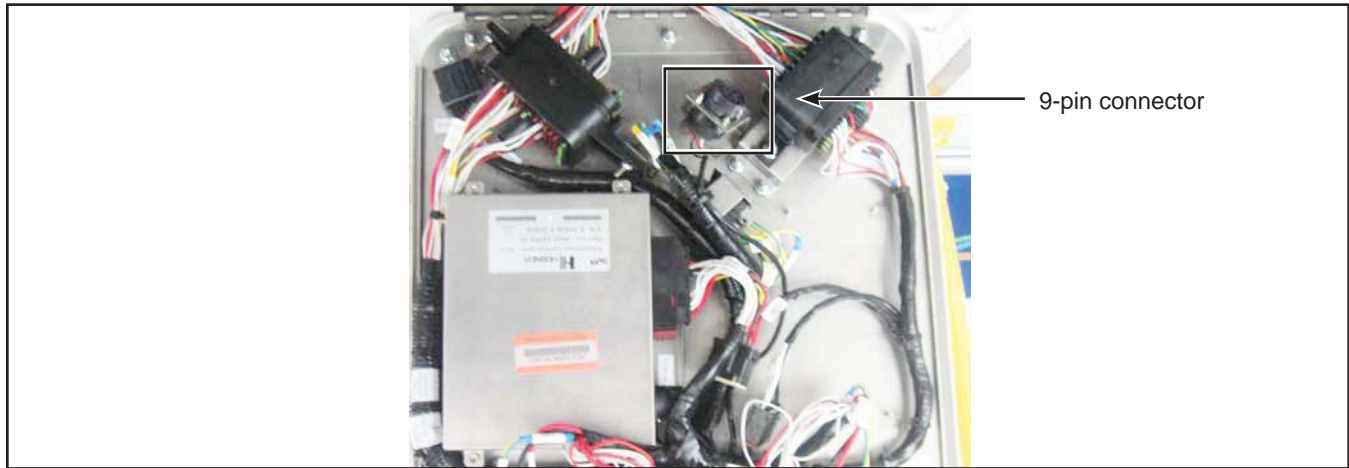
Locate the ACU's 9-pin connector. See Figure 3.

Figure 3 - ACU 9-pin Connector Location in RF9 Panel

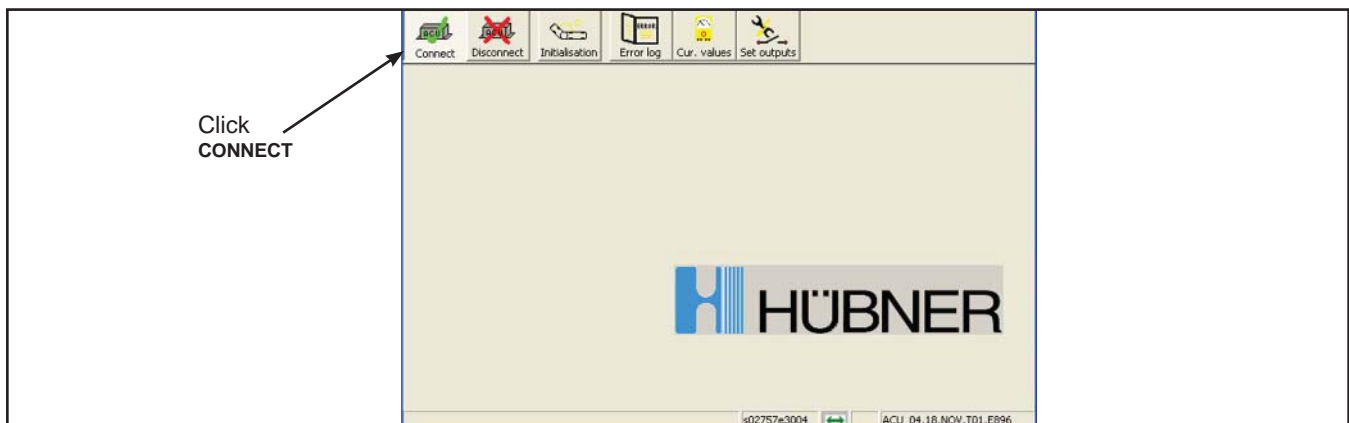
- 1.7. Click on the **CONNECT** button. See Figure 5. The interface's green light will come **ON** to indicate it is connected.

Figure 5 - Hübner Software Top Menu

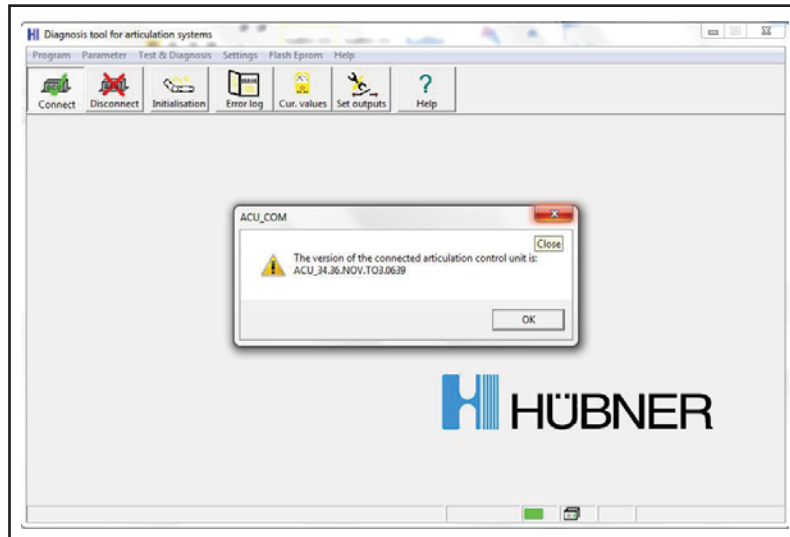
- 1.8. A pop-up window will appear to identify the already installed ACU software. See Figure 6. Click OK.

Figure 6 - Typical Window Identifying the already Installed ACU Software

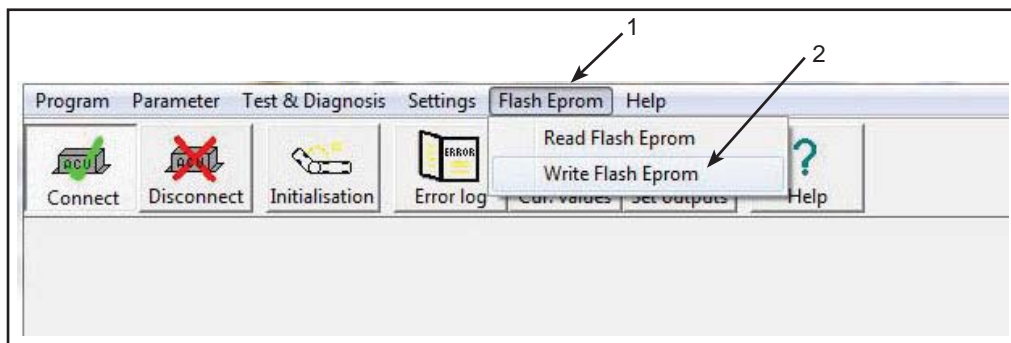
- 1.9. Select **FLASH EPROM** (1) from the Hübner software top menu. See Figure 7.

Figure 7 - Hübner Software Top Menu

- 1.10. Click on **WRITE FLASH EPROM** (2) in the sub-menu. See Figure 7.

If you can't access to the **WRITE FLASH EPROM** (2), see Figure 7, contact your Nova Bus service representative.

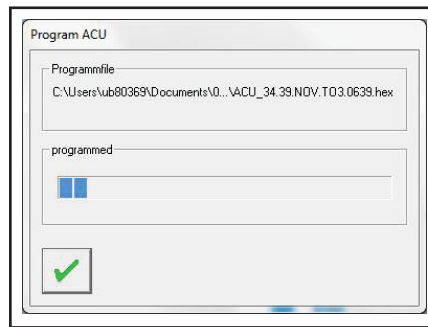
1.12. A progress window will appear. See Figure 8.

Figure 8 - Typical Progress Window

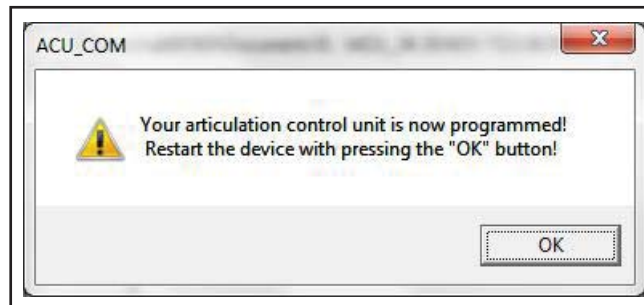
1.13. When the upload is finished, a pop-up window will appear to confirm that the unit is now programmed and if you want to restart the ACU. See Figure 9. Click OK.

Figure 9 - Upload Completed and ACU Restart Window

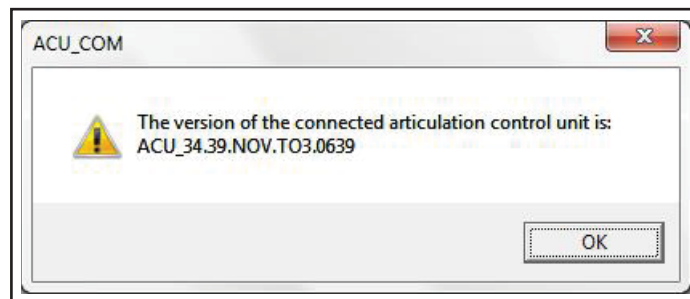
1.14. A second pop-up window will appear to confirm the ACU software version. See Figure 10. Compare the version in the pop-up with the one you did upload. If the two versions are identical, click OK. If not, redo the procedure from step 1.8.

Figure 10 - Software Version Typical Window

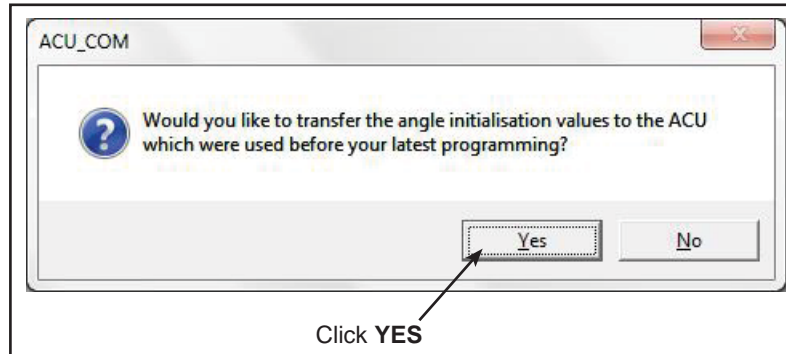
- 1.15. A third pop-up window will appear, asking you if you want to keep the initialisation values. See Figure 11. Click **YES**.

Figure 11 - Initialisation Values Pop-Up Window

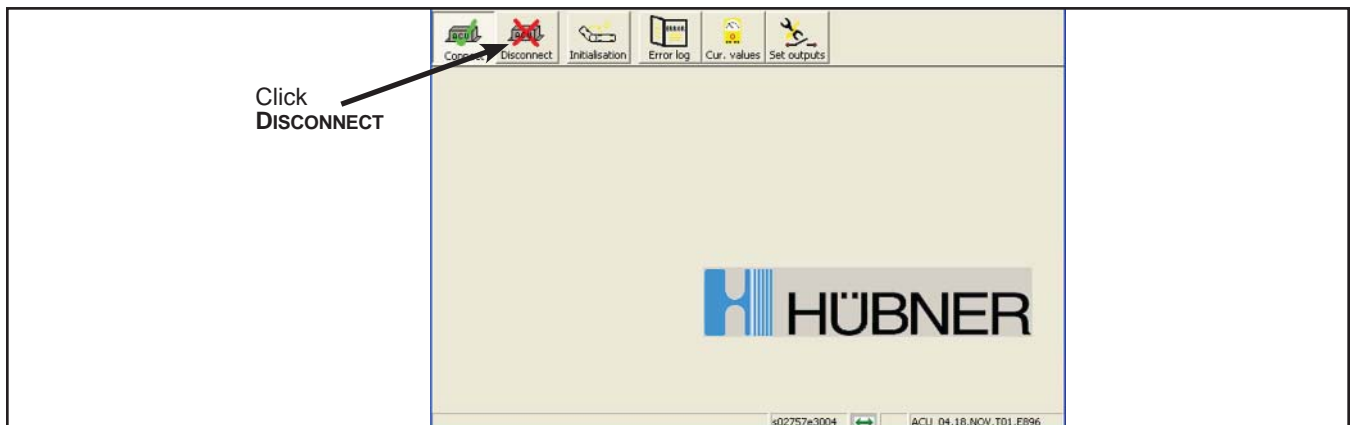
- 1.16. Click on the **DISCONNECT** button from the Hübner software top menu. See Figure 12.

Figure 12 - Hübner Software Top Menu
