**WF14 - Re-programming DME Control Unit (Workshop Campaign)**

**Vehicle Type:** Macan S/Macan Turbo

**Concerns:** DME control unit

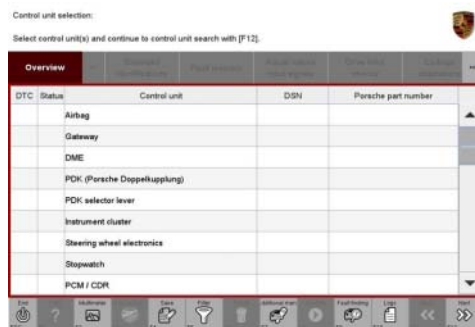
*Control unit selection*

- Start the engine.
  - Turn the steering wheel fully to the left.
  - Turn the steering wheel fully to the right.
- 5 Once you have erased the fault memories, select the ⇒ **'Overview'** menu to return to the control unit selection screen ⇒ *Control unit selection*.

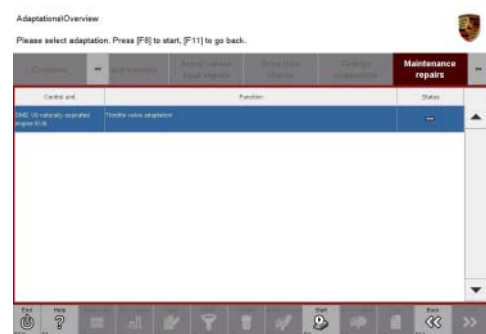
*Throttle valve adaptation*

- 5 Select the ⇒ **'Throttle valve adaptation'** function so that the corresponding text line turns blue and press **•F8** to start the throttle valve adaptation ⇒ *Throttle valve adaptation*.

- 6 Follow the instructions on the PIWIS Tester while throttle valve adaptation is being performed.  
Once throttle valve adaptation is complete, a tick will appear in the "Value" field on the PIWIS Tester display.  
If throttle valve adaptation is **not** completed successfully, adaptation must be **repeated**.
- 7 Press •F8" ("Stop") to end throttle valve adaptation.

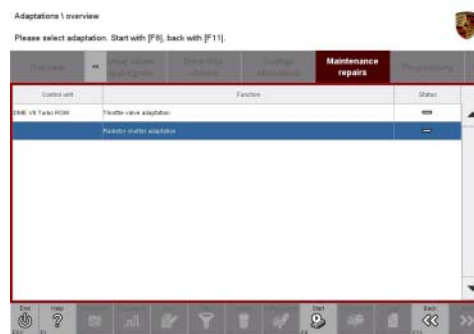
*Radiator shutter adaptation*

- 1 Select the ⇒ **'Radiator shutter adaptation'** function so that the corresponding text line turns blue and then press •F8" to start radiator shutter adaptation ⇒ *Radiator shutter adaptation*.

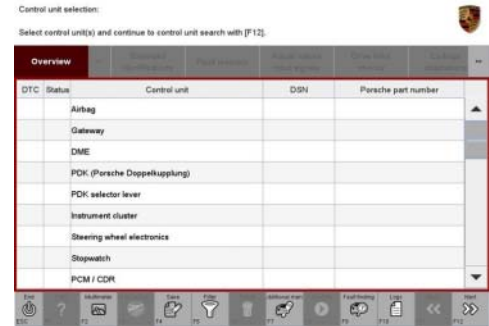
*Control unit selection*

- 4 Press •<<" to return to the start page of the ⇒ **'Maintenance/repairs'** menu.
- 5 Select the ⇒ **'Overview'** menu to return to the control unit selection screen ⇒ *Control unit selection*.
