WF13 - Re-programming DME Control Unit (Workshop Campaign)

Model Year: As of 2014 up to 2016

Model Line: Panamera

Concerns: DME control unit

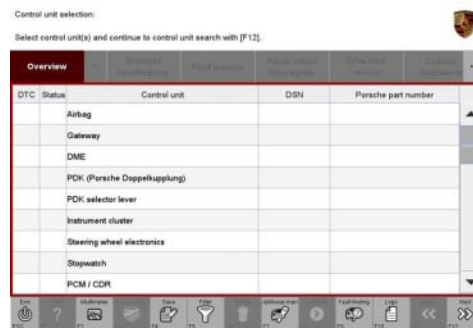
Control unit selection

- 4.5 Once you have erased the fault memories, select the ⇒ **'Overview'** menu to return to the control unit selection screen ⇒ *Control unit selection*.

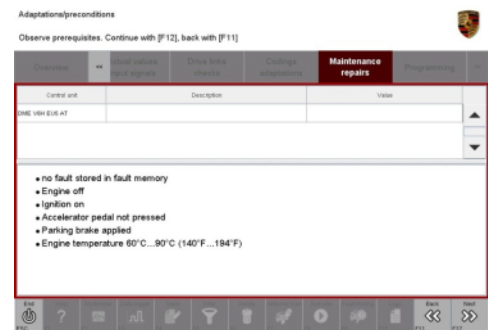
Adaptation preconditions

- 5.4 Comply with the displayed preconditions and press •>>" to confirm ⇒ *Adaptation preconditions*.

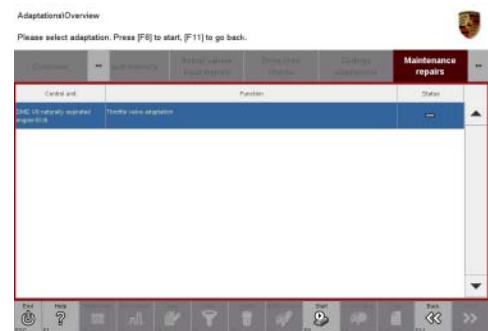
Throttle valve adaptation

- 5.5 Select the ⇒ **'Throttle valve adaptation'** function so that the corresponding text line turns blue and start throttle valve adaptation by pressing •F8" ⇒ *Throttle valve adaptation*.

- 5.6 Follow the instructions on the PIWIS Tester while throttle valve adaptation is being performed.

Once throttle valve adaptation is complete, a tick will appear in the "Value" field in the PIWIS Tester display.

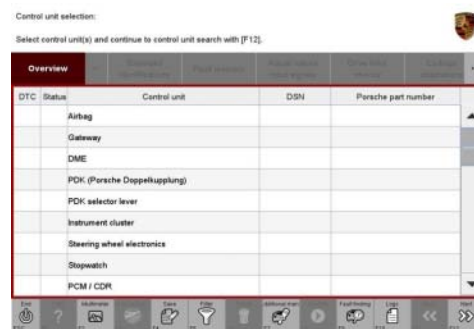
Control unit selection

- 5.8 Press •<<" to return to the start page of the ⇒ **'Maintenance/repairs'** menu.
- 5.9 Select the ⇒ **'Overview'** menu to go back to the control unit selection screen ⇒ *Control unit selection*.

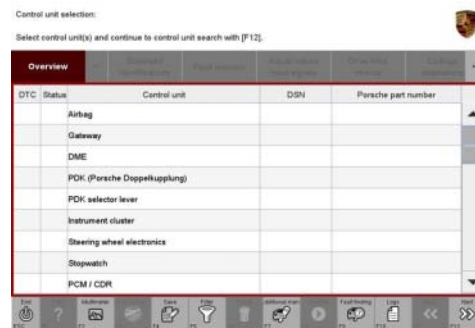
Control unit selection

- 5.5 Once you have erased the fault memories, select the ⇒ **'Overview'** menu to return to the control unit selection screen ⇒ *Control unit selection*.

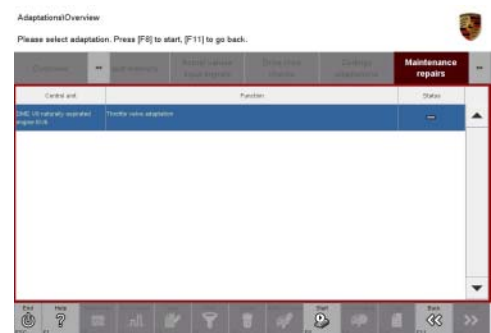
Throttle valve adaptation

- 6.5 Select the ⇒ **'Throttle valve adaptation'** function so that the corresponding text line turns blue and start throttle valve adaptation by pressing •F8" ⇒ *Throttle valve adaptation*.

- 6.6 Follow the instructions on the PIWIS Tester while throttle valve adaptation is being performed.

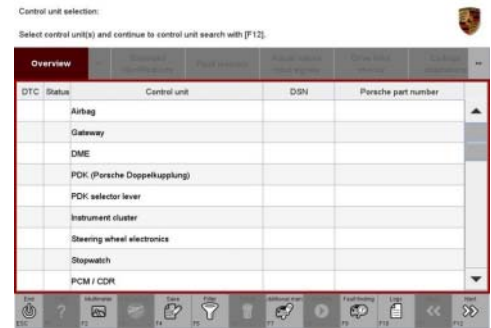
Control unit selection

- 6.8 Press •<<“ to return to the start page of the ⇒ **'Maintenance/repairs'** menu.
- 6.9 Select the ⇒ **'Overview'** menu to go back to the control unit selection screen ⇒ *Control unit selection*.
