**SUBJECT: 2014-2015 Mazda3 MAZDA CONNECT™ Software Update  
Special Service Program (SSP) 98**

Mazda Motor Corporation has decided to conduct a Special Service Program (SSP) on certain 2014-2015 Mazda3 vehicles, equipped with MAZDA CONNECT™ System.

The latest version of software for the Connectivity Master Unit (CMU) is now available. By updating the CMU software, the features and functionality of the MAZDA CONNECT™ system will be further enhanced.

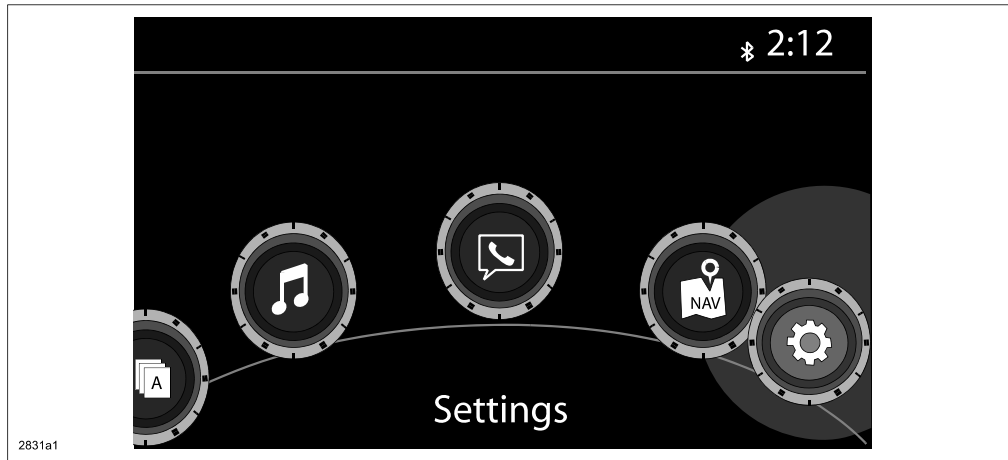
1. Select "Settings" from the Home screen to check the software version.

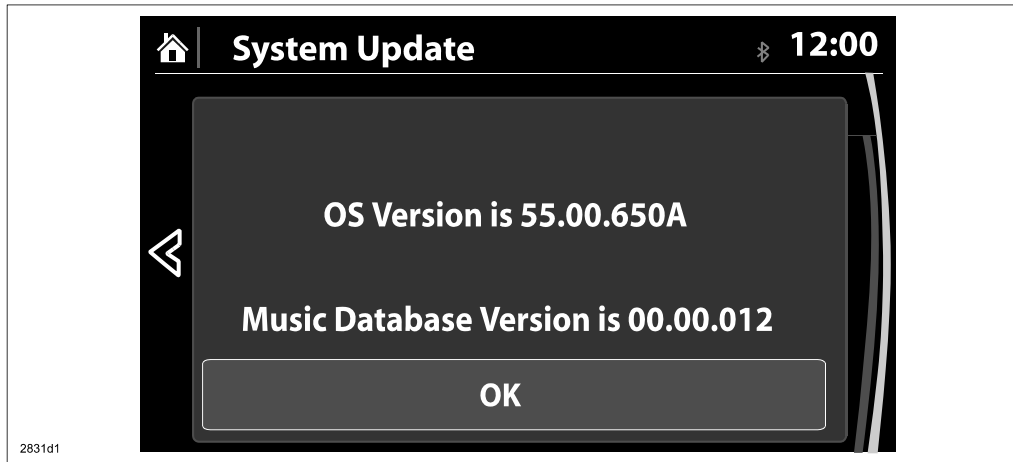
4. Make sure the software version is 55.00.XXX or later, then select OK. If it is not 55.00.XXX or later, update the system using a USB memory stick with the latest software according to the “Reflash Procedure.” If needed, refer to “Downloading Update Software to a USB Memory Stick (for additional USB memory sticks)” below.

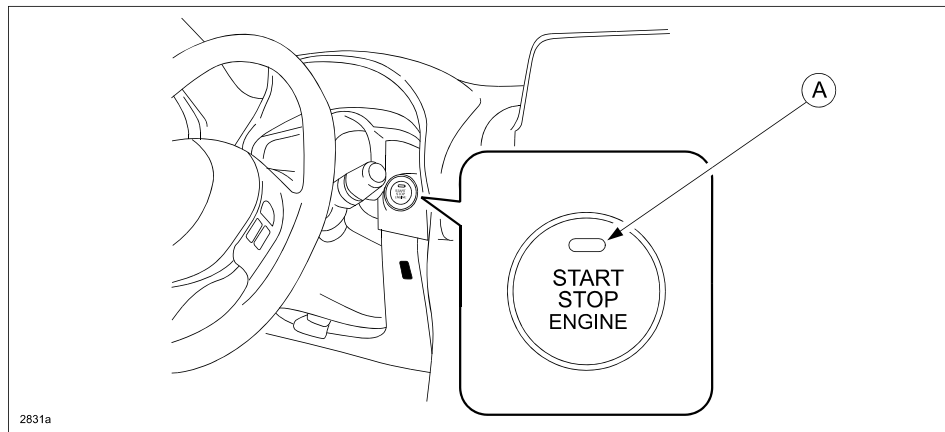
4. Install the ROOM FUSE and AUDIO FUSE to the fuse block in the engine compartment (if not installed).
5. Connect battery charger (charge current maintained about 7A) to the vehicle to stabilize voltage fluctuation.
6. Press the START/STOP ENGINE push button 1 time without depressing the clutch pedal (manual transaxle) or the brake pedal (automatic transaxle), to switch the ignition position to ACC. Confirm that the push button start indicator light (A) is illuminated (amber) and the display in the instrument cluster is OFF (ignition position is in ACC).

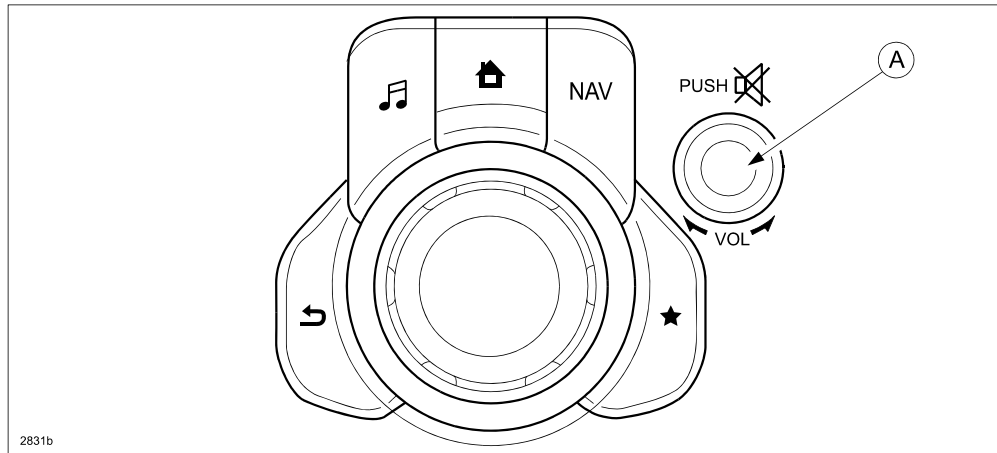
7. Verify that there is a sound coming from the speakers. If sound cannot be heard, turn the volume dial (A) to turn the volume up, or make sure that MUTE is not on.

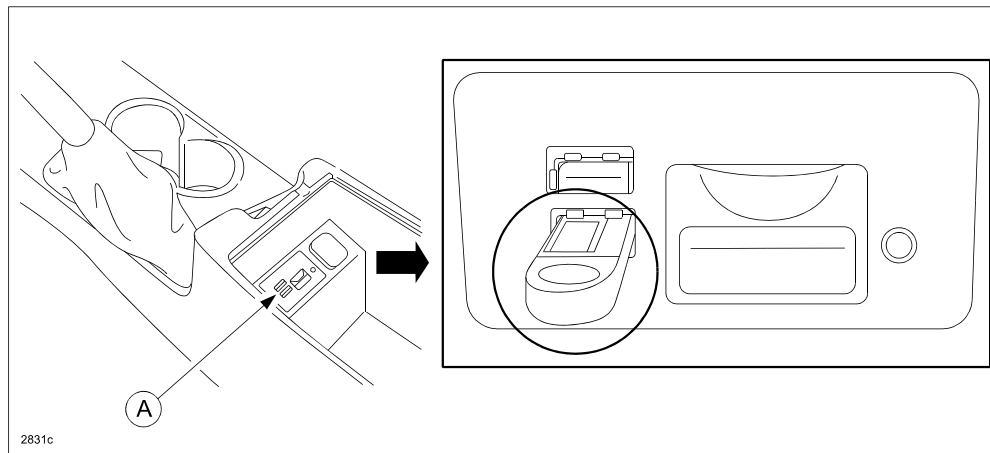
8. Connect the prepared USB memory stick to the either one of the two USB port (A).

**NOTE:** There should only be the prepared USB memory stick inserted in one of the USB ports. Nothing should be inserted in the other USB port during the re-flashing process.

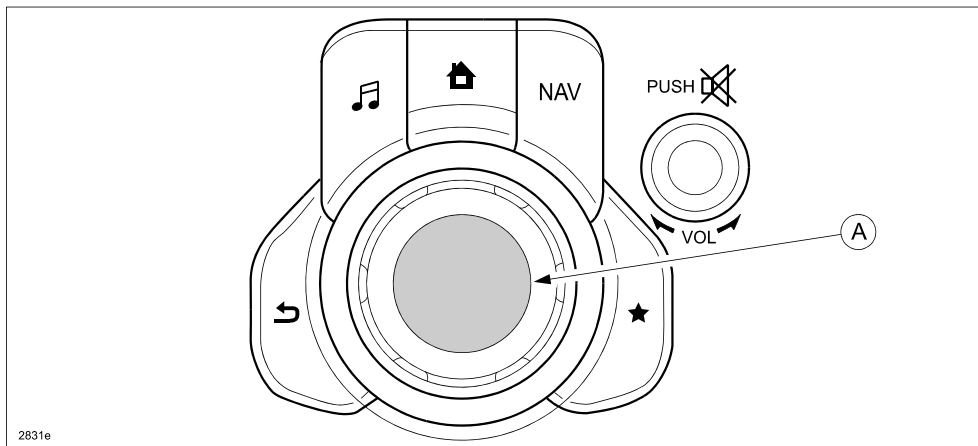
- It takes approx. 5 seconds before the USB memory stick is recognized.
- If the USB memory stick is not recognized, perform the following:
  - (1) Select "Setting".
  - (2) Select "System".
  - (3) Select "Factory Reset".
  - (4) Push the commander switch knob (A) to "Enter".

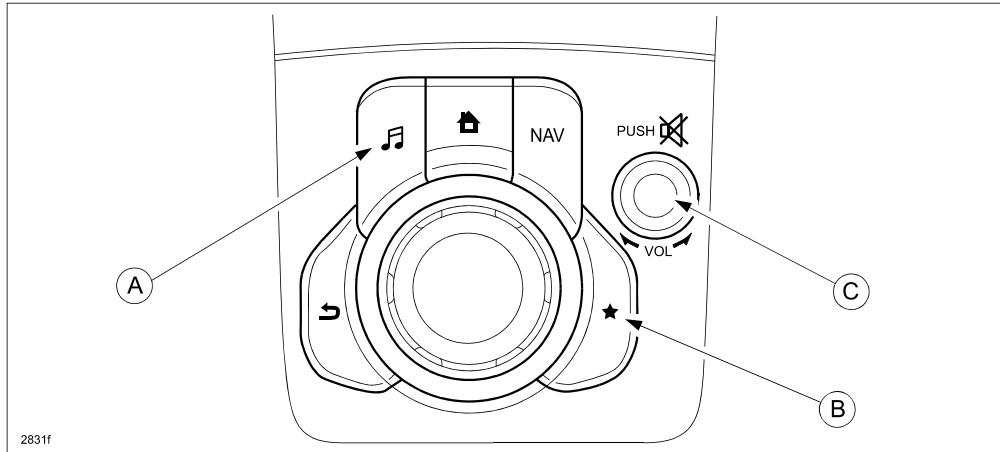
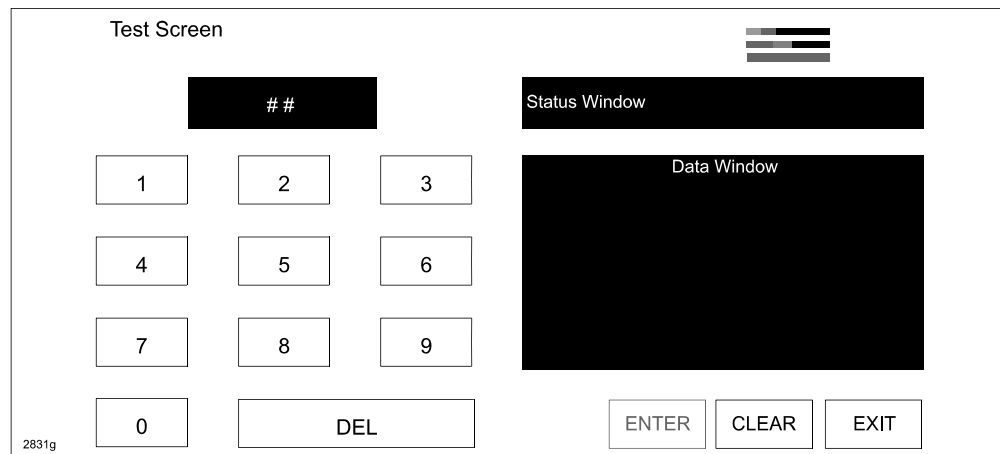
10. Press the three buttons (Music (A) + Favorites (B) + Volume Mute(C)) on the commander switch at the same time for 2-5 seconds and the Diagnostic Test Screen will appear.

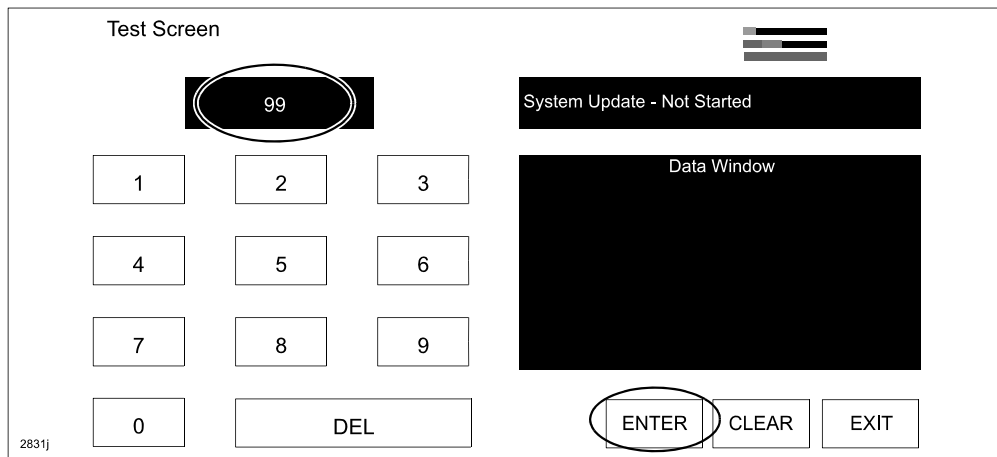
13. Use the touchscreen or the commander switch to input '99' and then select "ENTER" on the Test screen.

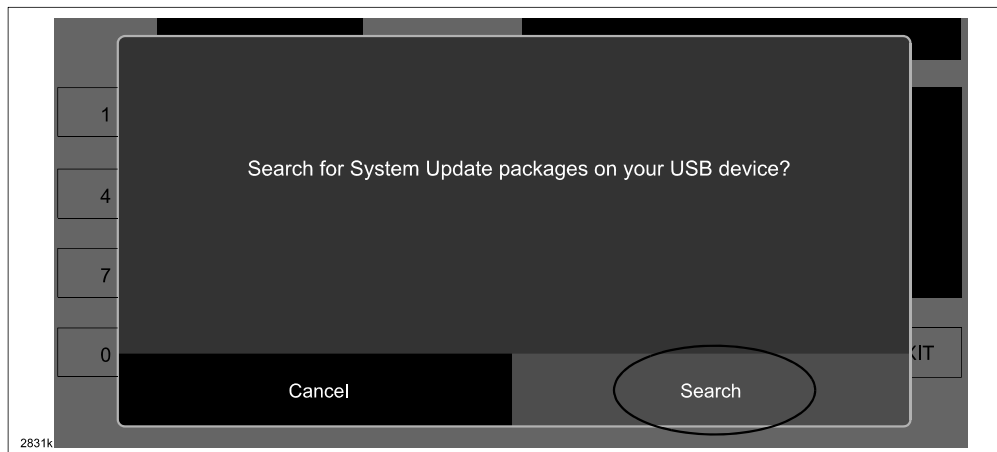
14. Select "Search" on the screen below.

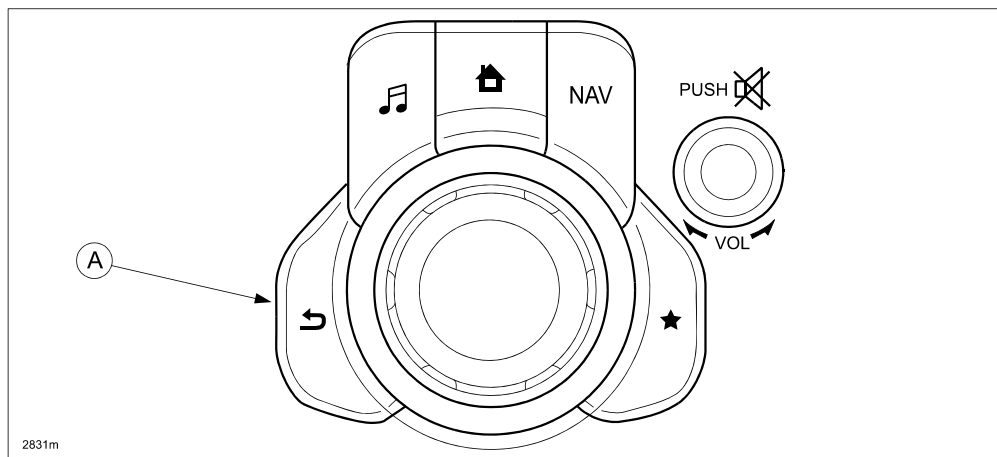
(1) Press the “Return” button (A) on the commander switch.

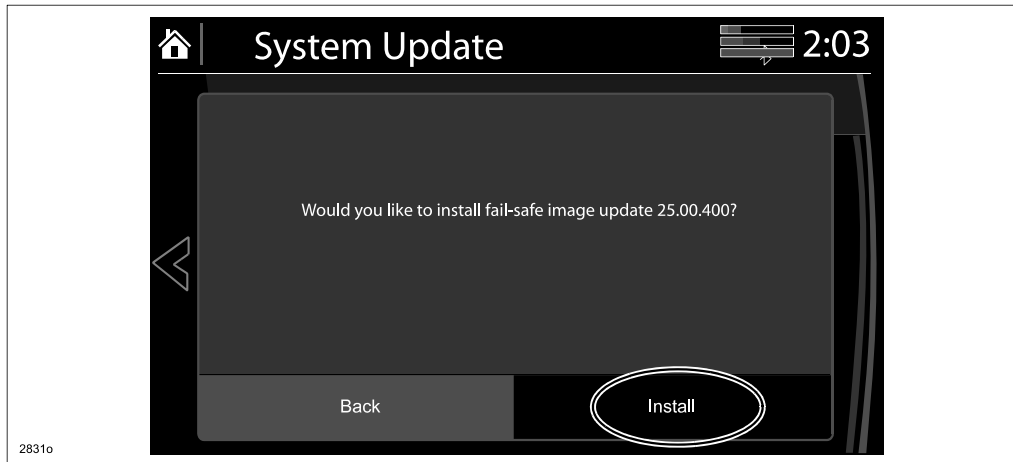
15. Select “Fail Safe Package” first using the touch screen.

**CAUTION:** Always do the “Fail Safe Package” first, followed by “Reinstallation Package”.

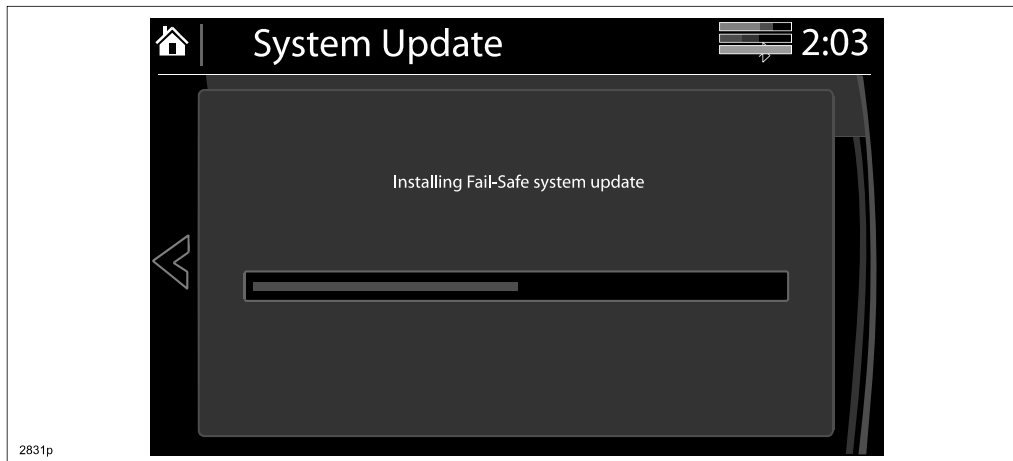
16. Select “Install” on the screen below and the Failsafe installation process will start.

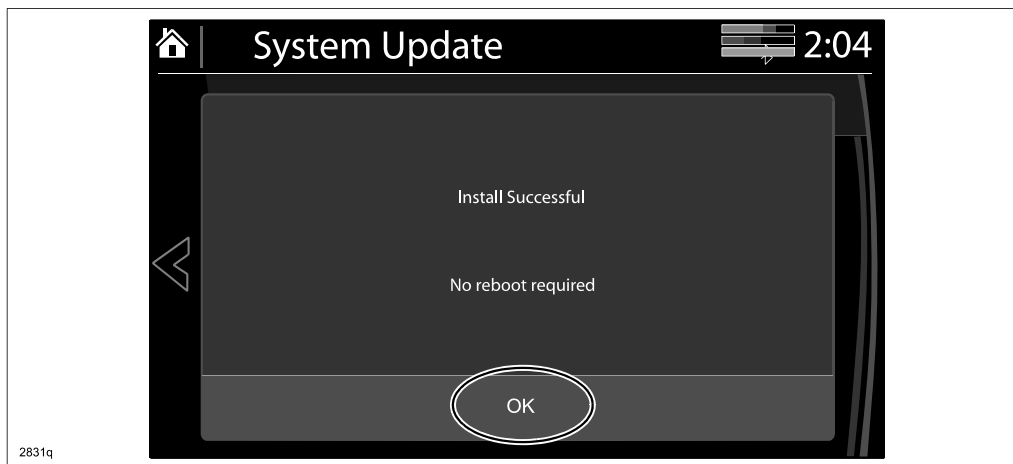
17. After the Failsafe installation process is completed, select “OK”.

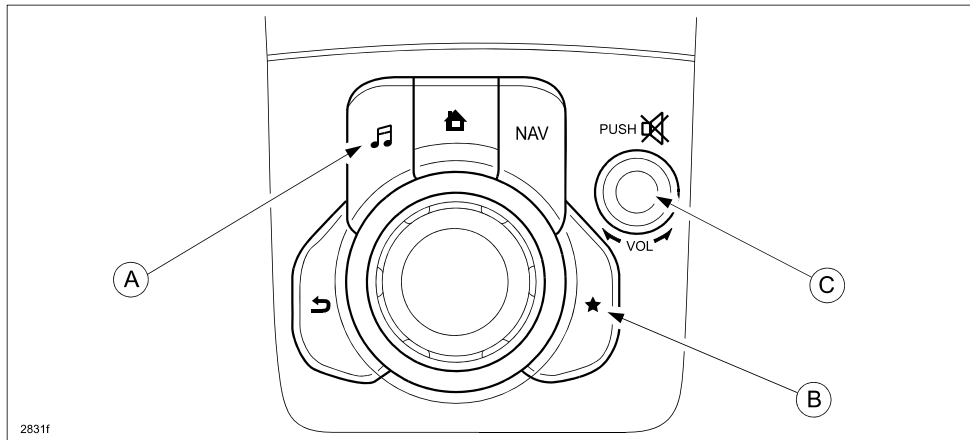
19. Press the three buttons (Music (A) + Favorites (B) + Volume Mute(C)) on the commander switch at the same time for 2-5 seconds to open the Diagnostics Test screen again.

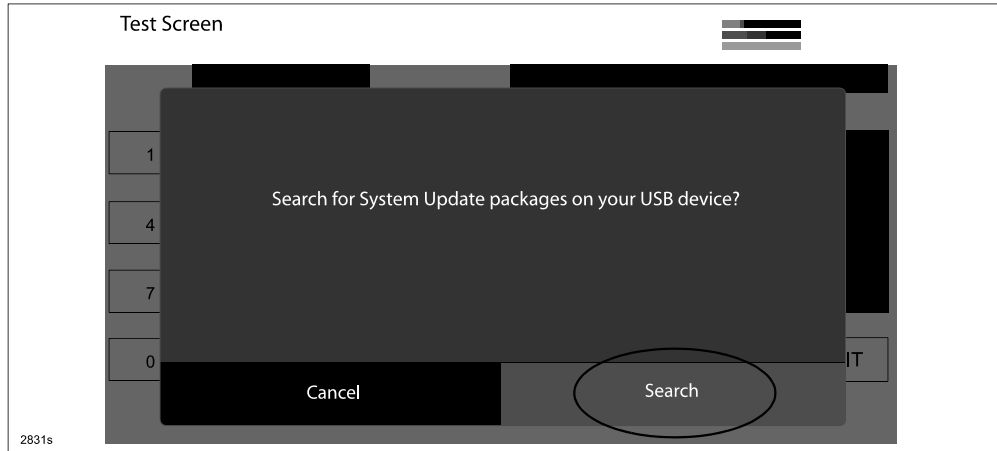
21. Select "Search" on the screen below.

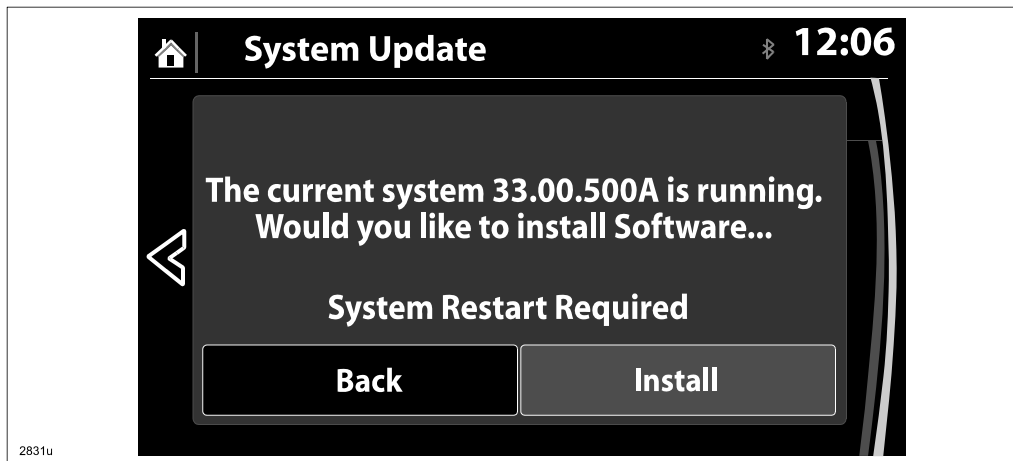
23. Select "Install" on the screen below.

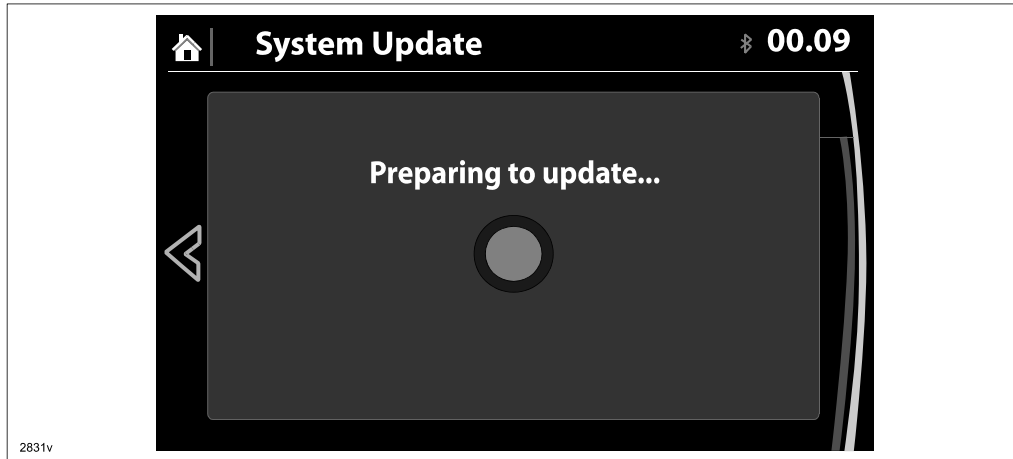
24. The screen below will be displayed.

**NOTE:** A blank screen is displayed momentarily. It will take approx. 2 minutes before the reflashing process moves to the next screen.

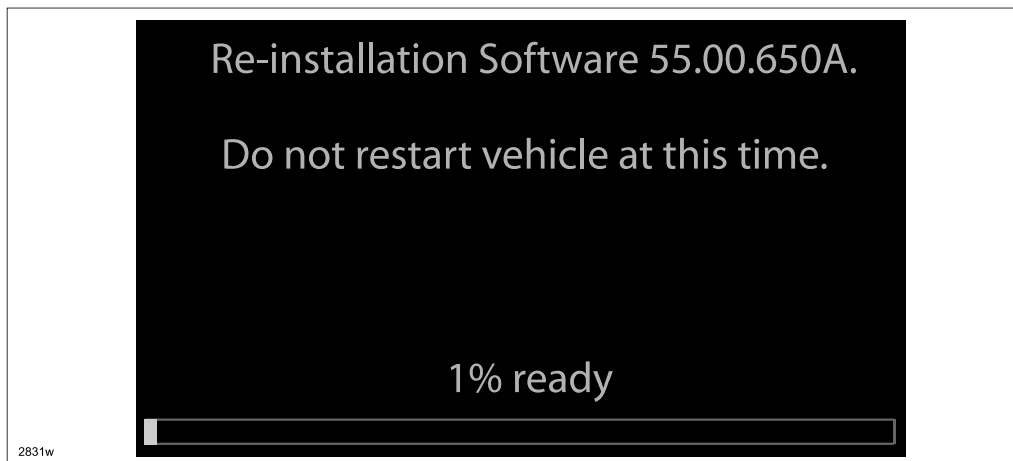
25. Reinstallation will start from 0% and as the reflashing process takes place, the progress bar will gradually increase to 100%.

**NOTE:** It may be difficult to read the display at times as it becomes dark, but "Do not restart vehicle at this time" is displayed.

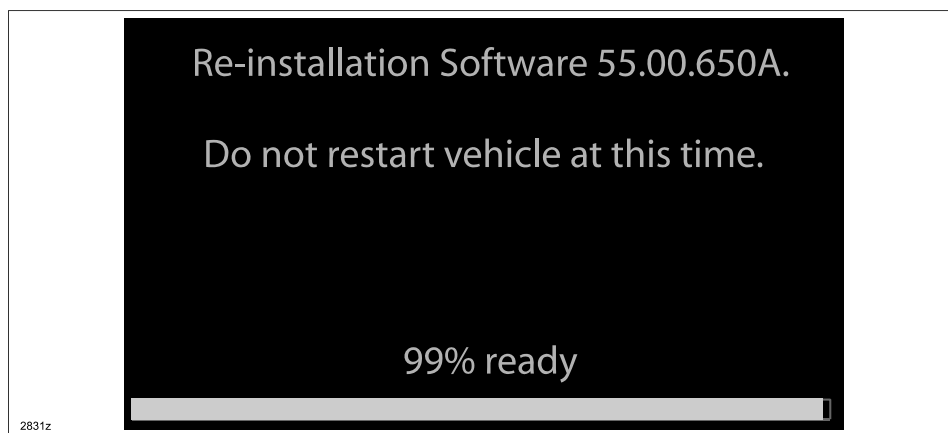
Type B: The ignition was turned “OFF” during the reflashing process. This screen will continue to be displayed until reflashing is completed. After the reflashing is completed, go to next step.
