Technical Service Bulletin

91 MMI3G+ Audi connect only reaches 2G service - Telephone module replacement instructions for A6 & A7

91 15 00 2039515/3 June 30, 2015. Supersedes Technical Service Bulletin Group 91 number 15-85 dated May 15, 2015 for reasons listed below.

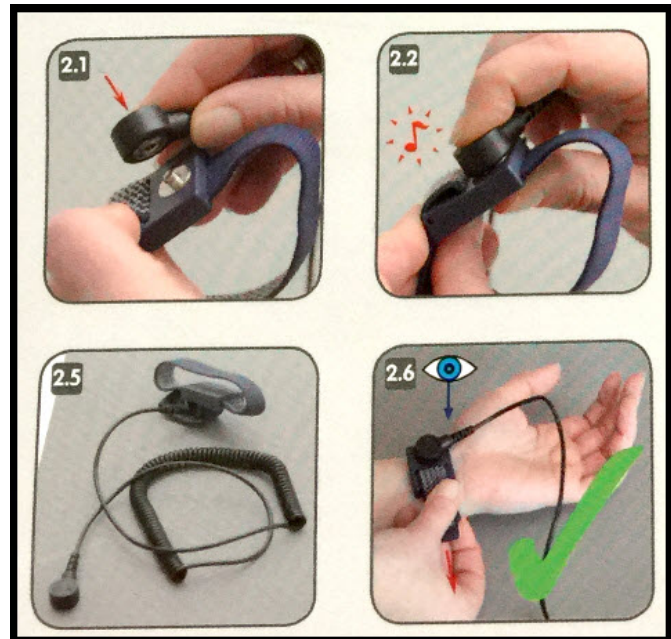
5. Ground yourself by placing the elastic strap around your wrist. Make sure it is securely touching your skin. It cannot be loose-fitting or over your shirt cuff (Figure 3).

Figure 3. VAS6613 ESD work surface grounding wrist strap.

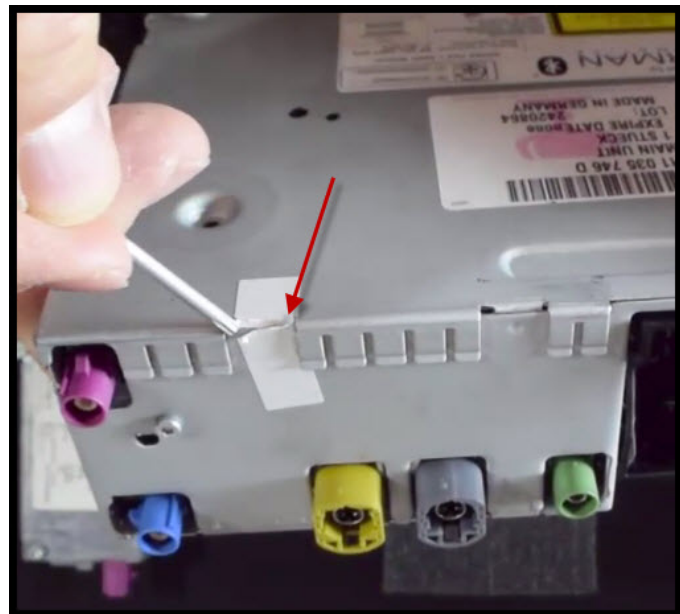
8. Break the white warranty seal on the back of the main unit (Figure 7).

Figure 7. Break the white warranty seal.

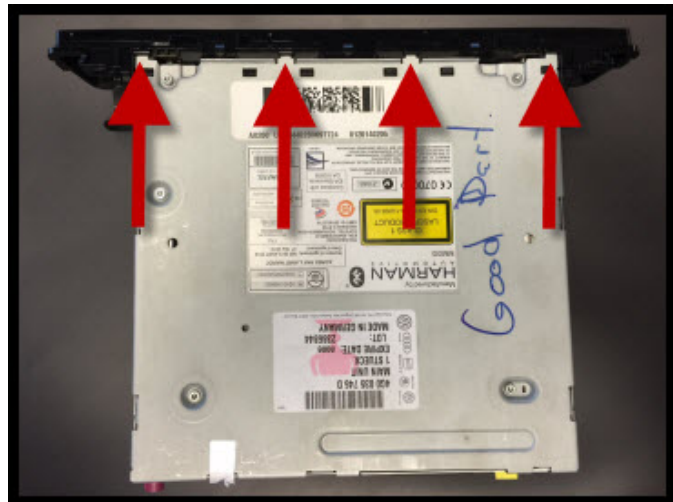
The top cover of the main unit has four metal tabs that are slotted into the plastic front face plate (Figure 9). Slightly lift on the rear of the cover and pull back on the cover until the metal tabs are released. Lift up on the cover and pull it away from the face plate at the same time to prevent bending the top cover's metal tabs (Figure 10). If the metal tabs bend during this process, straighten them with a pair of pliers.

Figure 9. Top cover metal tabs indicated by the red arrows.

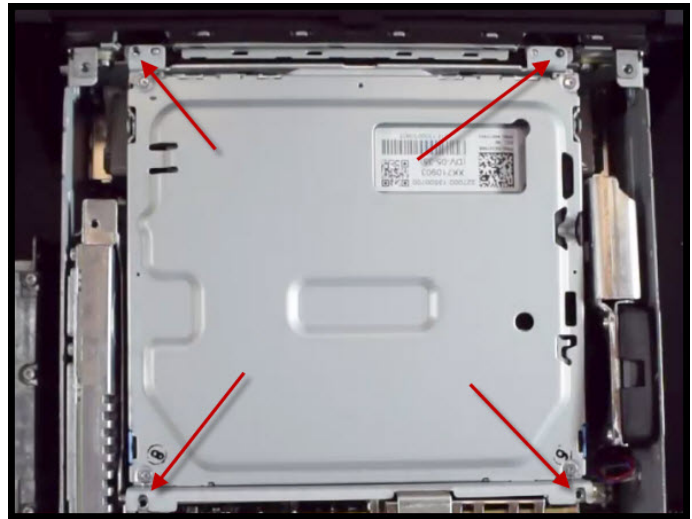
Do not flip the main unit over at this point. The CD drive, which was held in place by the top cover screws, is no longer secured. If the CD drive moves significantly, the ribbon cable can detach from the circuit board and disable the CD drive's functionality (Figure 11).

Figure 11. CD drive mounting points are now free.

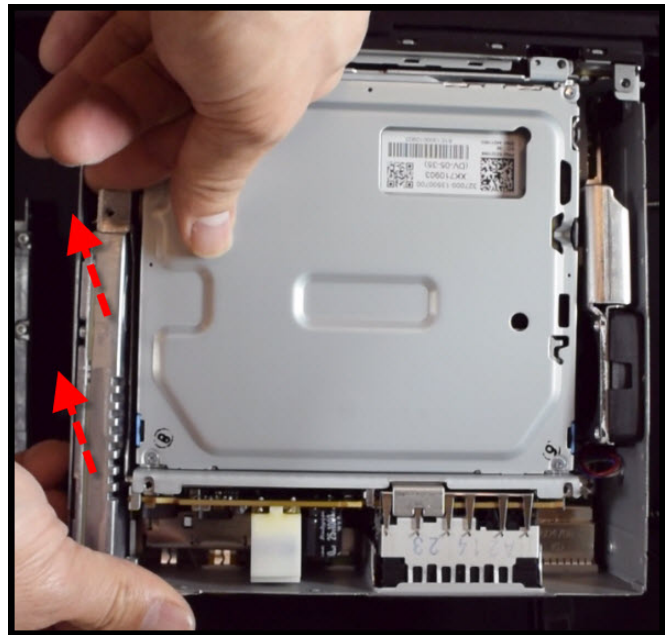
- Carefully lift up the telephone module, using both ends as points of contact when pulling up (Figure 13). The module is held in place with a computer socket-type attachment and will release when enough force is used.

Figure 13. Lift up on both ends of the telephone module as indicated by the red arrows.

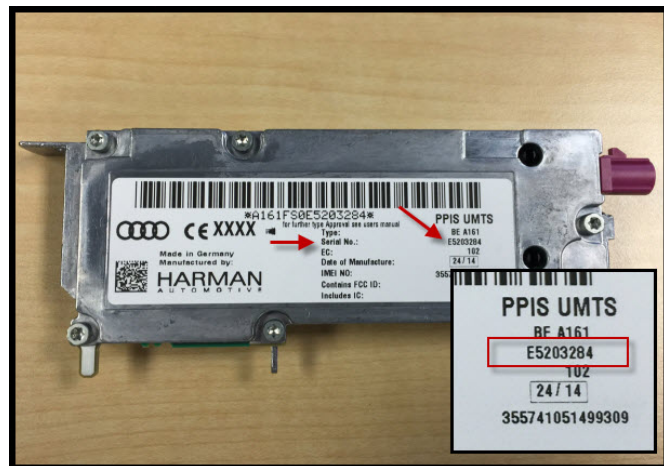
- Before proceeding, write down the serial number of the new replacement UMTS telephone module (Figure 14).

Figure 14. Serial number of the PPIS UMTS telephone module indicated by the red arrows and red box.
