Technical Bulletin

91 15 01 January 22, 2015 2039352

Modular Infotainment System (MIB) Radio Switches to FM Station 87.7

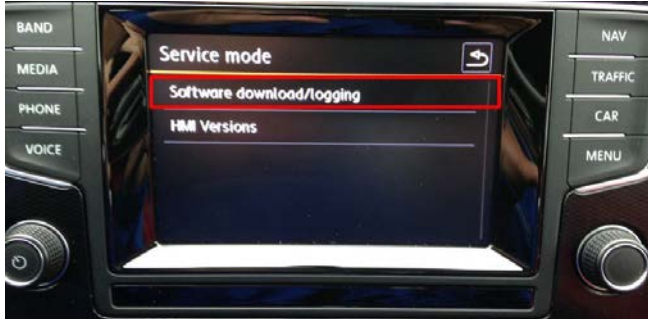
- Connect Midtronics InCharge 940 (INC 940) Tester/Charger to the vehicle's battery.
- Switch the ignition to the ON position.
- Switch on the MIB radio.
- Check the Software Version by pressing and holding the "Menu" button for 10 seconds to enter Service Mode.

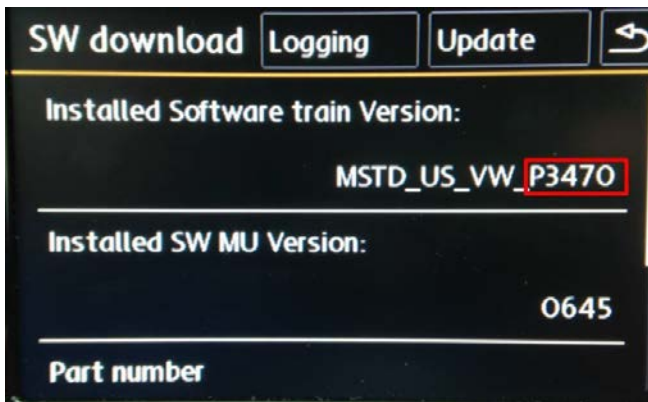
- Select “Software download/logging” on the touch screen menu.

- If the current Installed Software train Version ends in a number lower than **P4430**, proceed with this Technical Bulletin.
- If the current Installed Software train Version ends in a number greater than or equal to **P4430**, this work procedure does not apply.

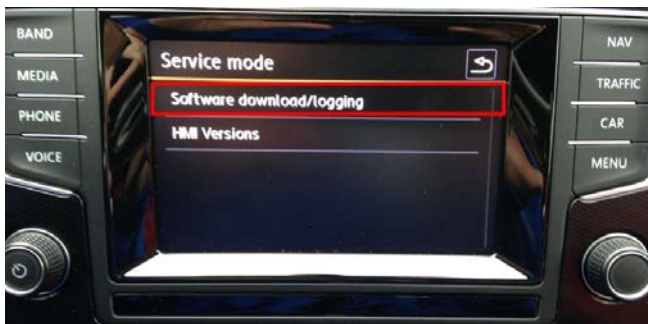
- Press the back arrow key on the touchscreen display to return to the main MIB menu.
- Insert the applicable software update SD card into the 5F module SD card reader located in the glove box (Composition Media if equipped with the non-navigation MIB system or Discover Media if equipped with the MIB system with navigation).
- Again press and hold the “Menu” button to enter Service Mode.

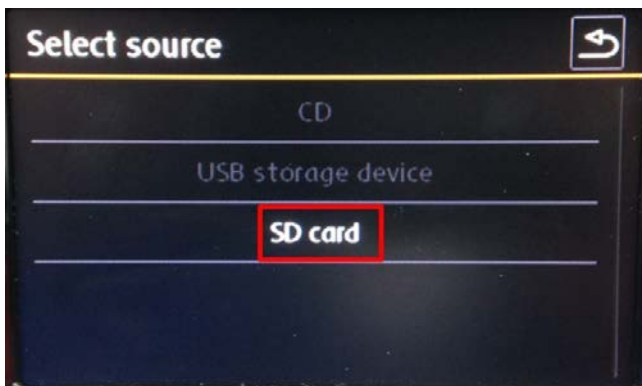
- Press "Update" on the touch screen menu.
