Technical Bulletin

91 15 02 March 19, 2015 **2036310** Supersedes **Technical Bulletin V911401** dated February 6, 2014. Software for downloading is now available on ServiceNet.

UMI Software Update for Various Bluetooth® Concerns

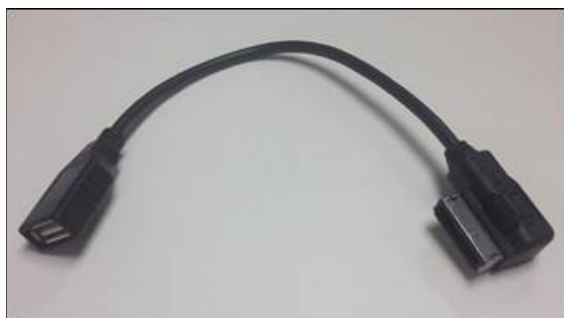
- Connect Midtronics InCharge 940 (INC 940) Tester/Charger to the vehicle's battery.
- Remove the iPod cable from the UMI module connector (located either in the center console or glove box depending on vehicle model).

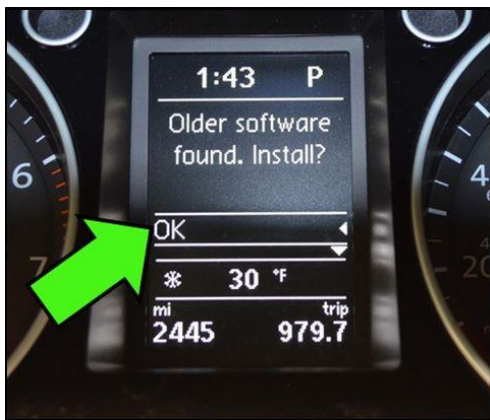
If the vehicles hood, trunk, or any doors are open, it may affect the MFI display directions. Close the hood, trunk, and/or doors as necessary. Press the OK button to return to the main menu.

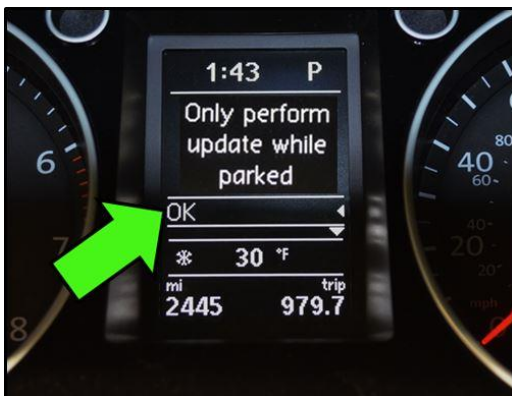
- On vehicles with high line cluster, select "OK" again <arrow>.

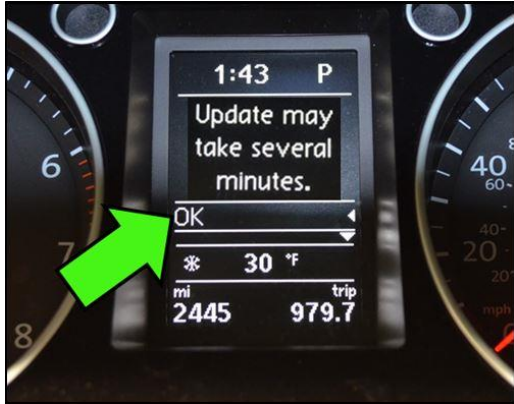
- On vehicles with high line clusters select “OK” button on the steering wheel <arrow>. An audio confirmation is played over the vehicle speakers. Follow audio guidelines as necessary.

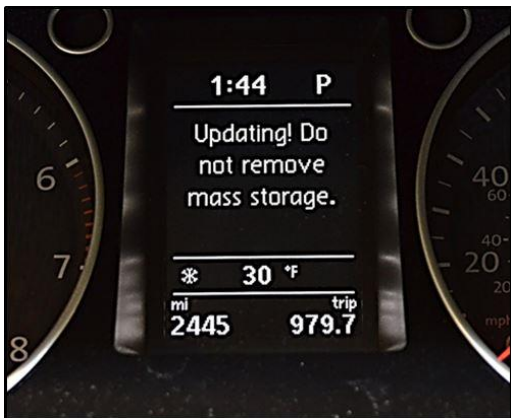
- On high line instrument cluster vehicles, the software update message <as shown> is displayed during the update.

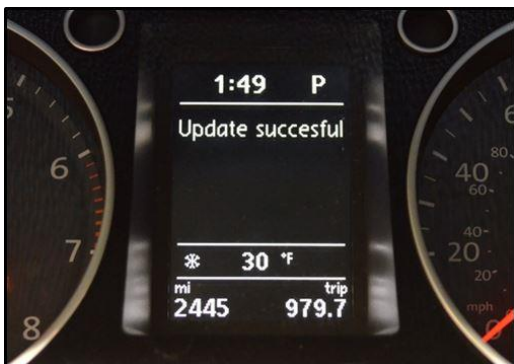
- Once software update is complete an audio confirmation is played over the vehicle speakers on all vehicles. On vehicles equipped with the high line instrument cluster, the message “Update successful” will also appear.
- Remove USB memory stick and adapter cable when prompted.
- After a few minutes, the audible message will state: “The language for voice recognition has been changed to English”. It is necessary to wait for this message before proceeding to Section B.
- Proceed to Section B.

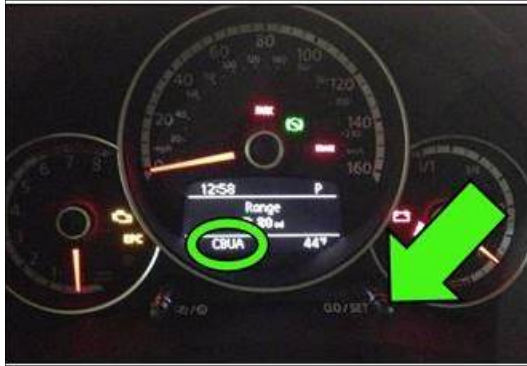
To obtain the engine code, press and hold the “0.0/SET” button for approximately 10 seconds. The engine code will appear as shown.

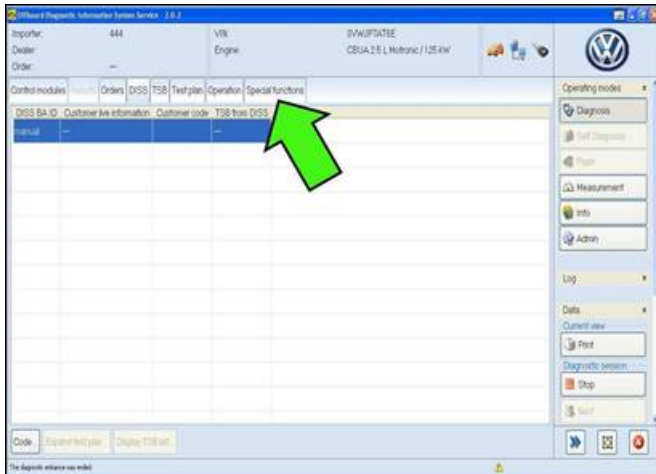
- Launch ODIS application, select “Diagnosis”, select “Start Diagnosis” and identify the vehicle.
- After the control units are identified, select the “Special Functions” tab.

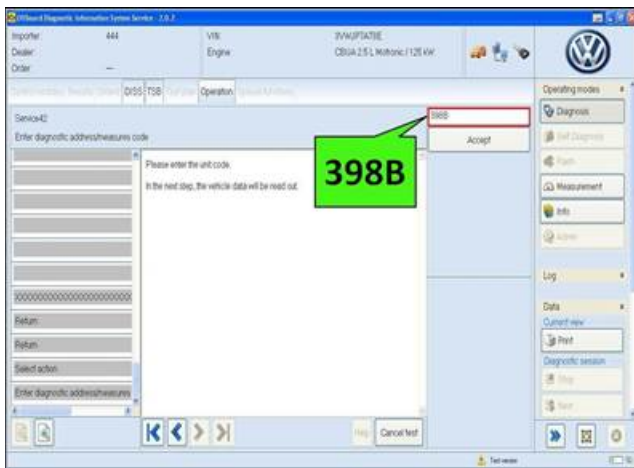
- Enter the SVM Unit Code “**398B**” and confirm the input.
- Follow the instructions on the screen.
