UPDATE Technical Bulletin

91N9 UPDATE – MIB2 MQB Modular Infotainment System Software Update (NVLW) – USA Only

Technical Background

Software level 0613 is available to enhance infotainment system functionality.

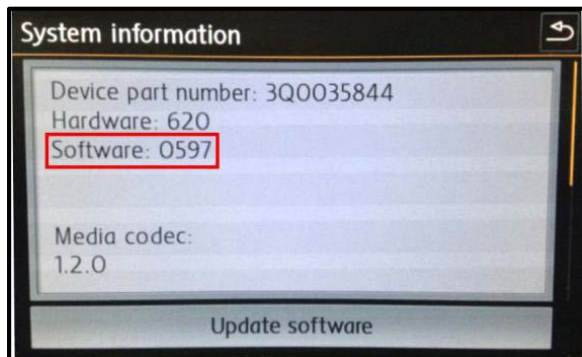
- Open the hood.
- Open the battery cover.
- Attach the GRX3000VAS Tester/Charger (or equivalent) to the vehicle battery.
- Switch the ignition ON.
- Switch the radio ON.
- Check the software version by pressing the “Menu” hard key on the infotainment unit.
- Using the tuner knob, scroll through the touch screen menu and stop on “setup”.
- Select “Setup” on the touch screen menu.
- Select “System Information” on the touch screen menu.

- If the currently installed software level is LOWER than **0613** <as shown>, proceed with these repair instructions.
- If the currently installed software level is GREATER than or EQUAL to **0613**, this work procedure does not apply.

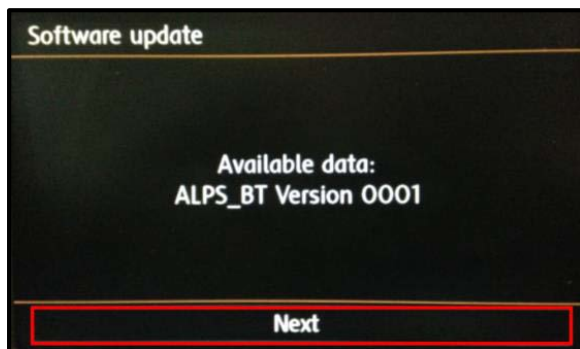
- Insert the SD card, P/N: SW0613UD, into the 5F module SD card reader located in the glove box.
- Select “Update Software” on the touch screen menu.

- Select “Next” <as shown> on the touch screen menu.

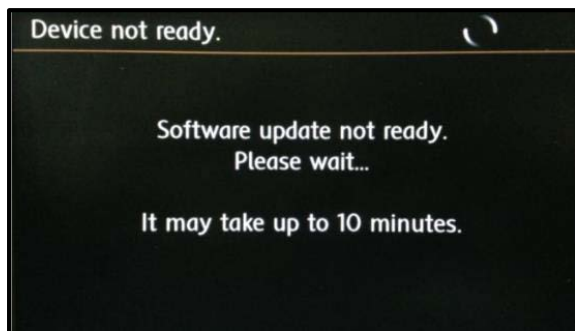
- The “Device not ready” screen will be displayed temporarily.
- After this screen is displayed, the Infotainment system will reboot and return to the normal operating mode.
- If the unit does not restart within 2 minutes, turn the unit ON using the ON/OFF button (volume knob).

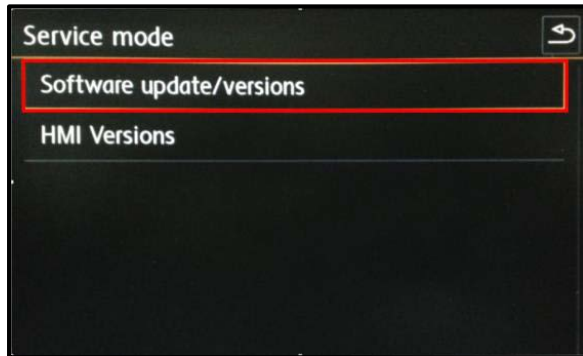
- After the Infotainment system turns back on, enter “Service Mode” by pressing and holding the “Menu” key button on the Infotainment unit for 10 seconds.

- Select "Software update/versions" <as shown> on the touch screen menu.

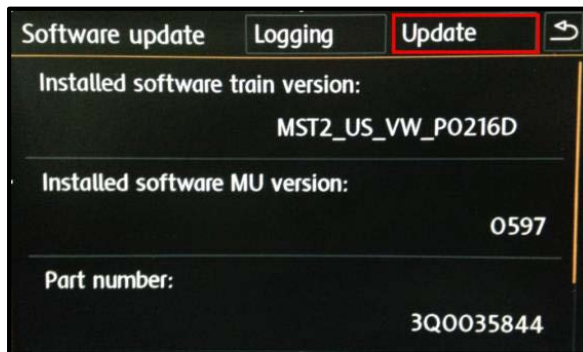
- Select "Update" <as shown> on the touch screen menu.

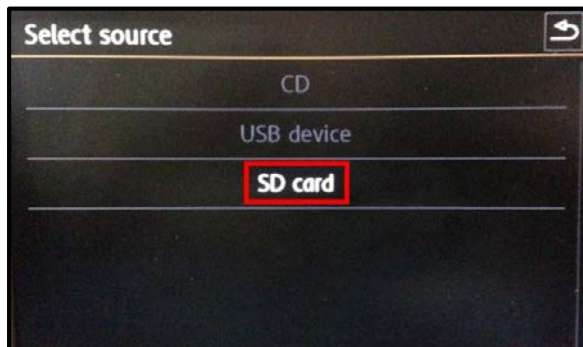
- Select "SD card" <as shown> on the touch screen menu.

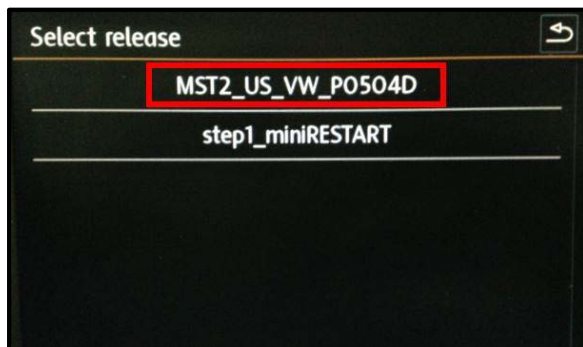
- Select "MST2_US_VW_P0504D" <as shown> on the touch screen menu.

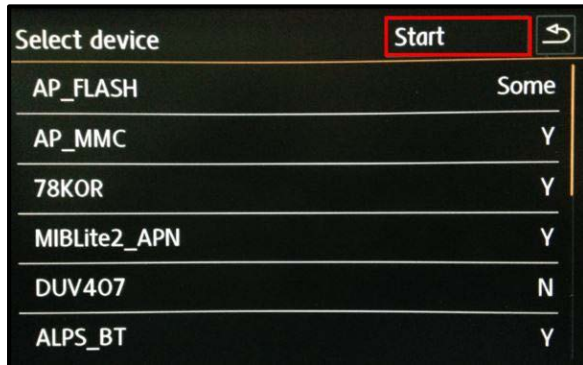
- Select “Start” <as shown> on the touch screen menu.

- Select “Next” on the touch screen menu to begin the software update.

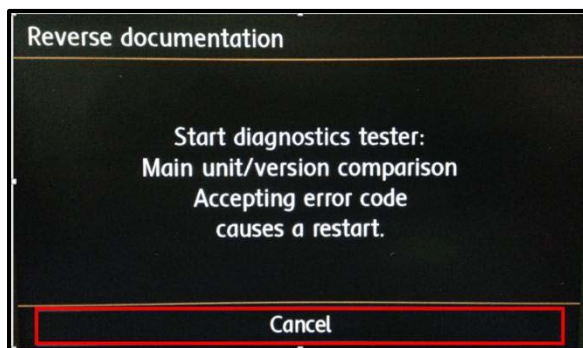
- When the “Reverse documentation” screen is displayed, select “Cancel” <as shown> on the touch screen menu.

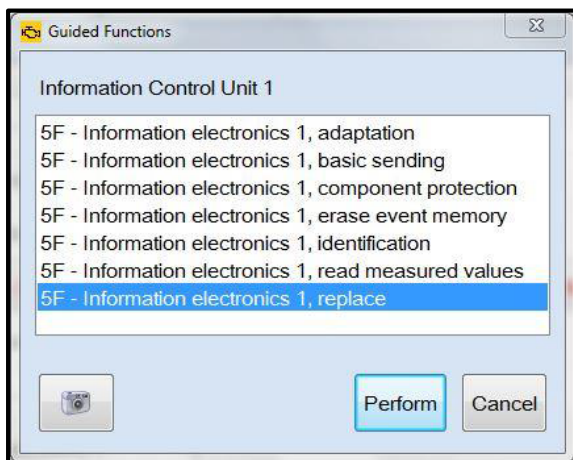
- Select “Guided Functions”.

- Select “5F – Information electronics 1, replace” <as shown>.
- Select “Perform”.

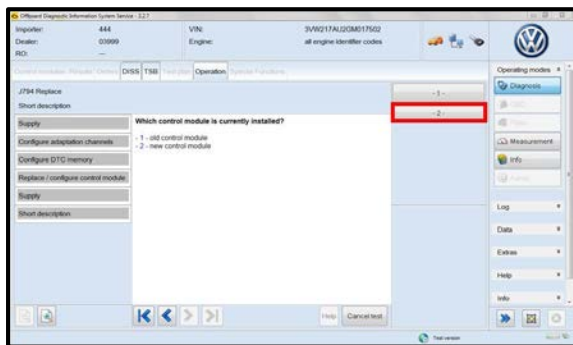
- Select option 2, “new control module” <as shown>.

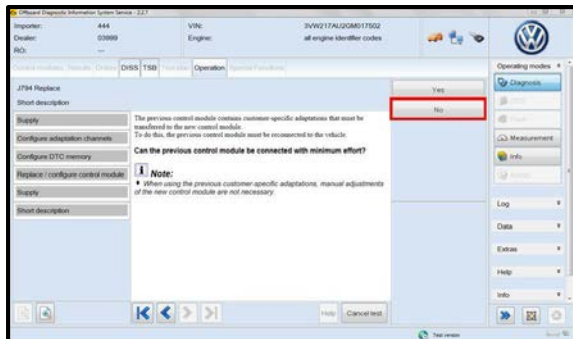
- Select “No” <as shown>.

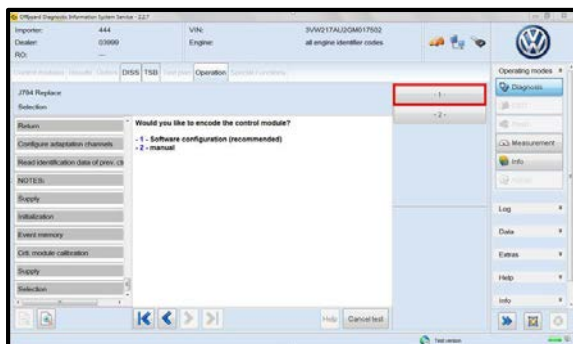
- Select option 1, “Software configuration (recommended)”.
