# Technical Bulletin

**93 15 01** April 30, 2015 **2040470**

### **High Voltage Battery Not Charging as Expected for Departure Time Set With Car-Net™ (U.S. Only)**

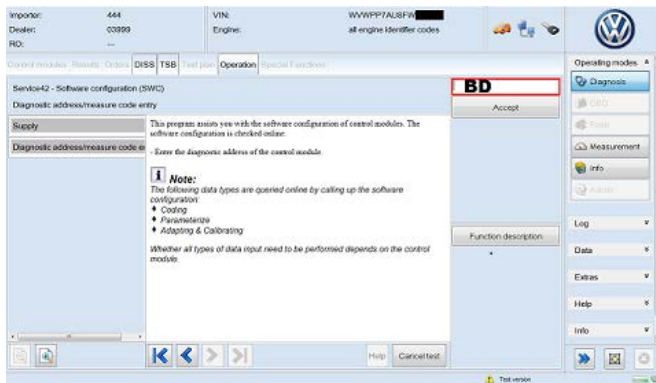
- In the “Special Functions” mode, select **“Ctrl. Module software configuration”**.

- The software update takes place by entering the address of the control module to be updated, **“BD”**, and then confirming the input.
- Follow the instructions on the screen to complete update.
