Technical Bulletin

87 15 06 July 7, 2015 2019947 Supersedes T.B. V871409 dated September 24, 2014 to include additional models, model years.

Air Conditioning, Cleaning of the Refrigerant Circuit (U.S.Only)

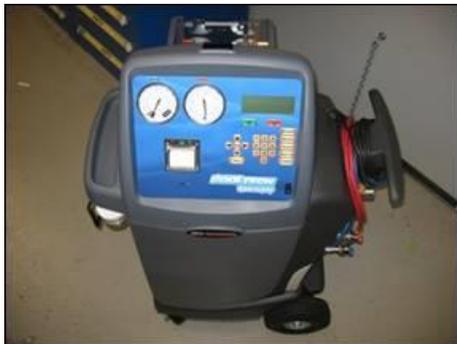
Figure 1. The ROB134APF Air Conditioning Service System with VAS 6337/1A Air Conditioning System Flushing Device.

- Use the ROB134APF Air Conditioning Service System with VAS 6337/1A Air Conditioning System Flushing Device (Figure 1) Used for effective refrigerant handling and air conditioning circuit flushing after air conditioning component failure.
- Now air conditioning system refrigerant recovery, evacuation, recharge *and* refrigerant circuit cleaning after component failure can be performed with a single servicing station.

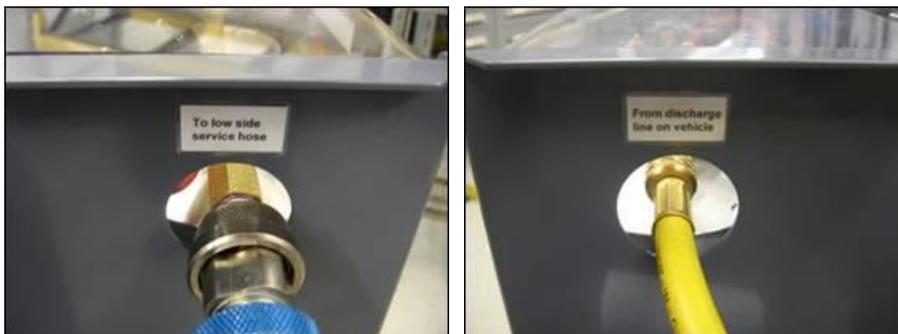
Figure 2. A flushing attachment port.

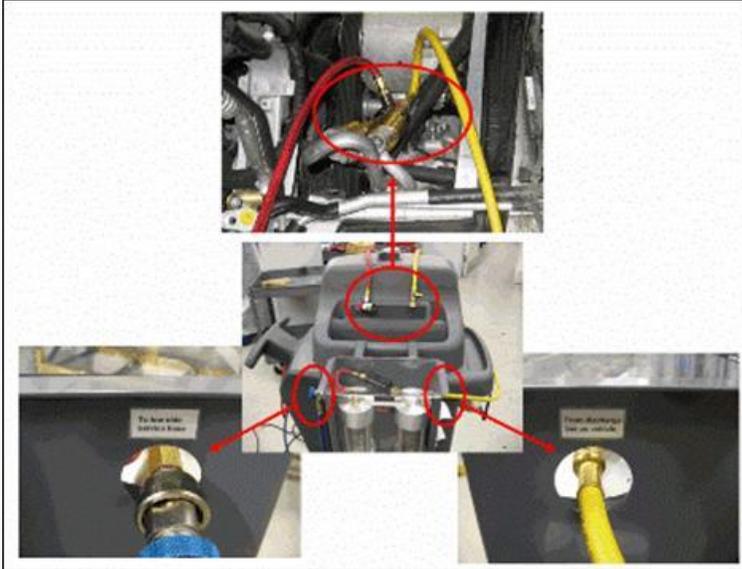
- This connection strategy allows for a system flush *in the opposite* direction of the normal refrigerant flow (Figure 4).

Figure 4. Connection strategy: Vehicle to service station to flushing device.

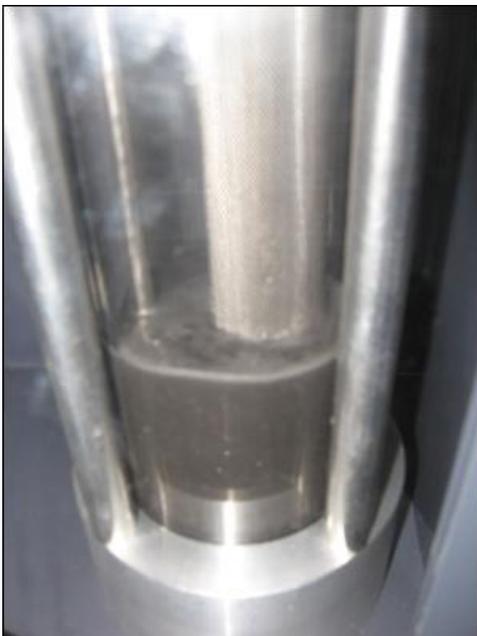
Figure 5. The first cycle.

- The flush program will begin with an evacuation of the system and a rate of rise test. This is necessary to test the integrity of the connections before the flush cycles begin. If the rate of rise test passes, the program will proceed into the flush cycles. (Figures 5 – 7). These cycles will occur automatically in succession.

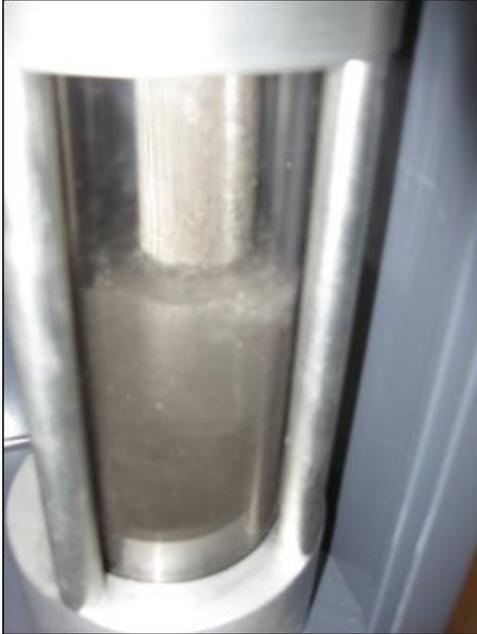
Figure 6. *The second cycle.*

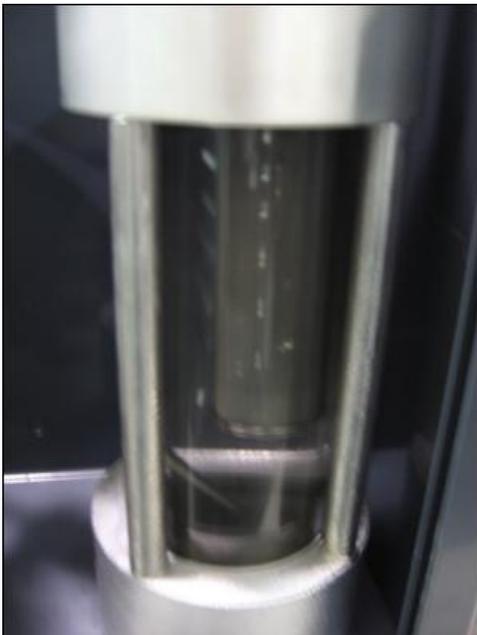
Figure 7. *The third cycle.*

- The debris is then rinsed from the circuit and contained within the filtration in the flusher. After the flush program, the system will be evacuated.

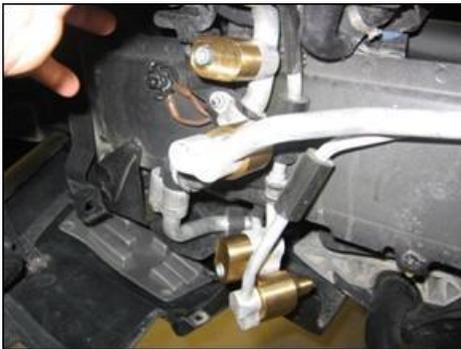
Figure 8. The location of the connections inside the left front wheelhouse on a Touareg with four zone climate control.

1. Separate the front and rear air conditioning systems for individual rinse operations.

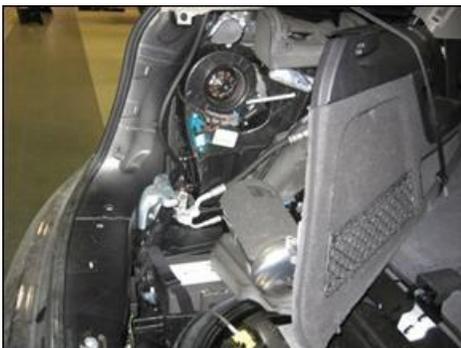
Figure 9. Location of rear air conditioning unit and expansion valve.

2. Bypass the rear expansion valve with an adapter from the VAS 6338/1.
3. Flush rear A/C.

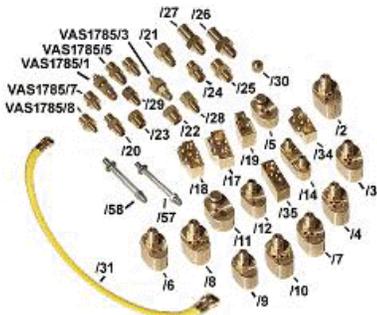
<p>VAS 6338/1</p>
<p>Additional adapter for bypass of the front expansion valve for Touareg</p>

The VAS 6338/1 Adapter Set for Refrigerant Circuits. Along with an additional adapter (VAS 6338/33 for the front expansion valve bypass for the Touareg) this kit contains the adapters necessary to complete a thorough flush operation of a contaminated circuit.
