Technical Bulletin

91 15 07 August 3, 2015 **2039352** Supersedes Technical Bulletin V911506 dated June 16, 2015 to enter comment about eGolf.

Modular Infotainment System (MIB) Radio Switches to FM Station 87.7

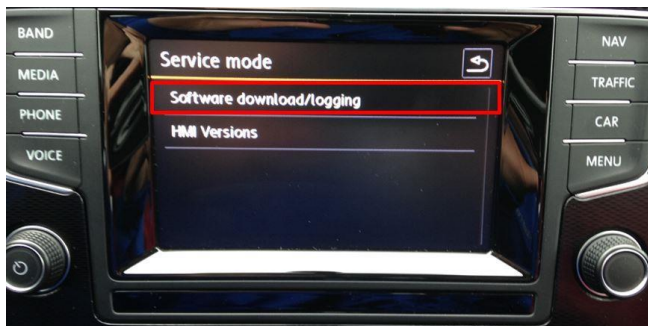
- Connect Midtronics InCharge 940 (INC 940) or GRX3000VAS Tester/Charger to the vehicle's battery.
- Switch the ignition to the ON position.
- Switch on the MIB radio.
- Check the Software Version by pressing and holding the "Menu" button for 10 seconds to enter Service Mode.

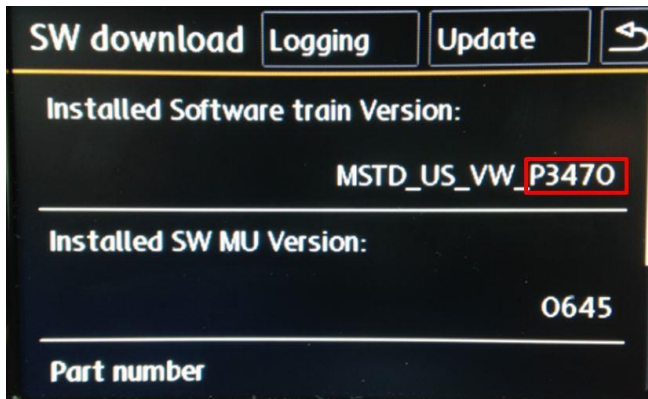
- Select "Software download/logging" on the touch screen menu.

- If the current Installed Software train Version ends in a number lower than **P4430**, proceed with this Technical Bulletin.
- If the current Installed Software train Version ends in a number greater than or equal to **P4430**, this work procedure does not apply.

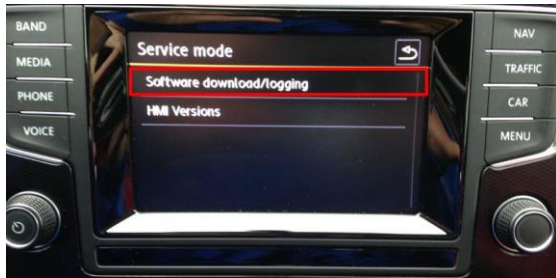
- Press the back arrow key on the touchscreen display to return to the main MIB menu.
- Insert the applicable software update SD card into the 5F module SD card reader located in the glove box (Composition Media if equipped with the non-navigation MIB system or Discover Media if equipped with the MIB system with navigation).
- Again press and hold the "Menu" button to enter Service Mode.

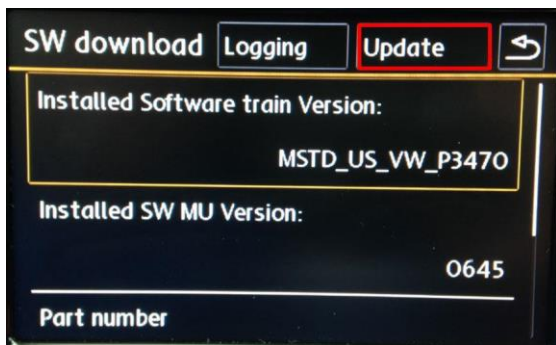
- Press “Software download/logging” on the touch screen menu.

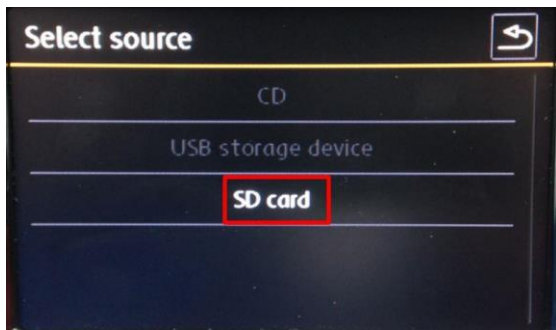
- Press “Update” on the touch screen menu.

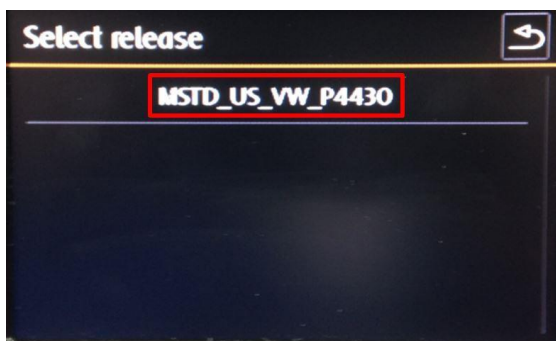
- Press “SD card” on the touch screen menu to select SD card as the source.

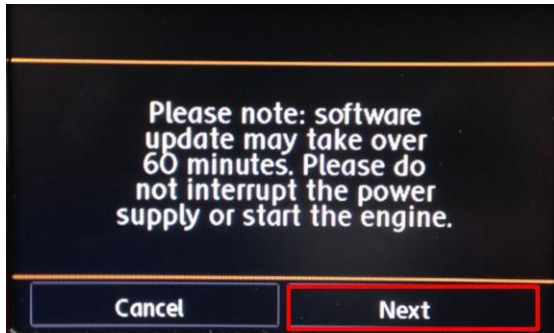
- Press “MSTD_US_VW_P4430” on the touch screen menu.

- Press “Next” on the touch screen menu.
- The update will now take place.

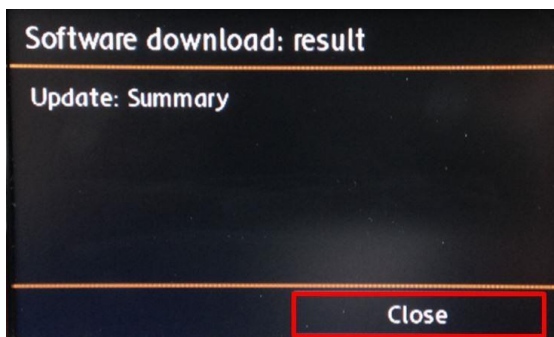
- Once the software update is complete, press “close” on the touch screen menu.
