Technical Service Bulletin

91 MMI3G+ Audi connect only reaches 2G service - Telephone module replacement instructions for A6 & A7

91 15 20 2039515/5 October 16, 2015. Supersedes Technical Service Bulletin Group 91 number 15-07 dated July 28, 2015 for reasons listed below.

Model(s)	Year	VIN Range	Vehicle-Specific Equipment
A6, A7	2011 - 2013	All	Audi connect

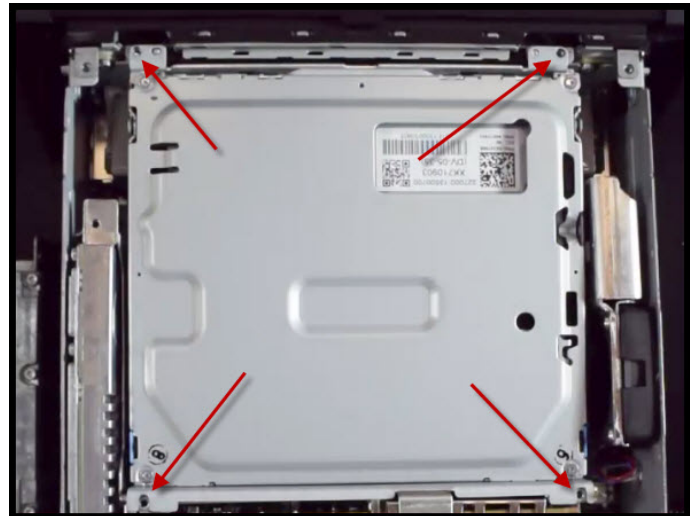
Do not flip the main unit over at this point. The CD drive, which was held in place by the top cover screws, is no longer secured. If the CD drive moves significantly, the ribbon cable can detach from the circuit board and disable the CD drive's functionality (Figure 11).

Figure 11. CD drive mounting points are now free.
