# Audi Elsa Newsletter

Edition 158: October 19, 2015

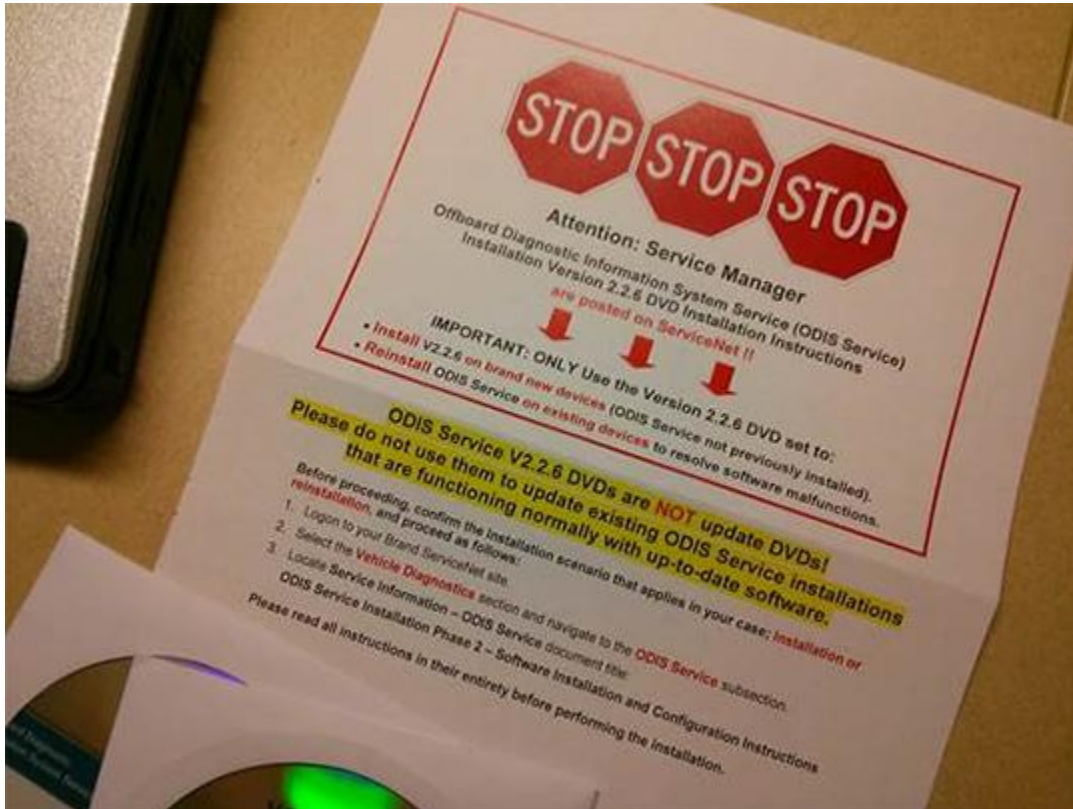
The DVD shipment cover letter (see below) clearly states that the V2.2.6 DVDs are **not update DVDs**, and that they are **ONLY** to be used to install ODIS Service on brand

new diagnostic devices, and to reinstall ODIS Service on exiting devices to resolve malfunctioning software:

To avoid confusion and unnecessary calls to DTSS, please ensure that the **V2.2.6 DVD shipment cover letter instructions remain attached to the DVD sleeves in their storage location**, and that all individuals tasked with managing ODIS Service in the workshop are aware of their intended use. If the cover letter has already been discarded, please request a replacement (.pdf for you to print locally) from [softwaresupport@vw.com](mailto:softwaresupport@vw.com).
