WF51 - Re-coding Instrument Cluster (Workshop Campaign)

Model Year: 2015

Vehicle Type: Cayenne S E-Hybrid (92A)

Concerns: Instrument cluster

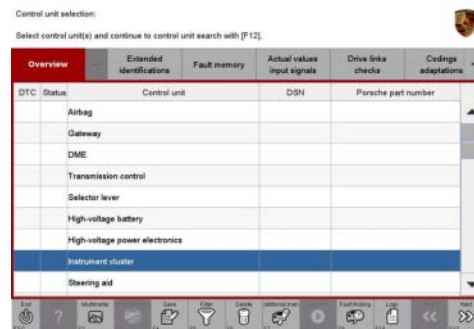
- Work Procedure: 1 Select ⇒ **'Instrument cluster'** in the control unit selection screen (⇒ **'Overview'** menu) and press •>>” to confirm your selection ⇒ *Control unit selection – Instrument cluster*.
- 2 When the question “Create Vehicle Analysis Log (VAL)?” appears, either press •F12” to create a VAL or press •F11” if you do not want to create a VAL.
- 3 Press •>>” to acknowledge the message informing you that campaigns for the vehicle are stored in the PIWIS information system.
- 4 Once the instrument cluster has been found and is displayed in the overview, select the ⇒ **'Codings/adaptations'** menu.

Control unit selection – Instrument cluster

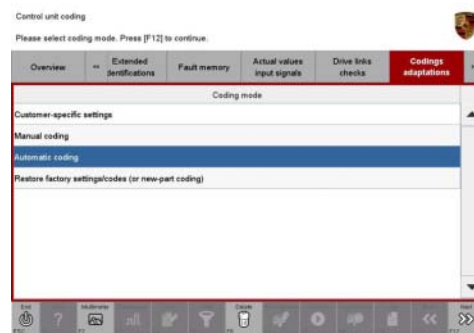
- 5 Select the ⇒ **'Automatic coding'** function and press •>>” to start coding ⇒ *Instrument cluster - Automatic coding*.

Instrument cluster - Automatic coding

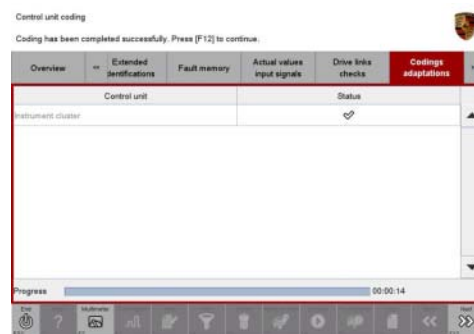
- 6 When coding is complete, the message “Coding has been completed successfully” is displayed and a tick appears in the 'Status' box ⇒ *Coding successful*.

Coding successful

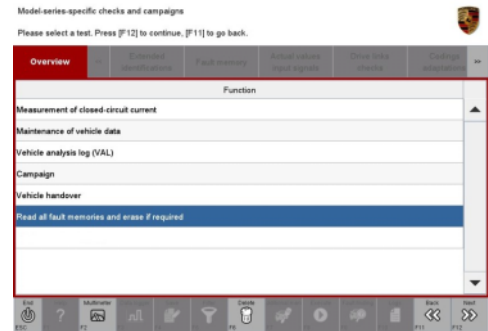
- 1 In the control unit selection screen (⇒ 'Overview' menu), press •F7" to call up the Additional menu.
- 2 Select the function "Read all fault memories and erase if required" and press •>>" to confirm ⇒ *Erasing fault memories*.

The fault memories of the control units are read out.

Erasing fault memories

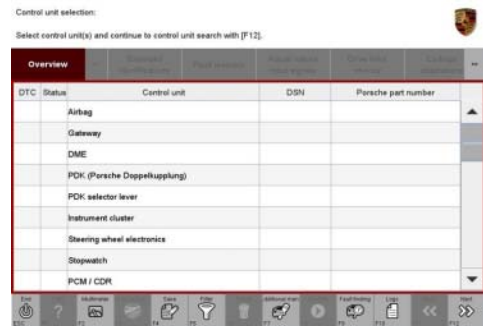
- Once you have erased the fault memories, select the ⇒ **'Overview'** menu to return to the control unit selection screen ⇒ *Control unit selection*.

Control unit selection
