# Entune Audio Head Unit Software Update (Panasonic)

## Entune Audio Head Unit Software Update (Panasonic)

Some 2014 model year applicable vehicles equipped with Entune™ Audio (version 010169) / Entune™ Audio Plus (version 010171) / Entune™ Premium Audio (version 010185) may exhibit one or more of the following conditions:

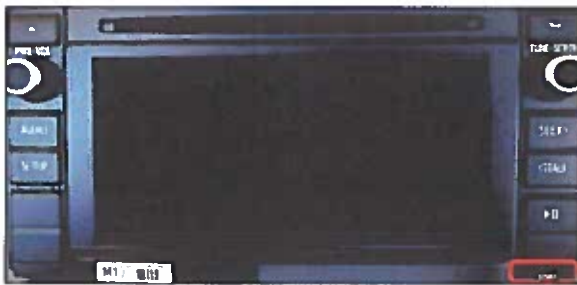
**Figure 1. Avalon, Avalon HV, Highlander, Highlander HV, Prius V, Sienna, Sequoia, Tacoma & Tundra.**

1. Confirm the audio system type by checking the Panel ID printed on the bottom-right or bottom-center of the machine.

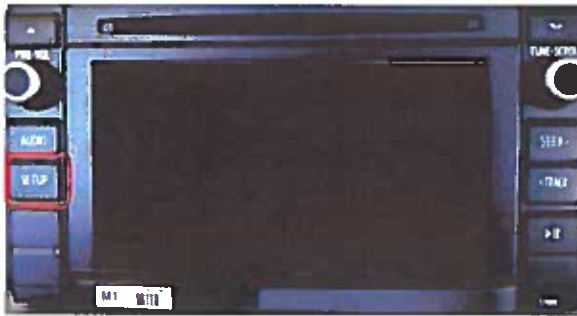
**Figure 3.** 4Runner, Highlander, Highlander HV, Sequoia, Tacoma & Tundra.

2. Start the engine.
3. Go to the *Setup* screen.
  - A. For Entune™ Audio:  
Press the **SETUP** button on the panel.

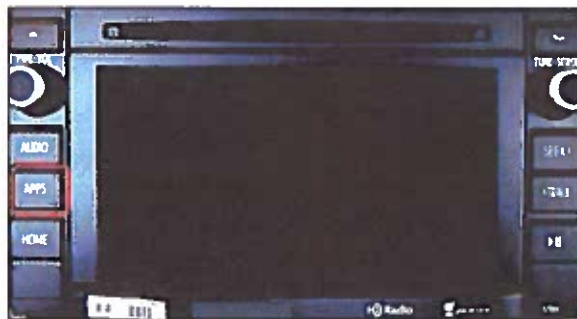
**Figure 5.** 4Runner, Highlander, Highlander HV, Sequoia, Tacoma & Tundra

- (1) Press the **APPS** button on the panel.

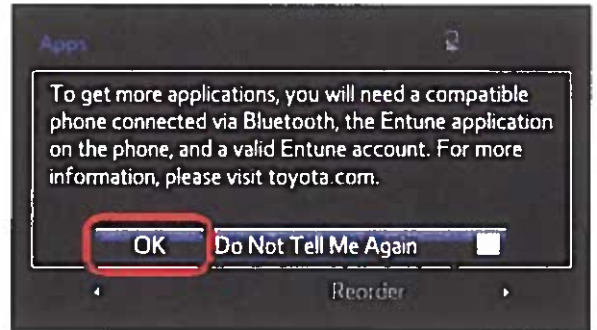
Figure 7.

If Entune™ pop-up displays, select **OK**.

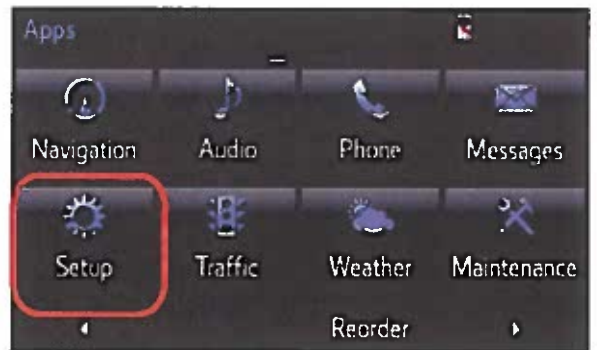
Figure 8.

(2) Select *Setup* on the Apps Screen.

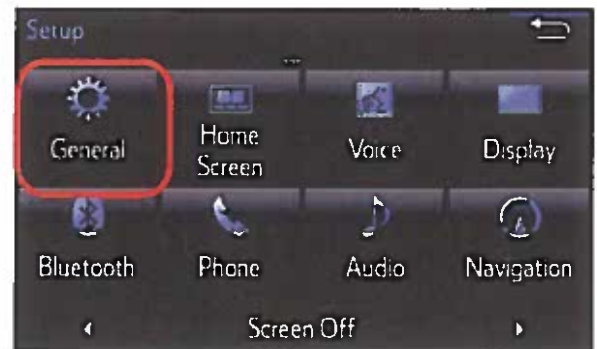
Figure 9.

4. Select *General* on the Setup screen.

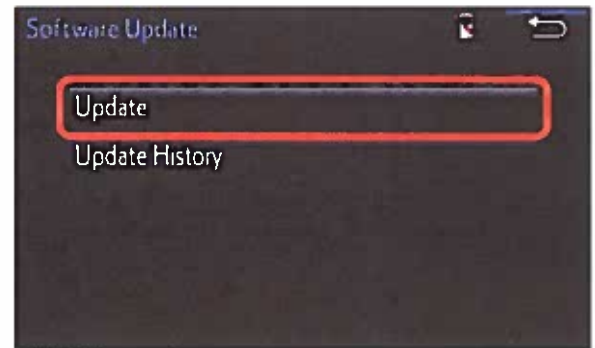
**Figure 11.**

6. Select *Update* on the *Software Update* Screen.

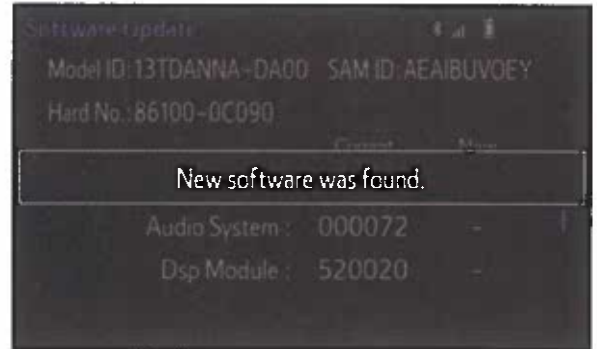
Figure 12.

If software has been detected properly, a "New software was found." Pop-up will be displayed.

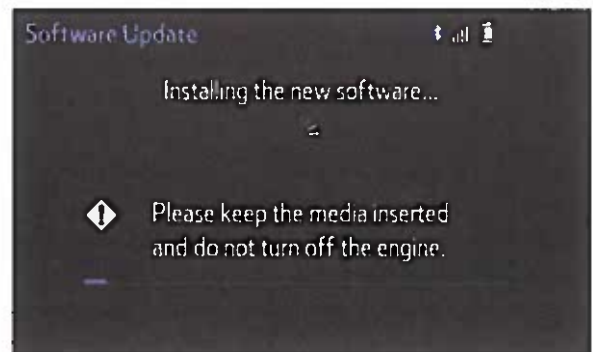
Figure 16.

10. The unit begins installation. The update will take about 10 minutes.

- Do NOT turn off the engine or ACC before the software is ready for updating.
- Do NOT pull the USB Drive SST out of the vehicle USB port.

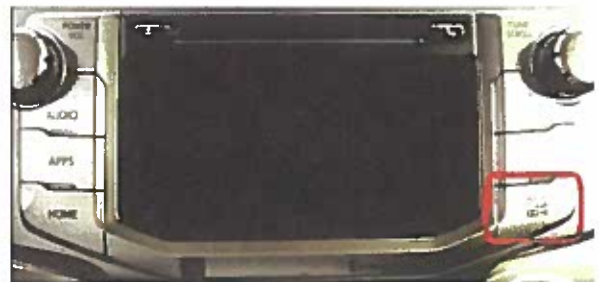
Figure 17.

If update fails and the error message “New software is not compatible with the system.” displays, cycle the ignition OFF, remove the Map Micro SD Card from the head unit, and repeat steps 2 – 11.

Once update is complete, reinsert the Map Micro SD card into the head unit, cycle the ignition OFF, and proceed to step 13.
