# Techstream ECU Flash Reprogramming Procedure

**Service Category** Engine/Hybrid System

**Section** Engine Control

## Techstream ECU Flash Reprogramming Procedure

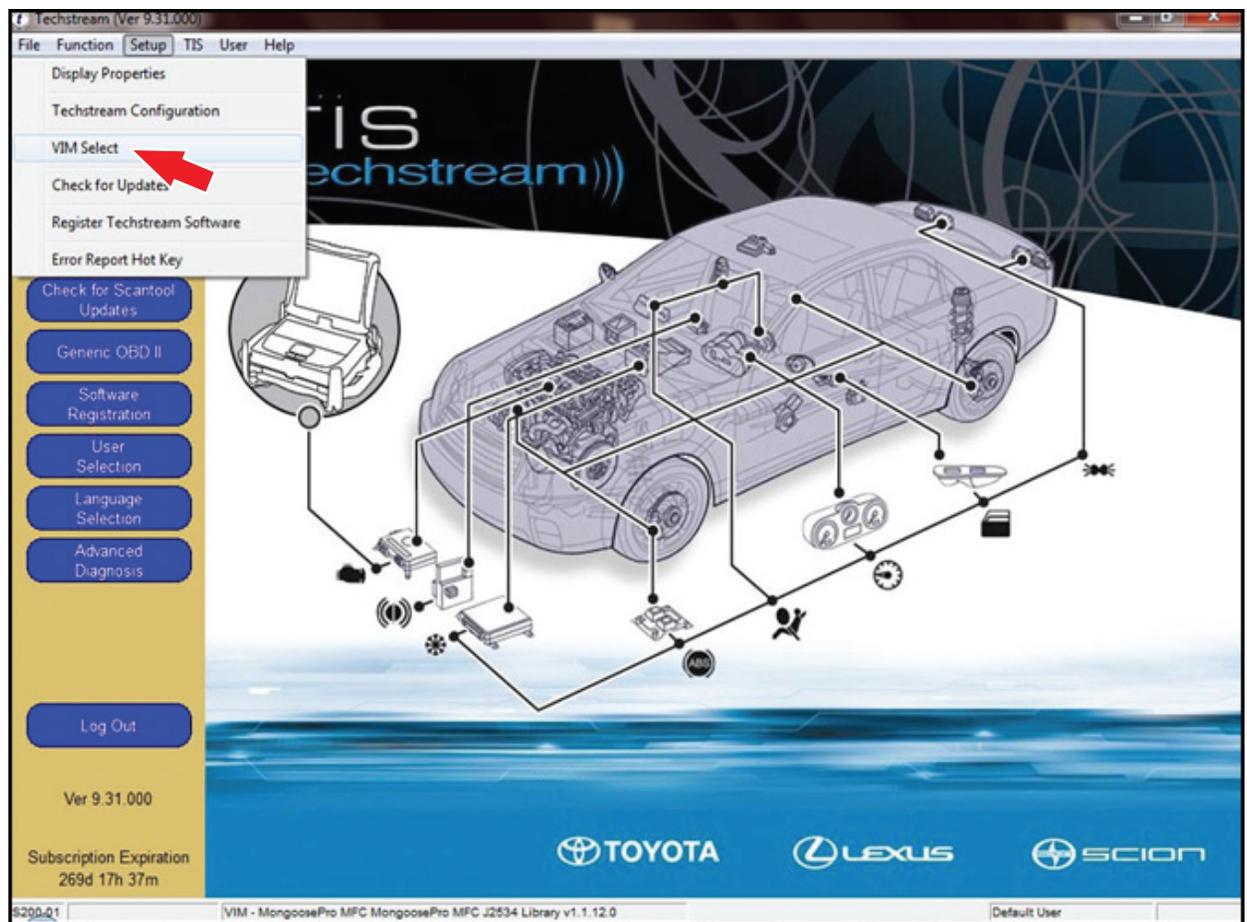
**Figure 1.**

1. Select *Setup* from the Techstream Main Menu screen.
2. Select *VIM Select* from the Setup drop down menu.

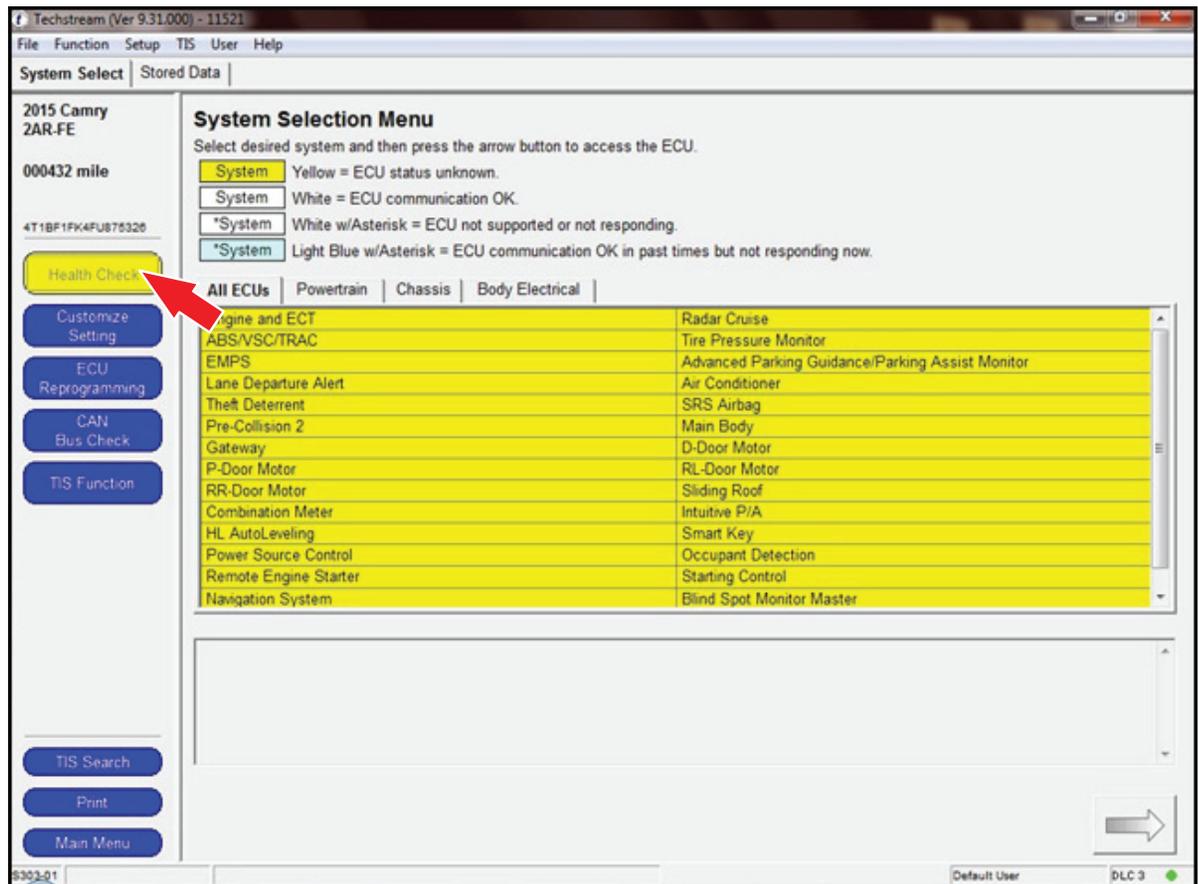
Figure 2.

1. Verify the vehicle's applicability for recalibration and locate desired calibration file.
  - A. Connect Techstream and establish a vehicle connection.
  - B. Click the *Health Check* button on the *System Select* tab.

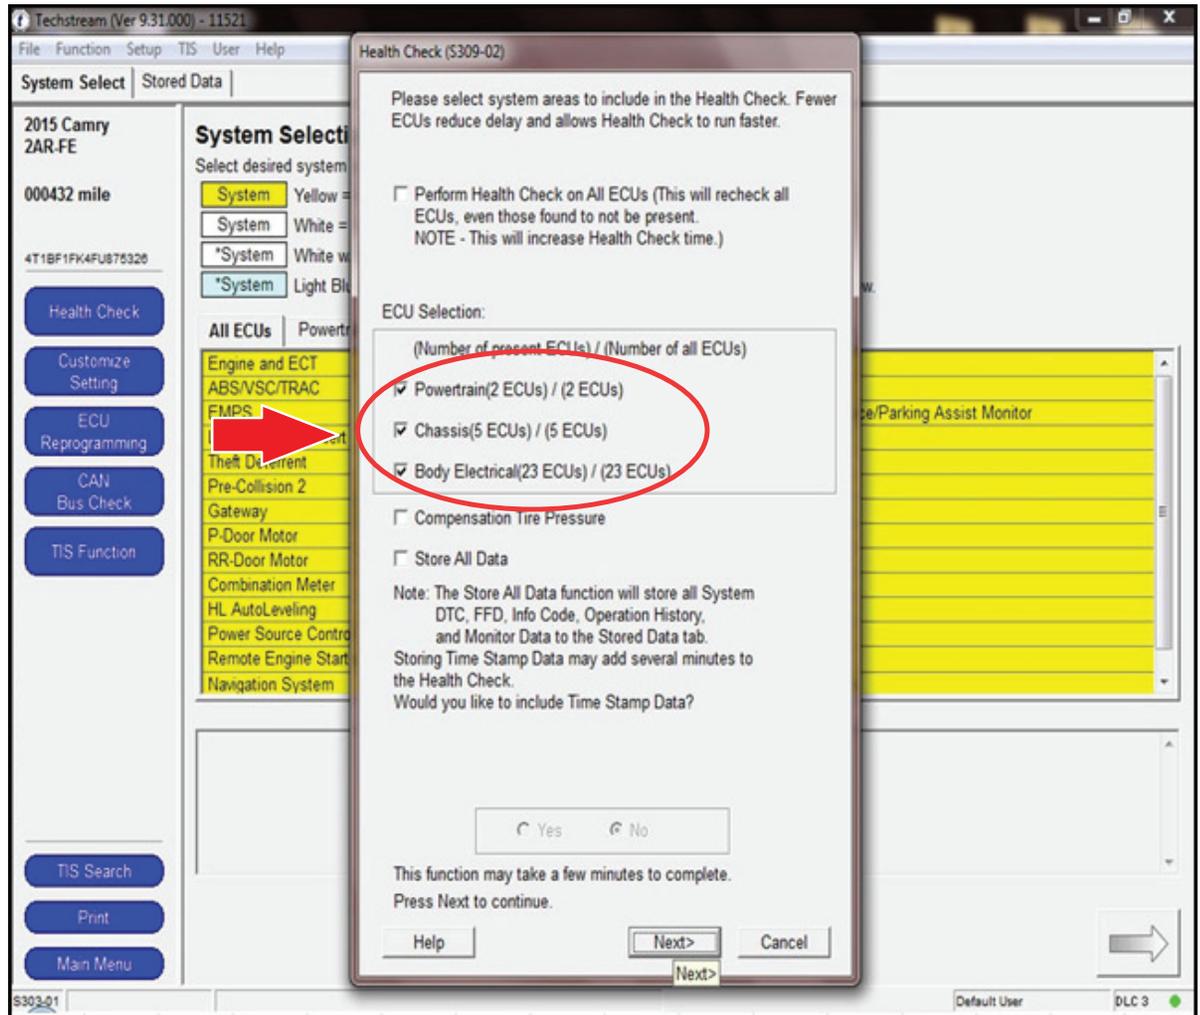
Figure 3.

C. Choose desired ECU group(s) in the *Health Check* dialog box.

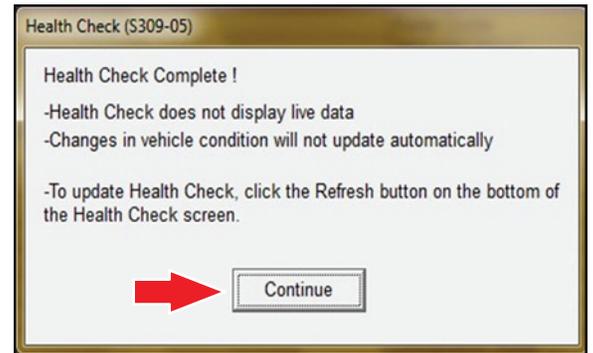
Figure 4.

E. Click *Continue* to view Health Check results.

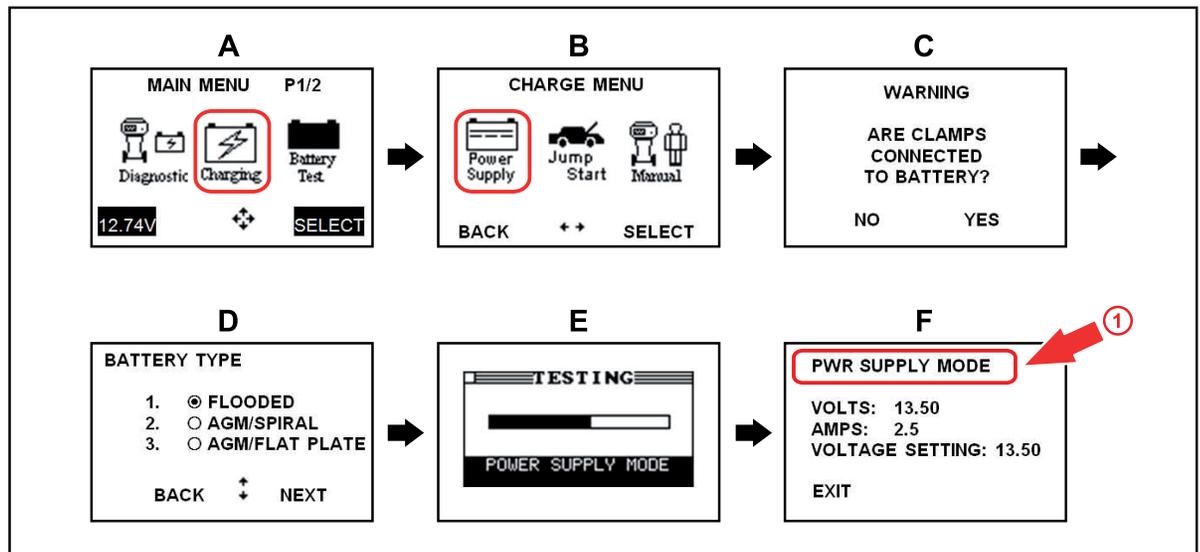
Figure 7.

- ECU damage may occur if the correct battery charger and mode setting are NOT used.
- Power Supply Mode is used to maintain battery voltage at 13.5 volts while flash reprogramming the vehicle.
- For details on how to use the GR8 Battery Diagnostic Station, refer to the [GR8 Instruction Manual](#) located on TIS, *Diagnostics – Tools & Equipment – Battery Diagnostics*.

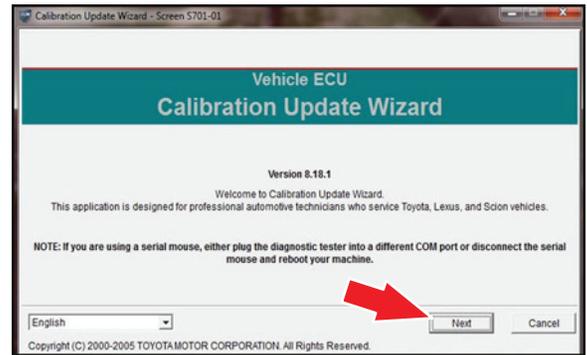
Figure 10.

- C. Click *Next* to start the calibration update process.

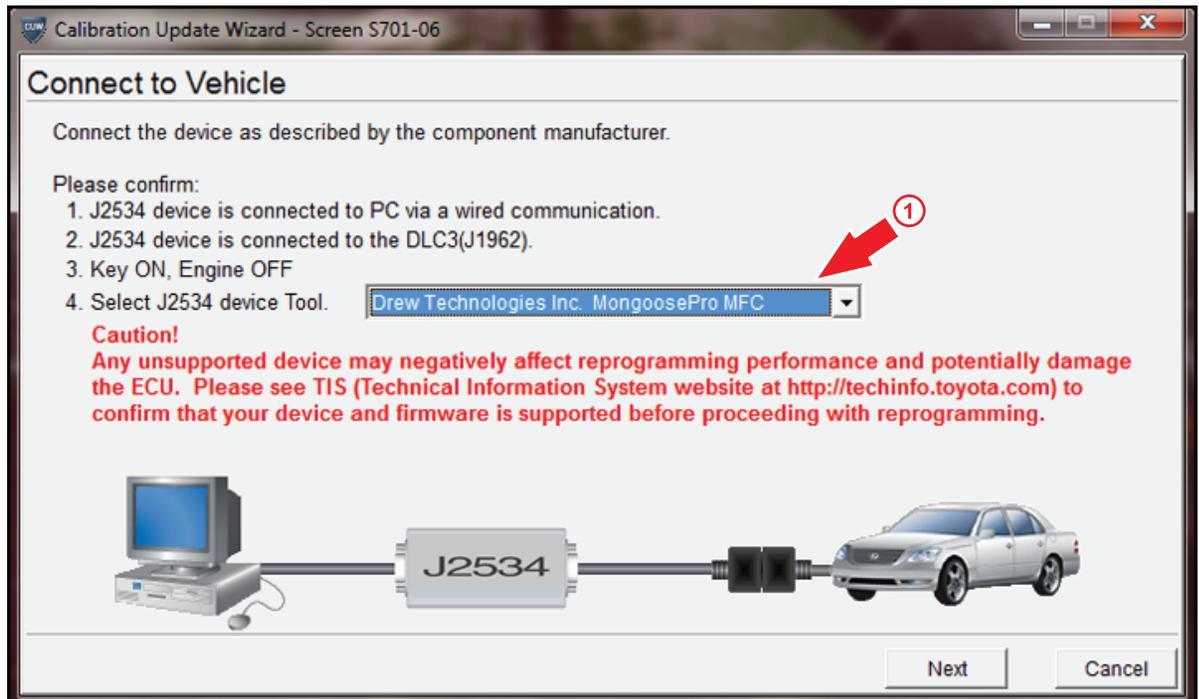
- D. Confirm the following:

- PC is connected to VIM.
- VIM is connected to DLC3 connector.
- Ignition is ON and engine is OFF or “READY” OFF (hybrid vehicles).

Then click *Next*.

Figure 11. Using Techstream 2.0 or Techstream Lite

<b>1</b>	Select Correct Device Tool (“Mongoose MFC,” “MongoosePro MFC,” or “MongoosePro MFC2” [green])
----------	---

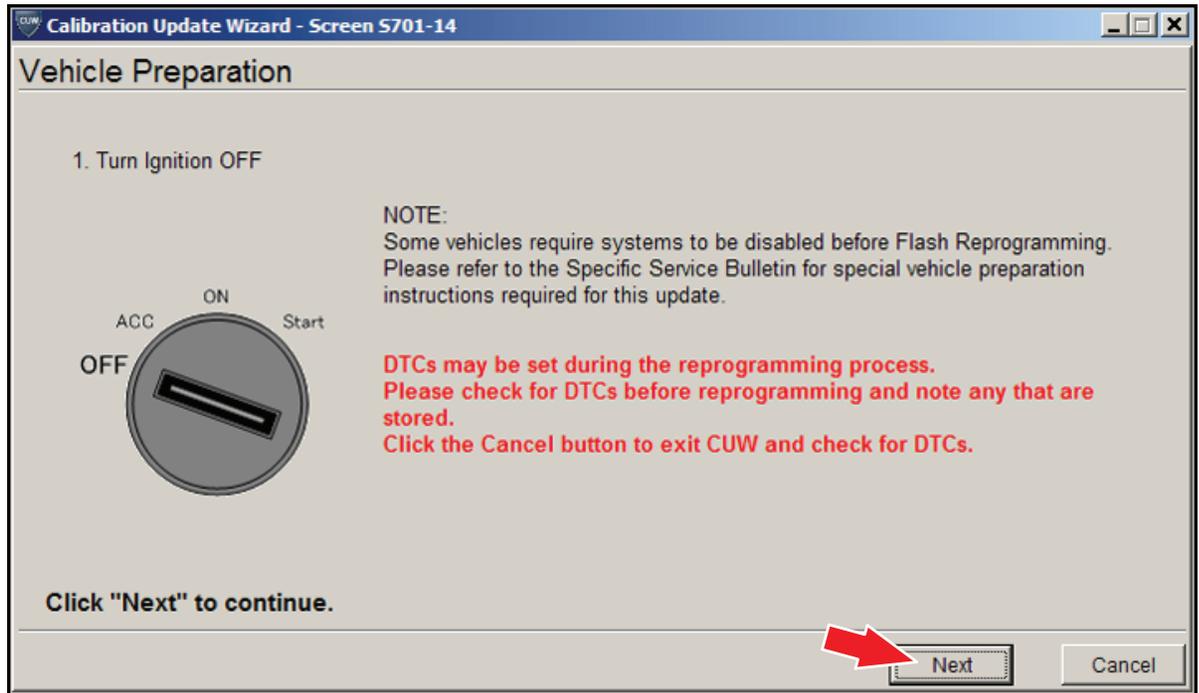
Figure 13.

F. Turn ignition OFF. Then click *Next*.

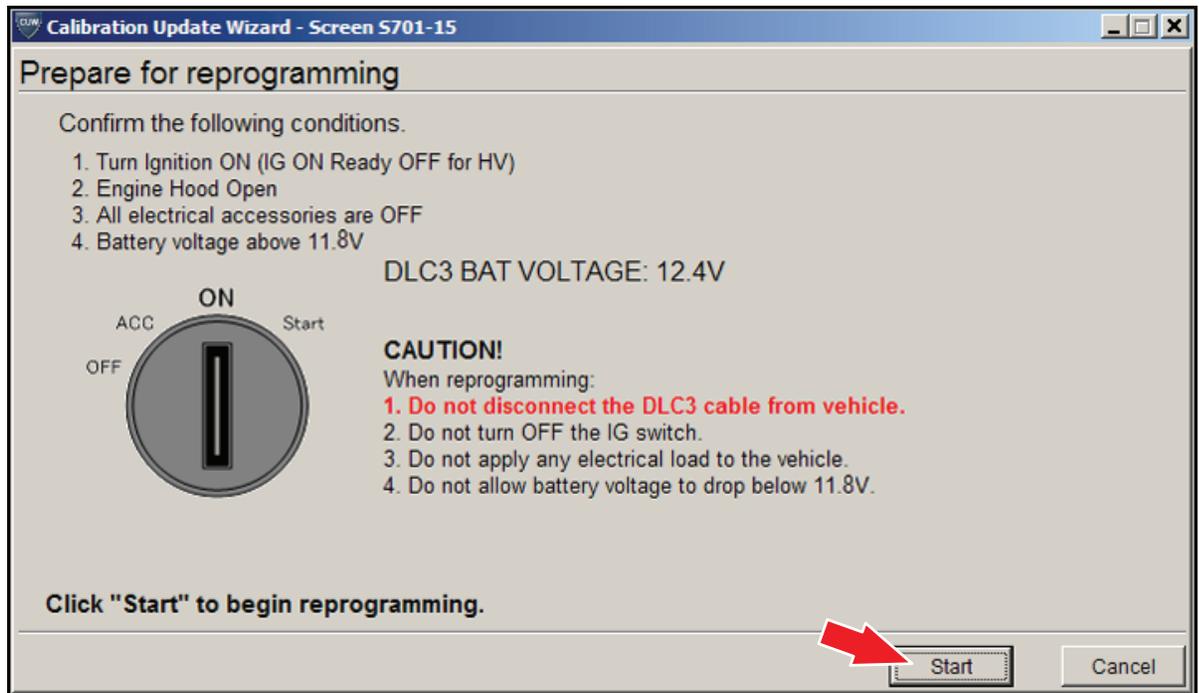
Figure 14.

Verify the vehicle is connected to a battery charger before continuing — If battery voltage falls below 11.8 volts, ECU damage may occur.

Then click *Start*.

If key cycle is NOT done properly, reprogramming will stop at 10% and Cal 1 will fail to load.

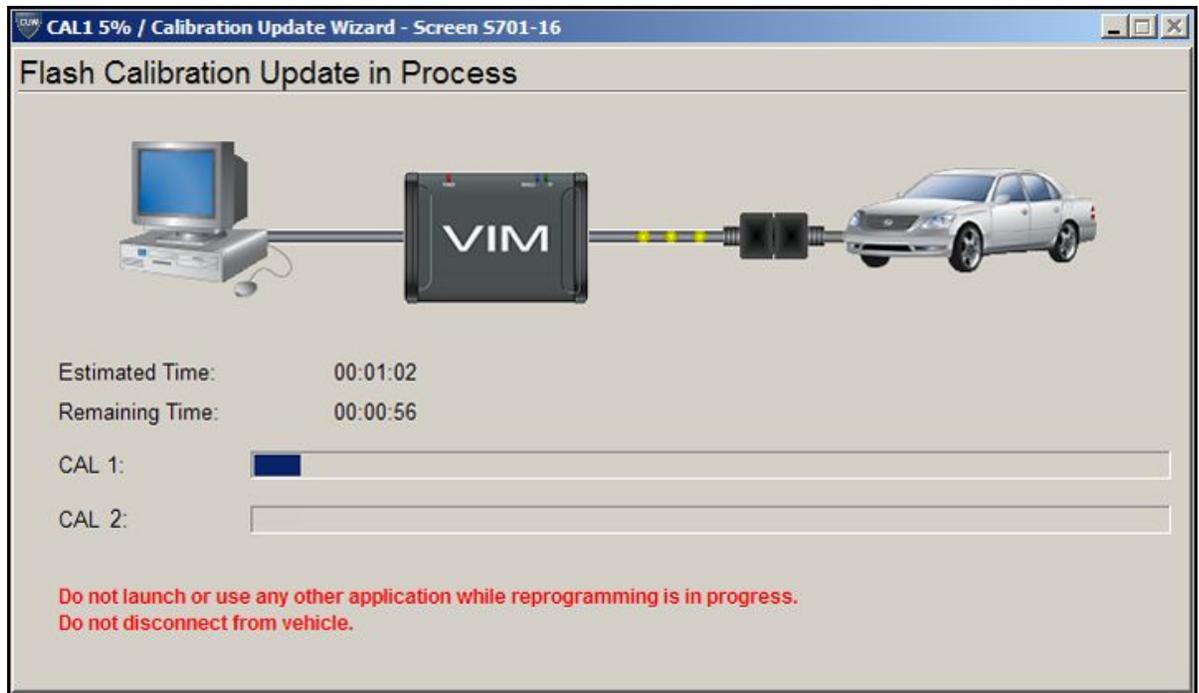
Figure 15.

- ECU flash reprogramming may take anywhere from 3 – 30 minutes per calibration file.
- Reprogramming time will vary depending on model and ECU communication protocol. Vehicles using CAN communication protocol will reprogram much faster (2 – 7 minutes).

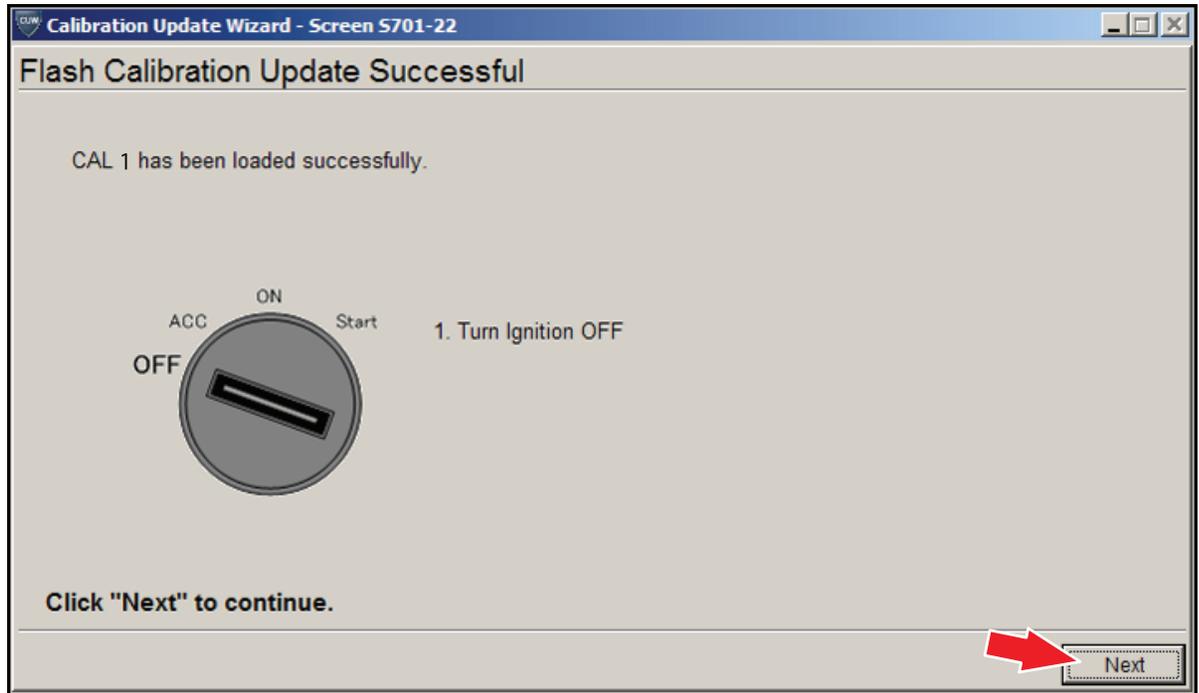
Figure 16.

- I. When Cal 1 has completed the update process, turn ignition OFF for a minimum of 10 seconds. Then click *Next*.

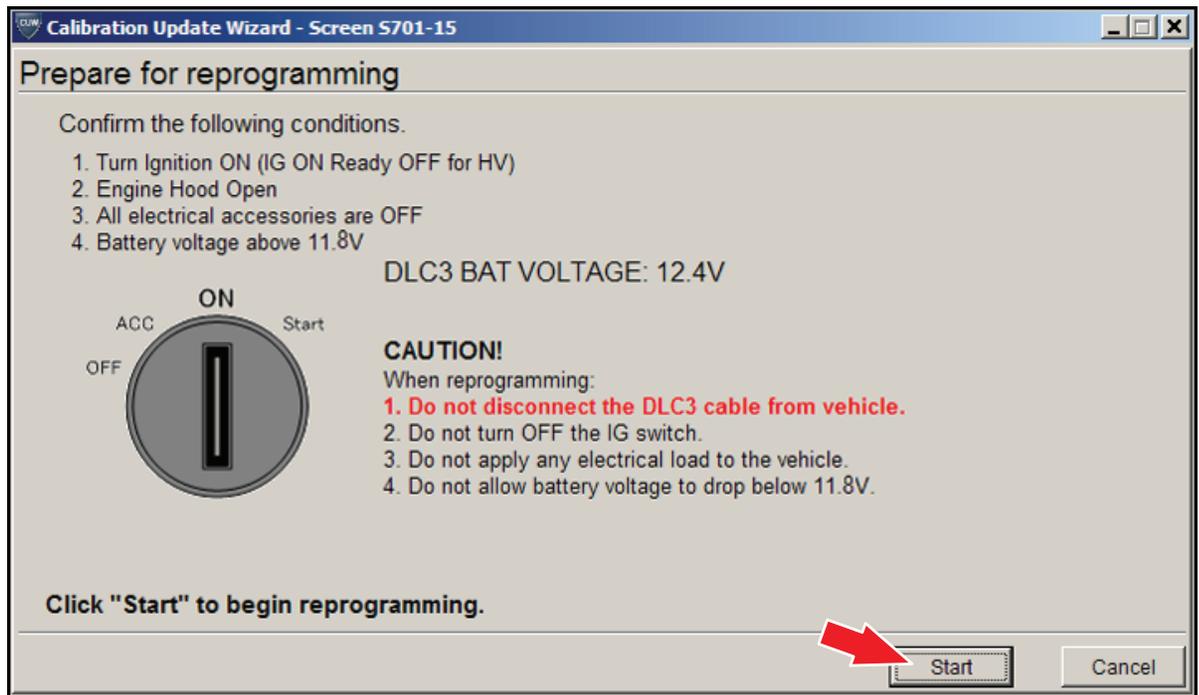
Figure 17.

J. Turn ignition to the ON position. Then click *Start*.

If key cycle is NOT done properly, reprogramming will stop at 10% and Cal 2 will fail to load.

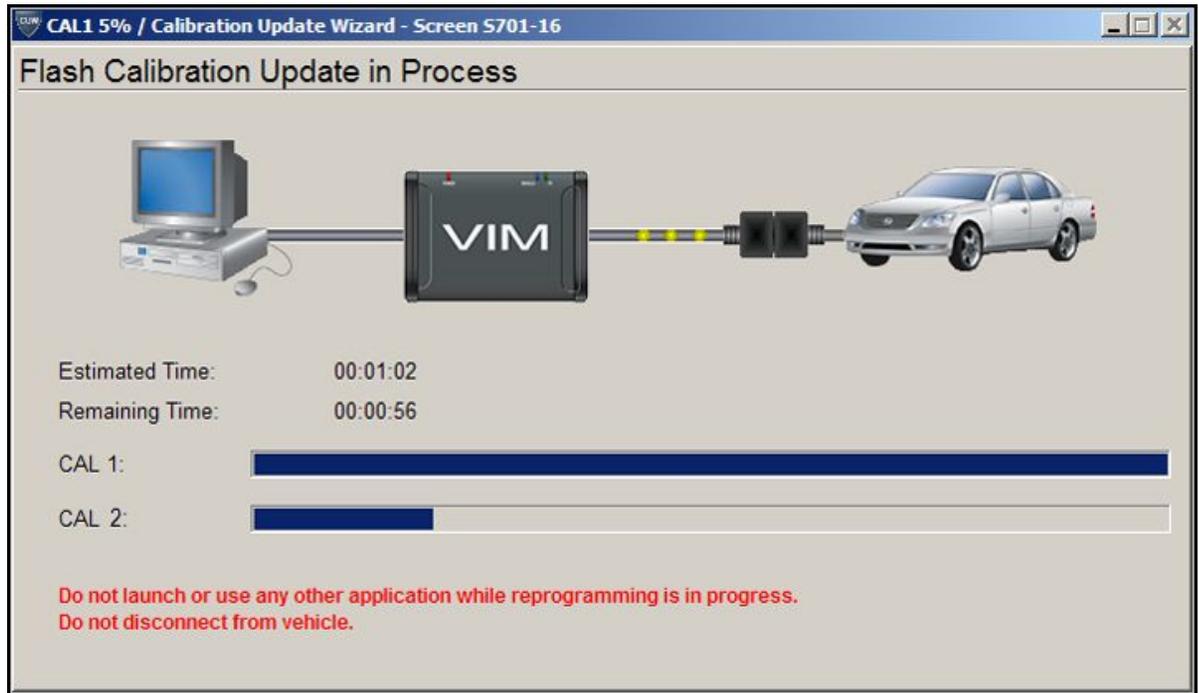
Figure 18.

K. Do NOT disturb the vehicle during flash reprogramming.

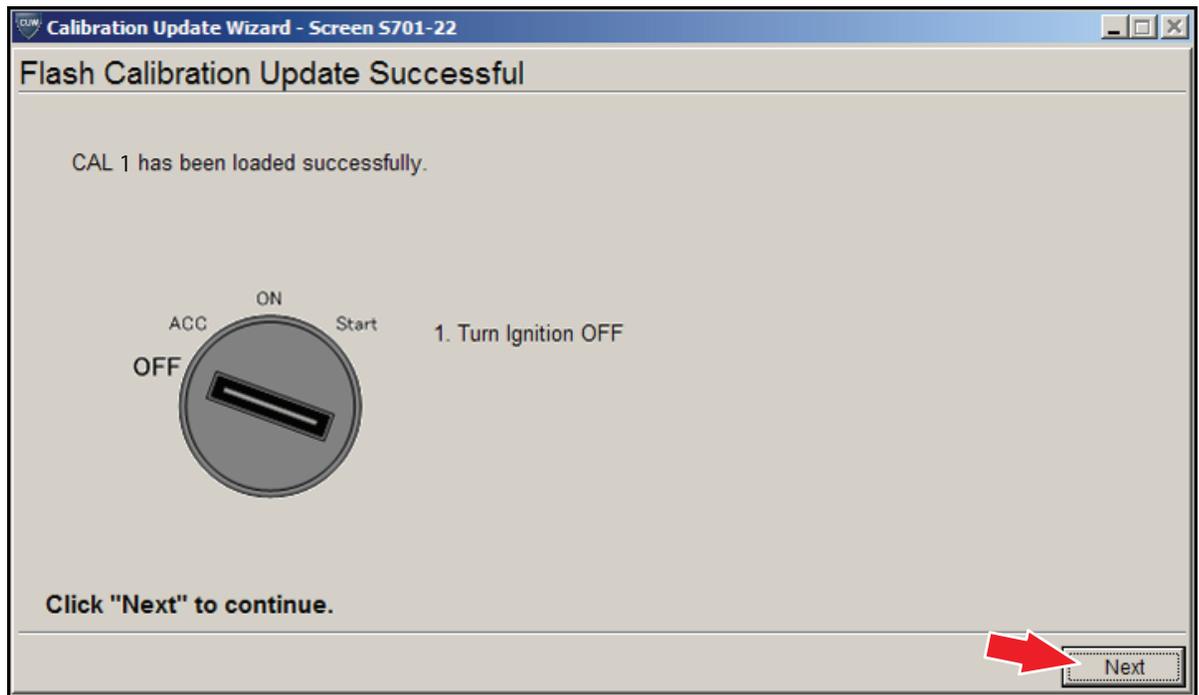
Figure 19.

- L. Turn ignition OFF for a minimum of 10 seconds. Then click *Next*.

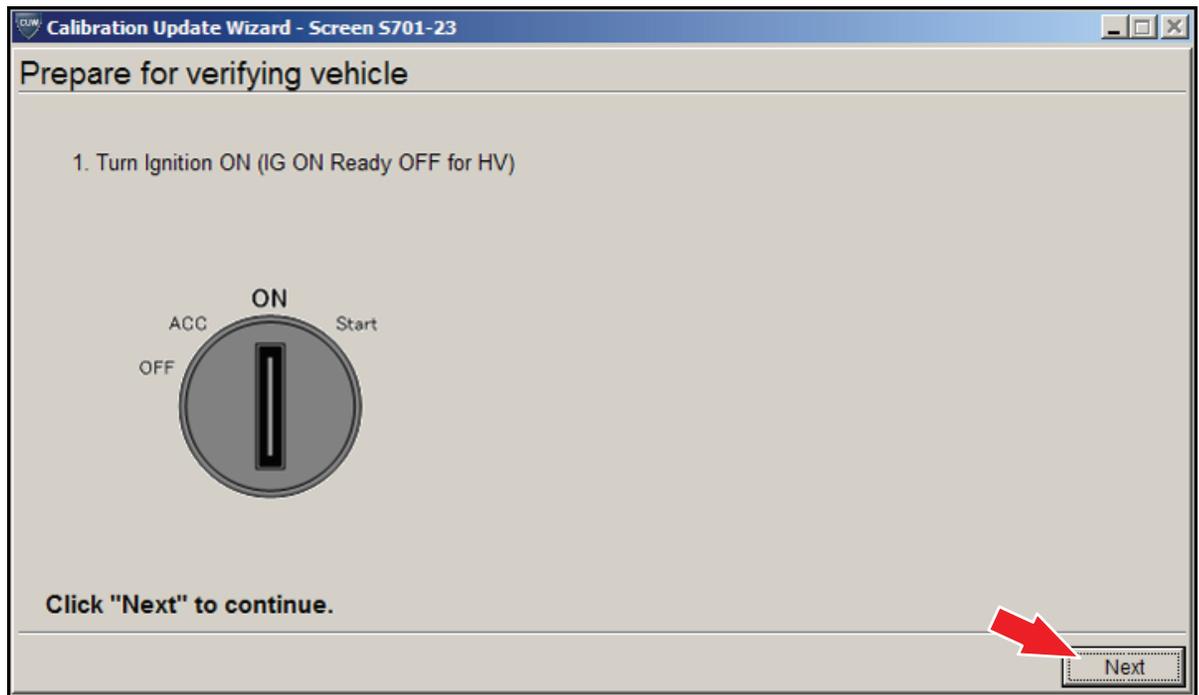
Figure 20.

M. Turn ignition to the ON position. Then click *Next*.

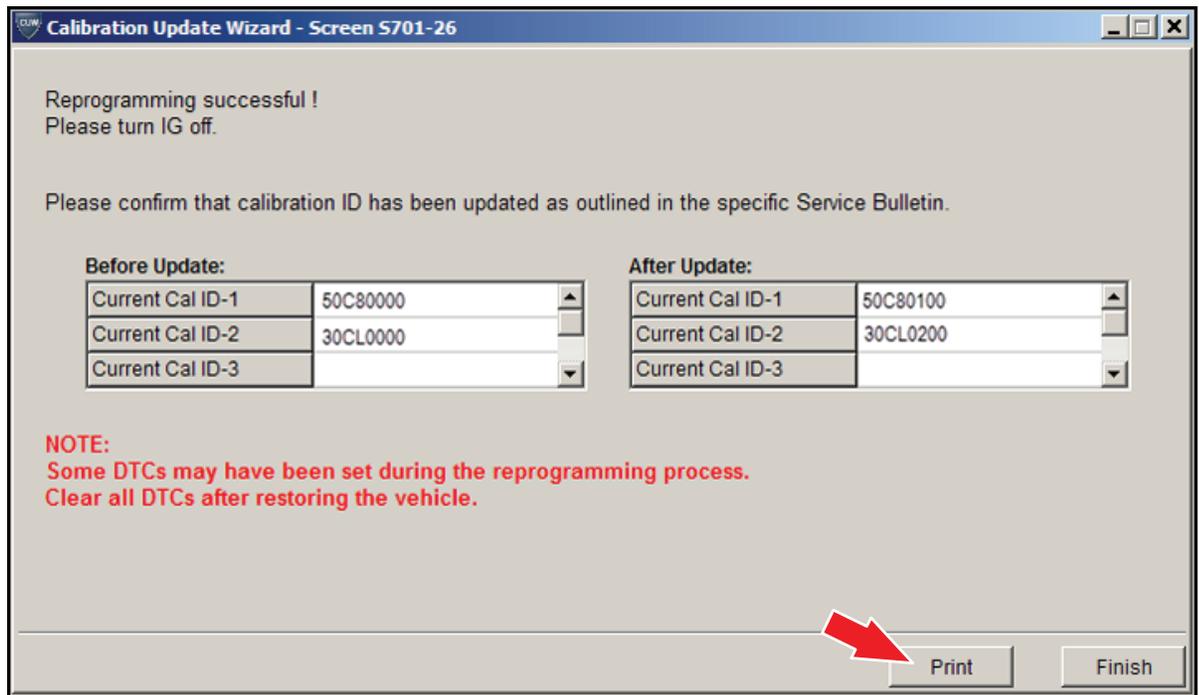
Figure 21.

N. Confirm all calibrations were updated as specified in the Service Bulletin. Then click *Finish*.

On some models, DTCs may set as a result of reprogramming. If DTCs are present, clear codes and run the Health Check again. Troubleshoot any remaining Current, Pending, or History codes. Permanent codes will not be cleared using Techstream. Permanent codes do not illuminate the MIL and do not require troubleshooting. They will clear during normal driving once the Universal Trip Drive Pattern is performed.
