Service Bulletin

Subject: Information on Upgrading an IO5 Non-Navigation Radio to an IO6 Navigation Radio

Models: 2014 Chevrolet Silverado 1500
2015 Chevrolet Silverado 2500/3500 (without AVF)
2014 GMC Sierra 1500
2015 GMC Sierra 2500/3500 (without AVF)
Equipped with IO5 Radio

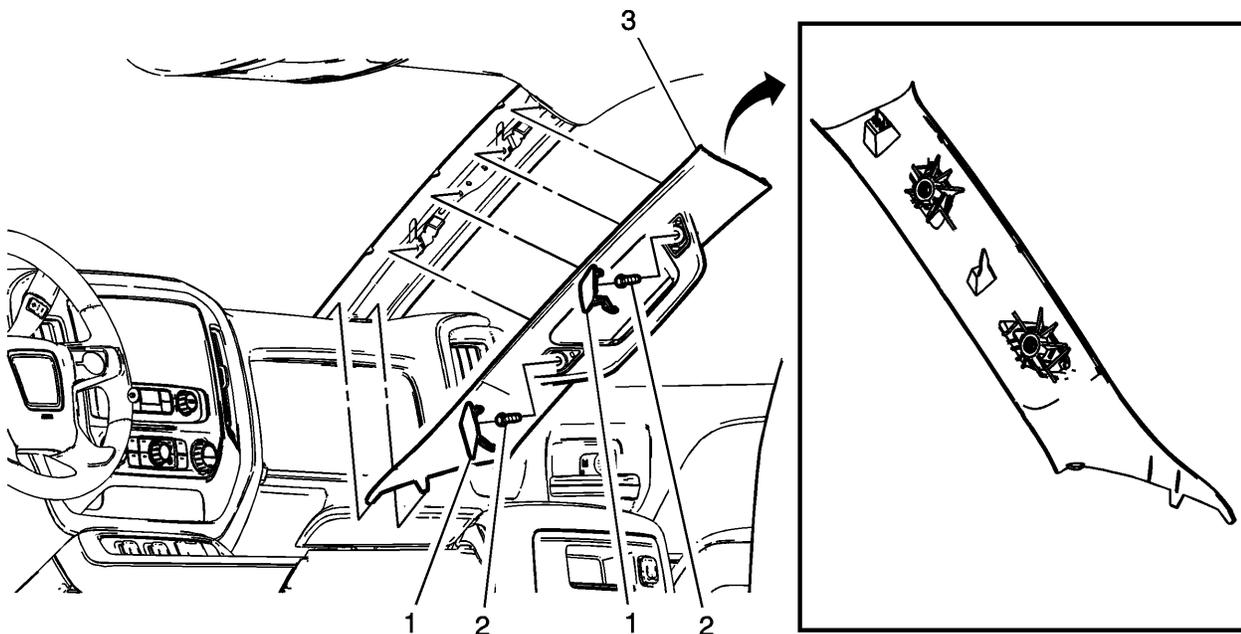
2. Remove the right windshield pillar assist handle covers (1).
3. Remove the right windshield pillar assist handle fasteners (2).

Tighten: Upon reassembly, tighten the right windshield pillar assist handle fasteners to 9 Y (80 lb in).

4. Disengage the retainers and remove the right windshield garnish molding assembly (3).

Note: Upon reassembly, ensure the tab is fully seated in the I/P upper trim panel prior to engaging the upper retainer.

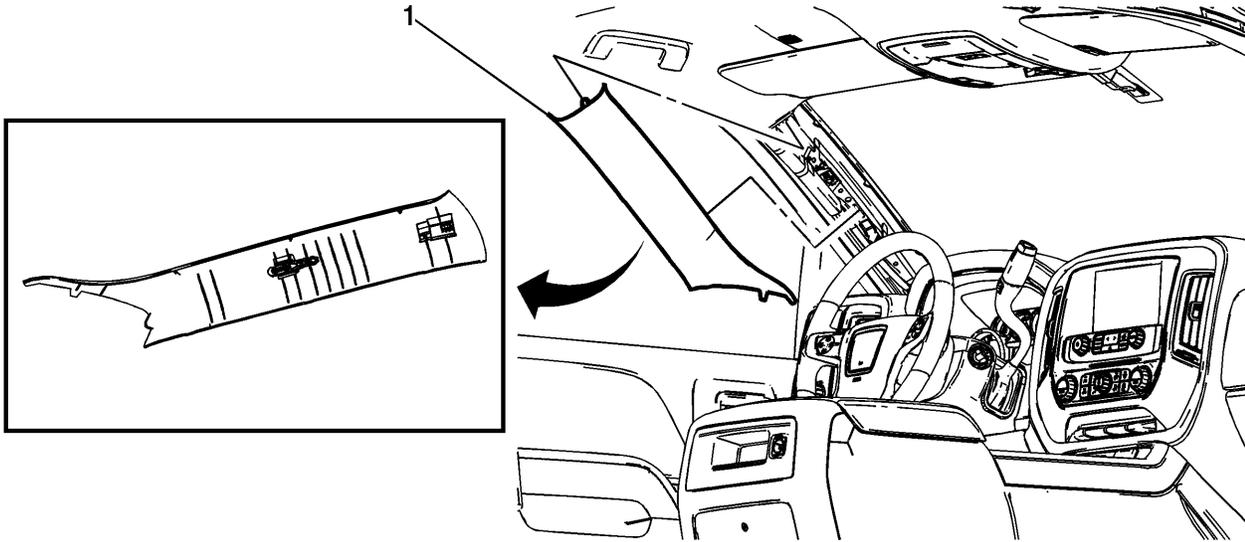
5. Disengage the retainers and remove the left windshield garnish molding assembly (1).

Note: Upon reassembly, the tether clip at the center portion of the left garnish molding must be replaced.

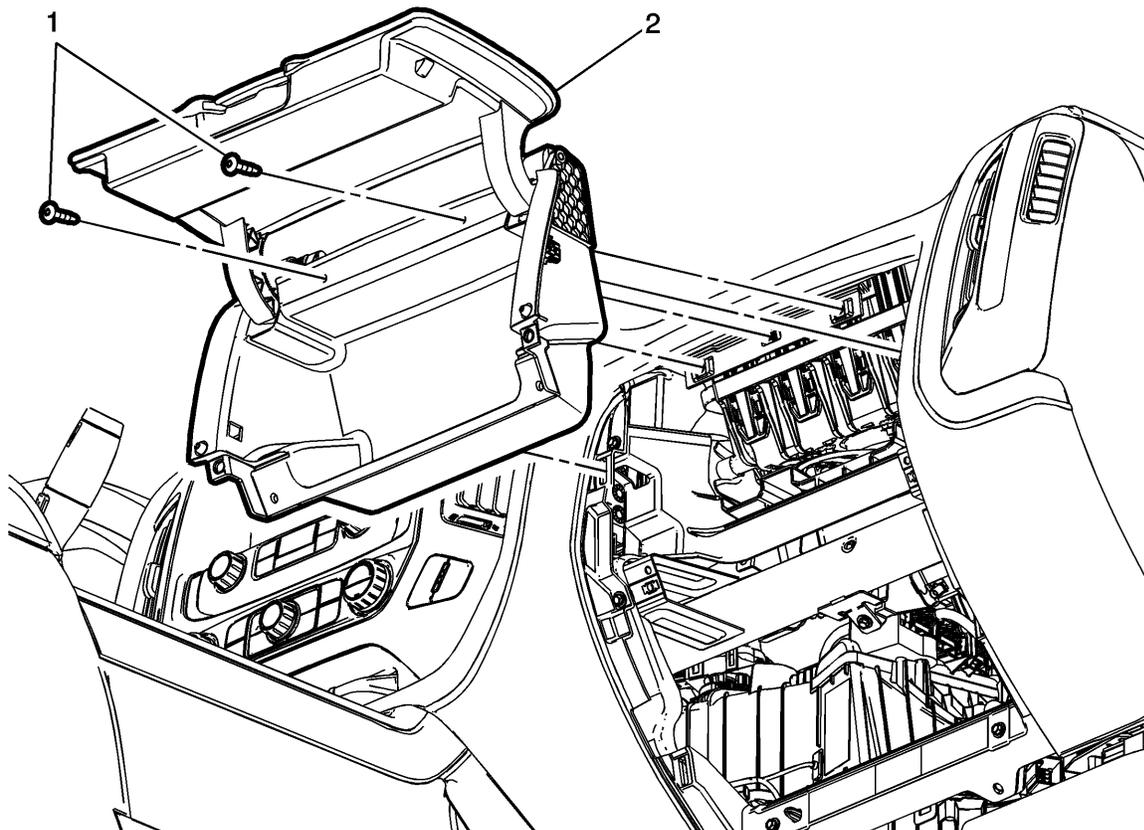
7. Remove the instrument panel compartment bolts (1).

Tighten: Upon reassembly, tighten the instrument panel compartment bolts to 2.5Y (22 lb in).

8. Using a flat-bladed plastic trim tool, release the retainer clips securing the instrument panel compartment (2) to the instrument panel assembly.

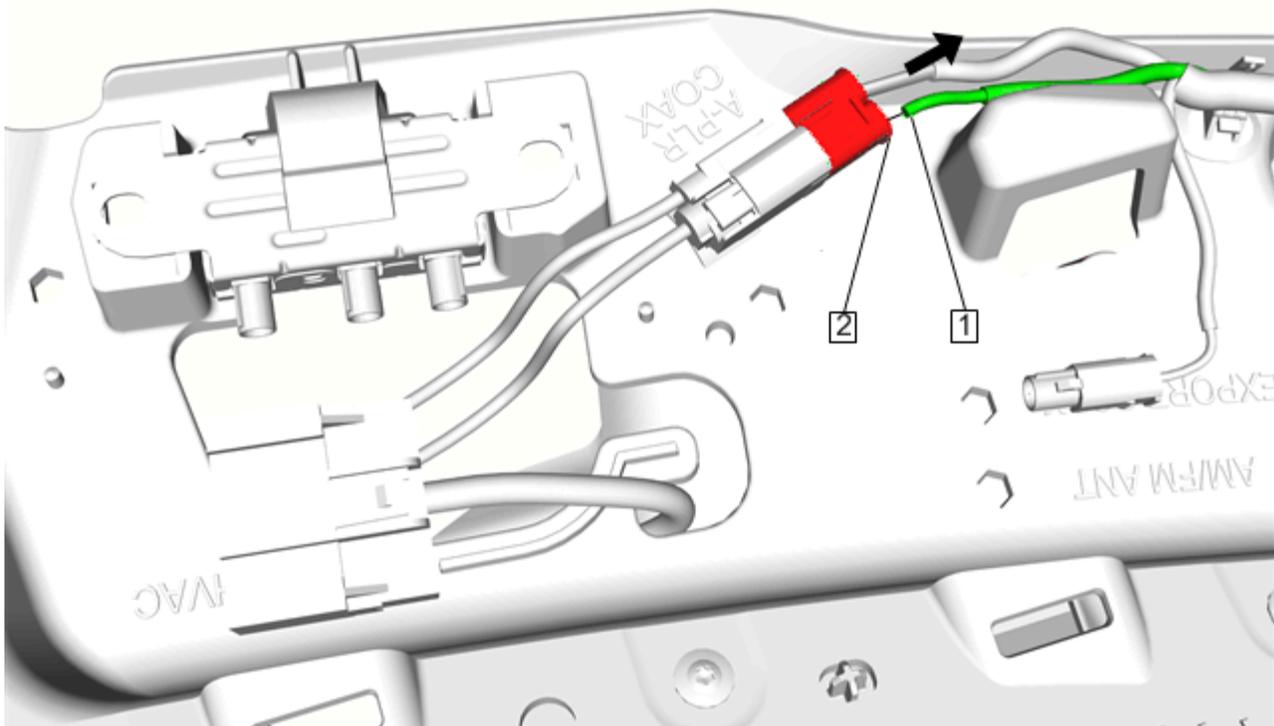
14. Install navigation splitter (1), P/N 20960972, to the retaining tabs on bracket.

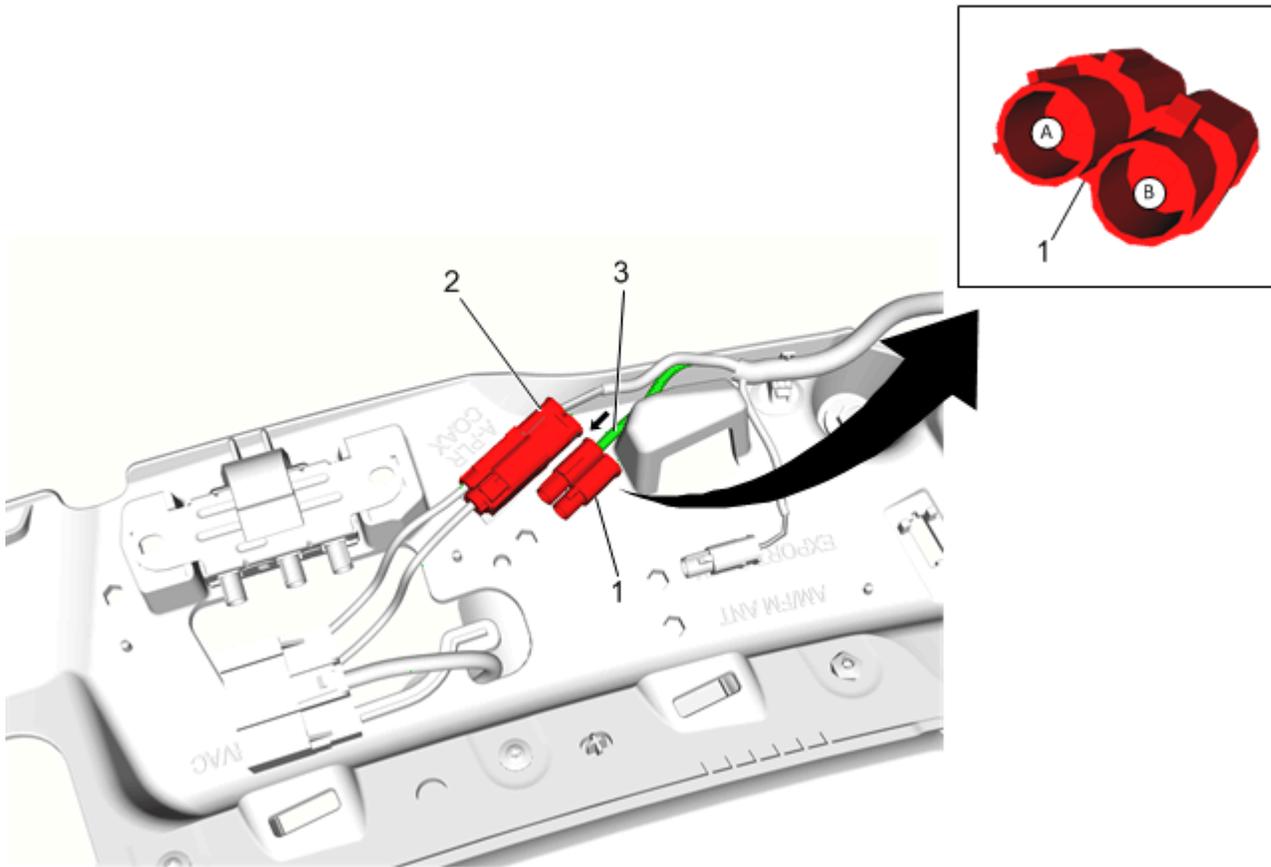
15. Unseat terminal (1) from cavity 2 of A-pillar harness connector (2).

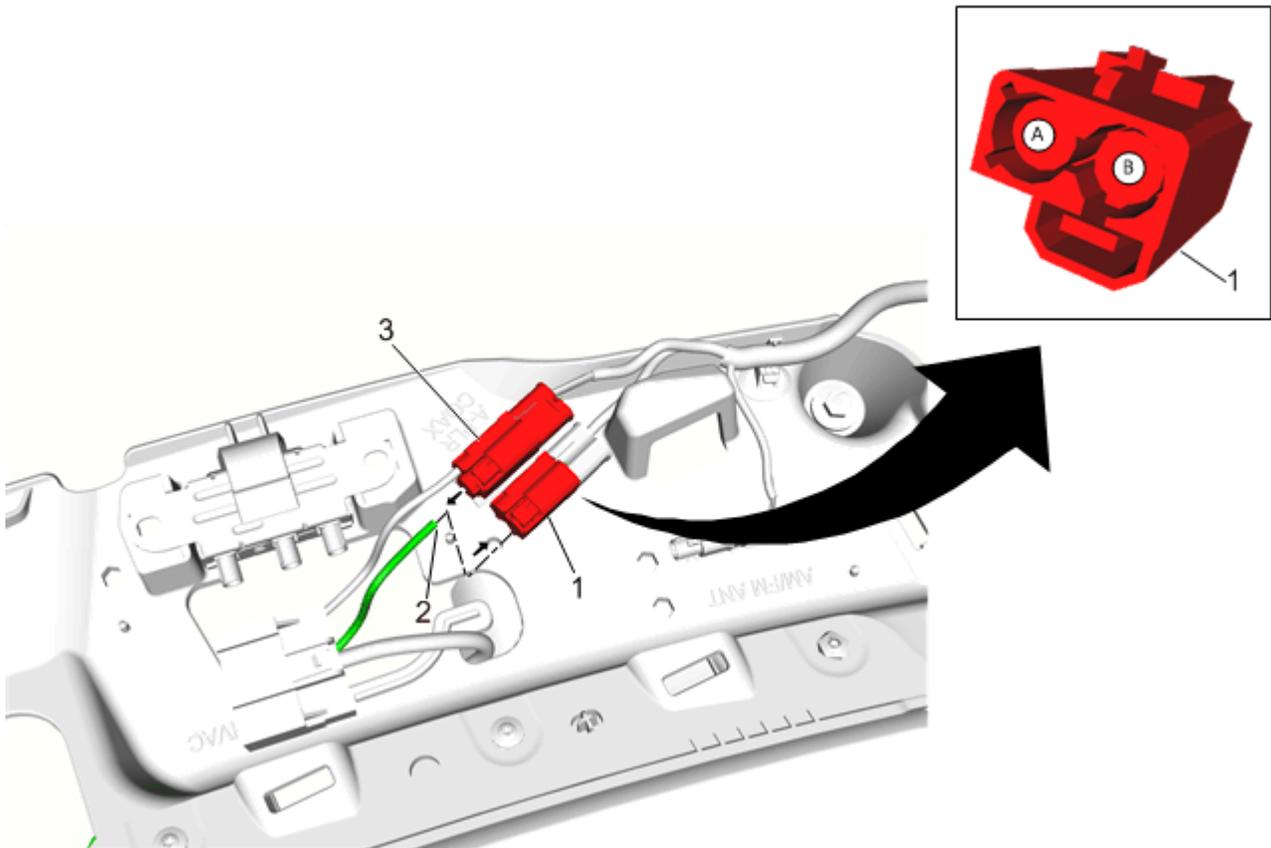
16. Position connector from kit (1), P/N 13589365, next to current A-pillar harness connector (2) and insert previously removed terminal (3) into cavity 1 (A) of connector (1) P/N 13589365.

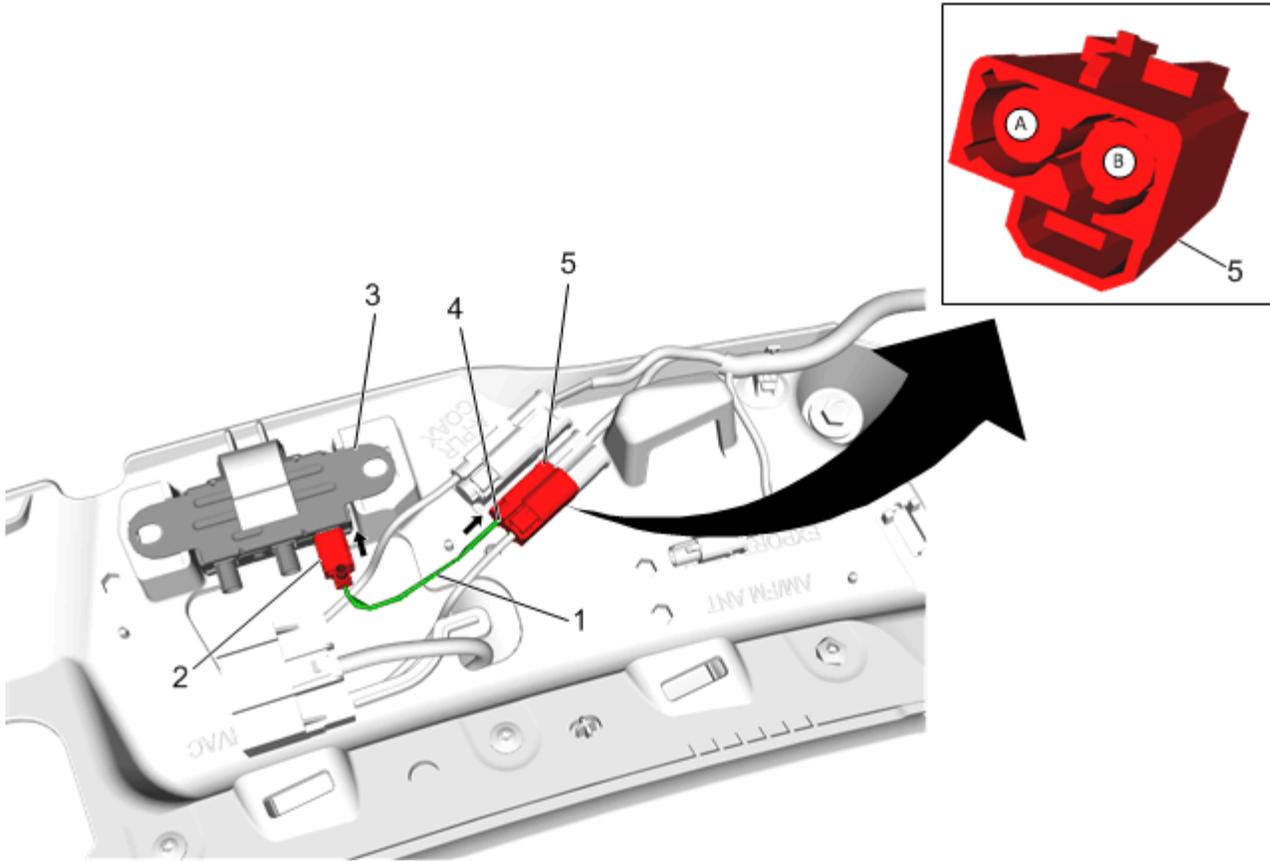
17. Unseat terminal (2) from cavity 2 of the A-pillar harness connector (3).

18. Position connector from kit (1), P/N 13589366, next to current A-pillar harness connector (3) and insert previously removed terminal (2) into cavity 2 (B) of connector (1) P/N 13589366.

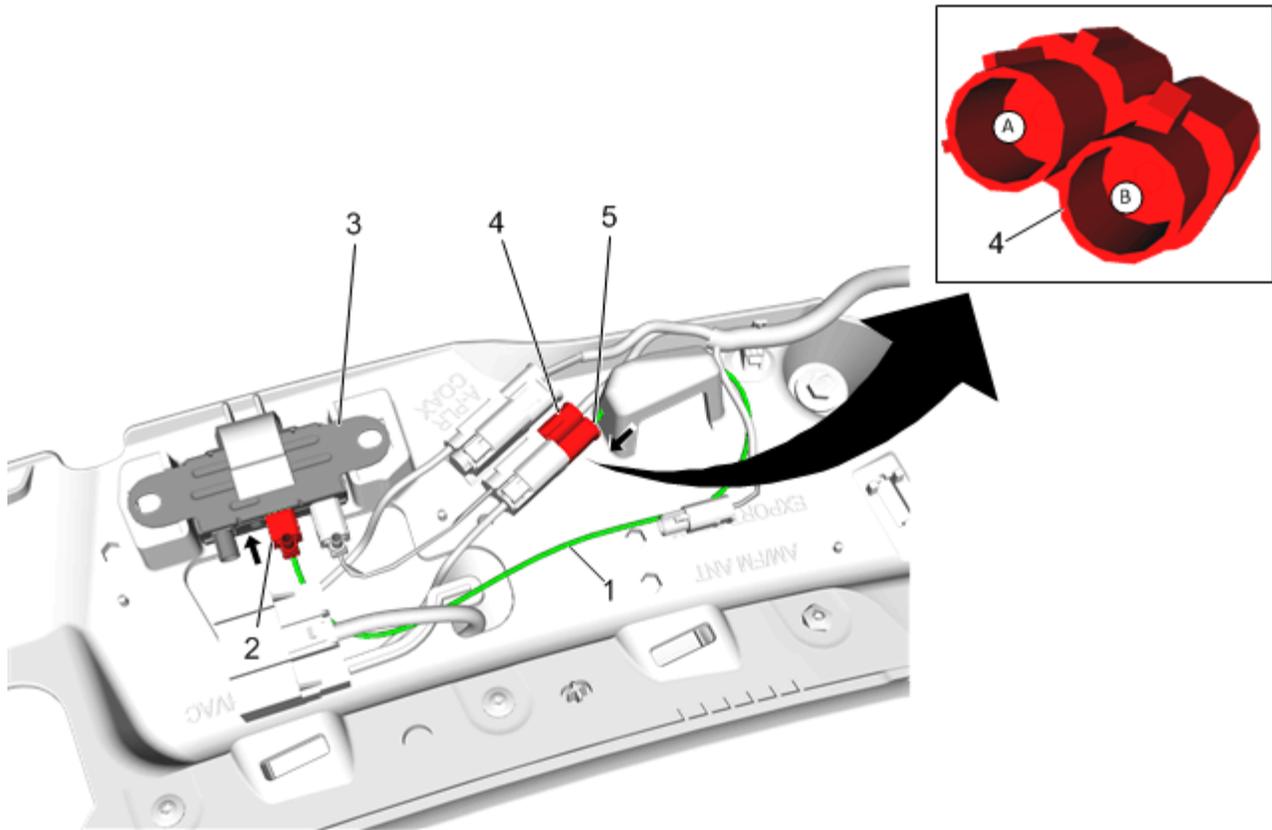
19. Install coax jumper (1), P/N 23497539, from kit.
20. Insert female terminal end (4) into cavity 1 (A) of connector (5) P/N 13589366.
21. Insert other end of jumper (2) into splitter (3) (Gray Connector).

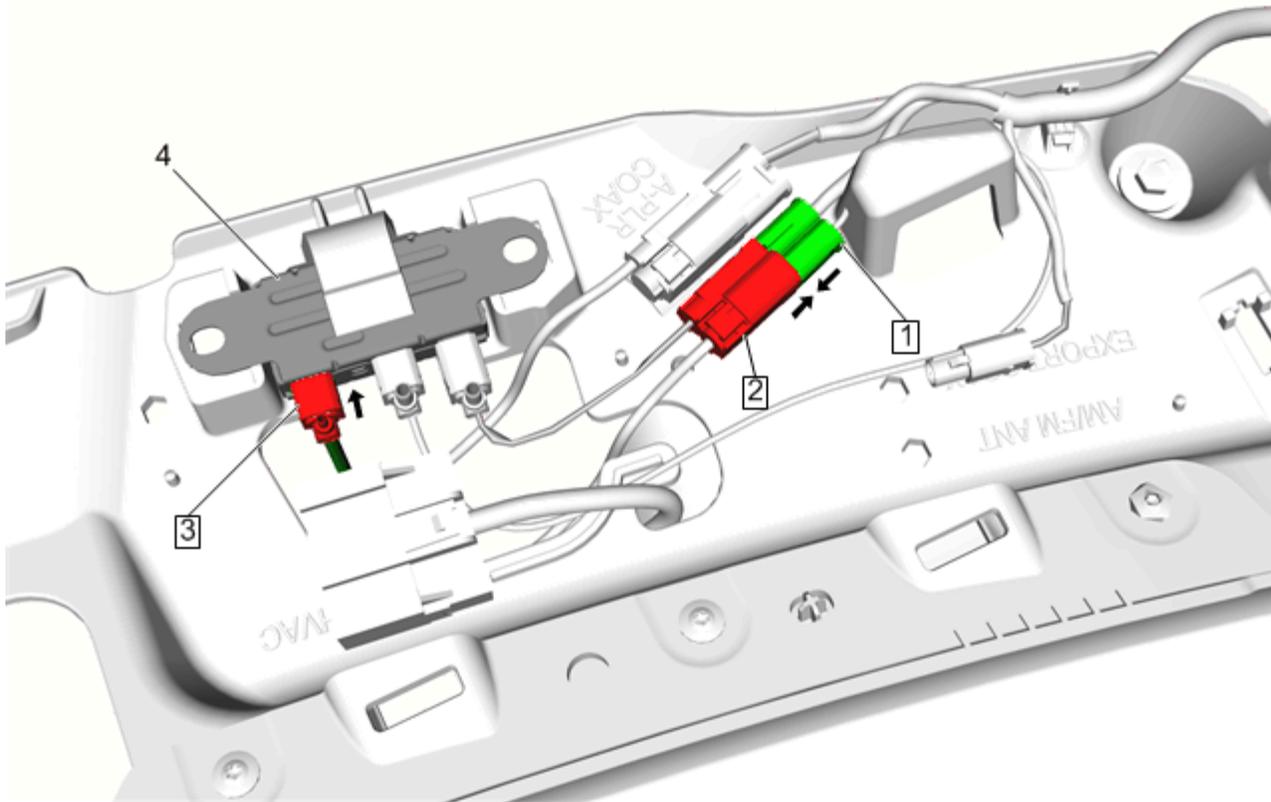
22. Install coax jumper (1), P/N 23497540, from kit.
23. Insert male terminal end (5) into cavity 2 (B) of connector (4) P/N 13589365.
24. Insert other end of jumper (2) into splitter (3) (Pink Connector).
