SERVICE BULLETIN

APPLICABILITY: 2015MY Legacy, Outback, Impreza and XV Crosstrek Models with Fujitsu-Ten (F10) Navigation System

NUMBER: 15-182-15
DATE: 06/17/15

SUBJECT: Procedures for Updating the Head Unit Operating Software

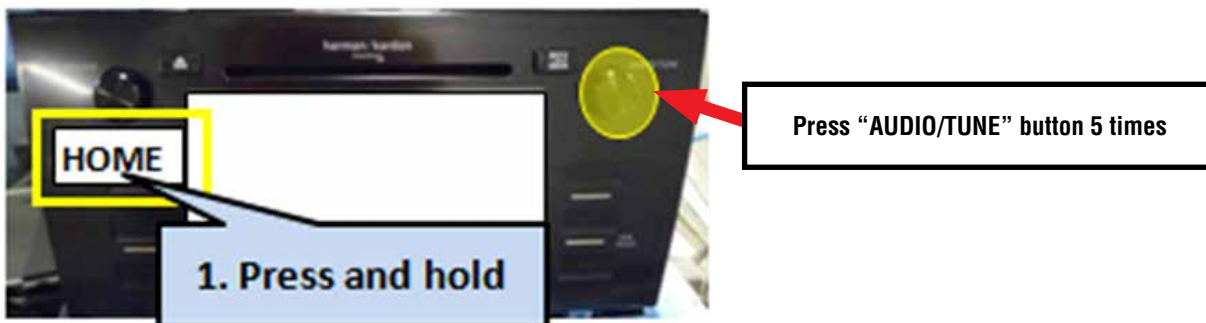
- Switch the unit into “Diagnosis Mode” by pressing and holding the HOME button while pressing the “AUDIO/TUNE” button 5 (five) times.

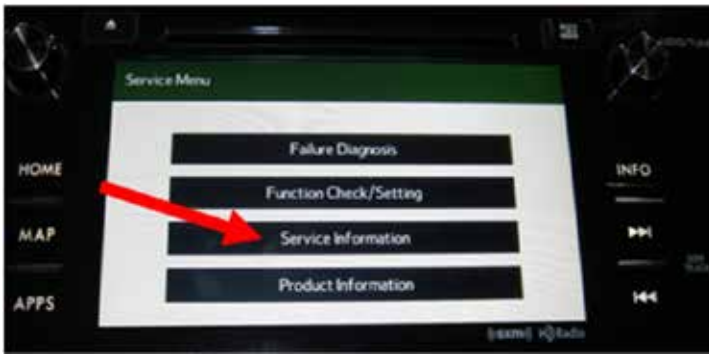
- Press “Service Information”

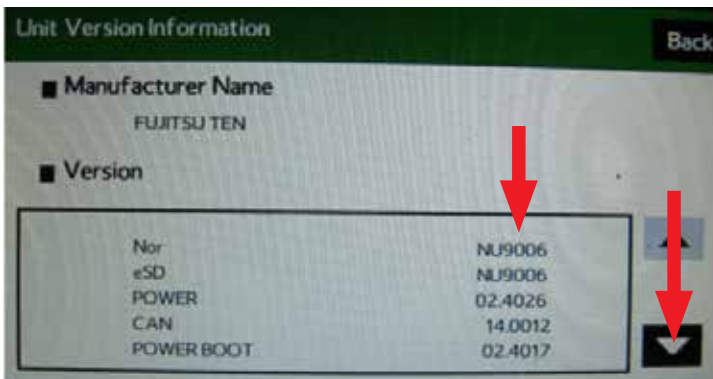
- Verify the current versions according to the “Version Check List” table shown below on page 5. Use the down arrow to scroll to the bottom of the list for complete verification.

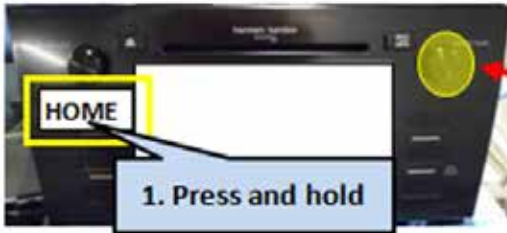
- Once the USB icon is illuminated, switch the unit into “Diagnosis Mode” by pressing and holding the HOME button while pressing the “AUDIO/TUNE” button 5 (five) times.

2. Press "AUDIO/TUNE" button 5 times

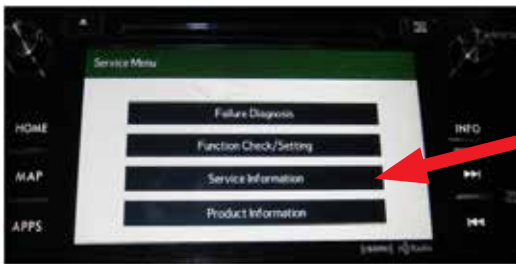
- Press “Service Information”

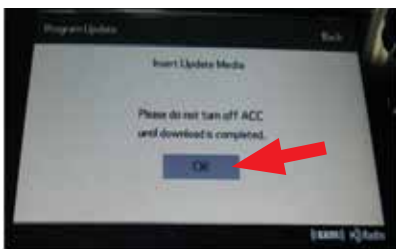
Wait for “OK” to activate
(turn black)

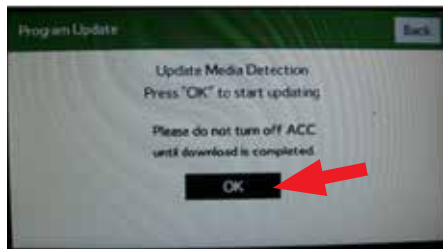
Press “OK”

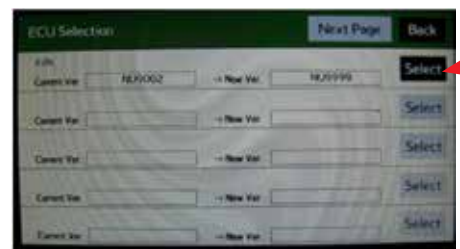
Press “SELECT”

NOTE: The “OK” button will not activate if the wrong software is on the flash drive. Please reload the proper files and start from the beginning of **Step 3**.

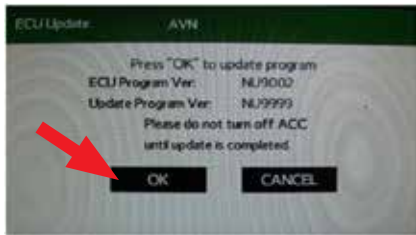
Press "OK"

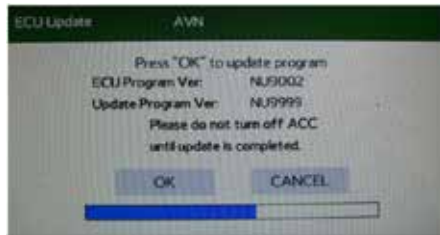
Once the updating starts, the status bar will run twice before "OK" illuminates (approximately 5 minutes).

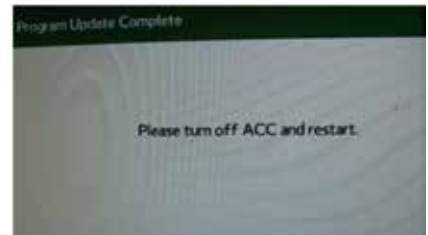
Turn off ACC

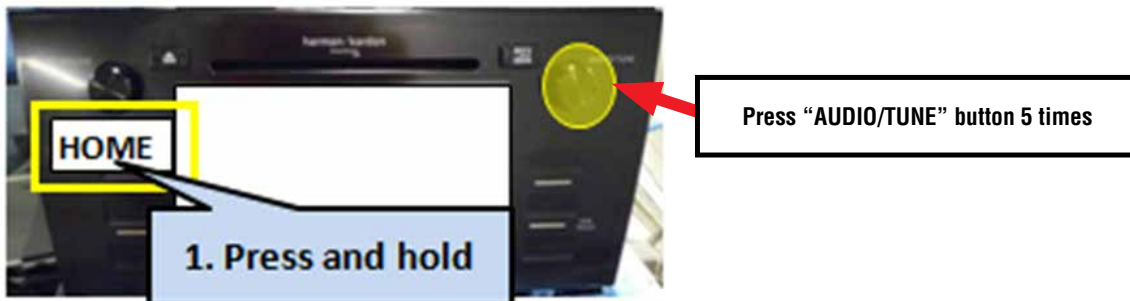
- Switch the unit into “Diagnosis Mode” by pressing and holding the HOME button while pressing the “AUDIO/TUNE” button 5 (five) times.

As mentioned earlier on page 5, once the update software installations are complete, the Version Check procedure must be performed again to confirm the updates have been installed successfully.

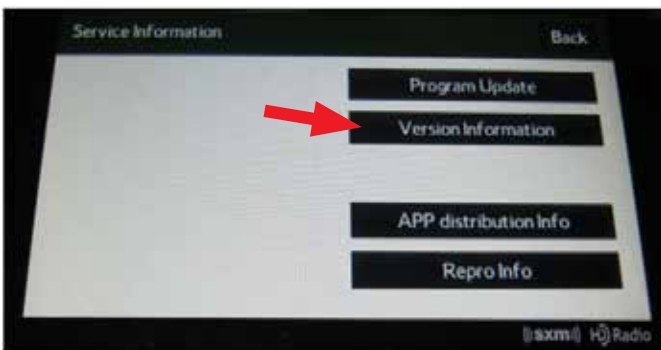
- Press “Service Information”

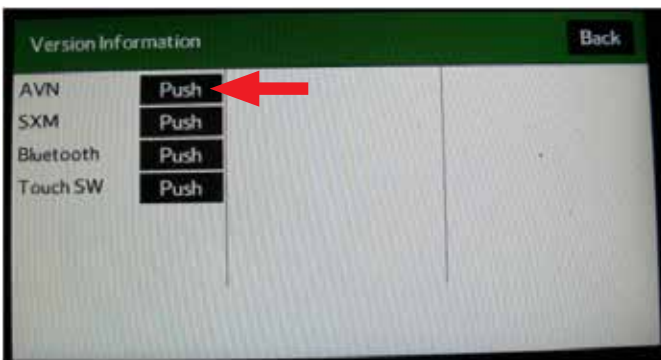
- Press “Version Information”

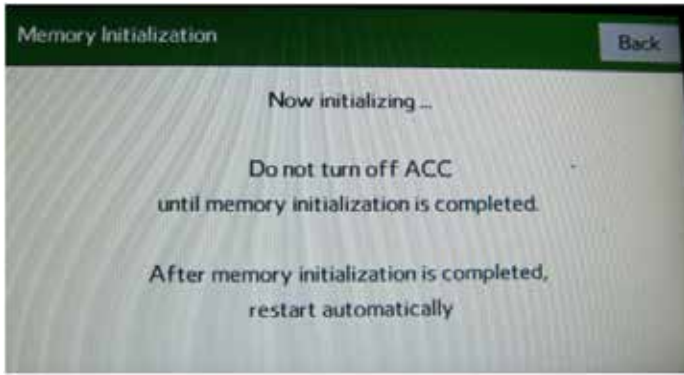
This screen will be displayed for about 1 minute while the unit restarts. After restart, the Loading screen and its status bar will be displayed. After the status bar completes, the Main Menu screen will be displayed. To complete the updating procedure, you must go through the series of Initial Setup screens, reset the radio station presets and re-pair any mobile devices (where applicable).
