SERVICE BULLETIN

APPLICABILITY: 2015MY Legacy, Outback, Impreza and XV Crosstrek Models with Fujitsu-Ten (F10) 7" Display Audio Systems (without navigation)

NUMBER: 15-183-15
DATE: 06/17/15

SUBJECT: Procedures for Updating the Head Unit Operating Software

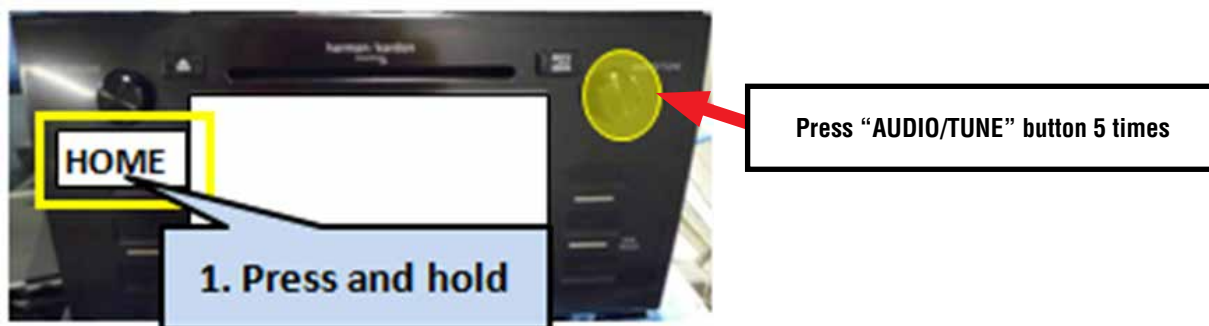
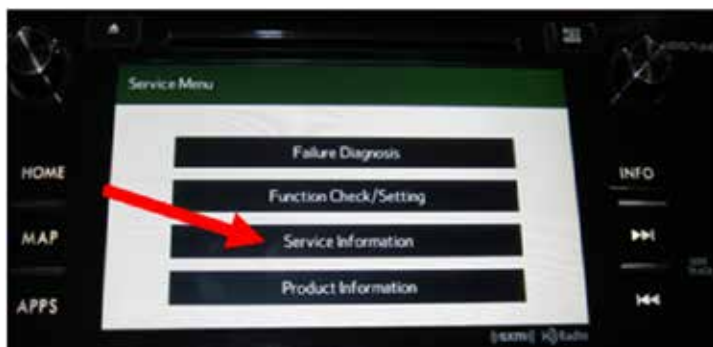
- Switch the unit into “Diagnosis Mode” by pressing and holding the HOME button while pressing the “AUDIO/TUNE” button 5 (five) times.

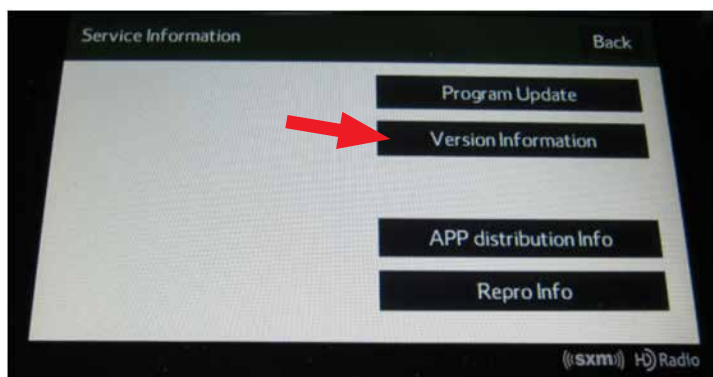
- Press “Service Information”

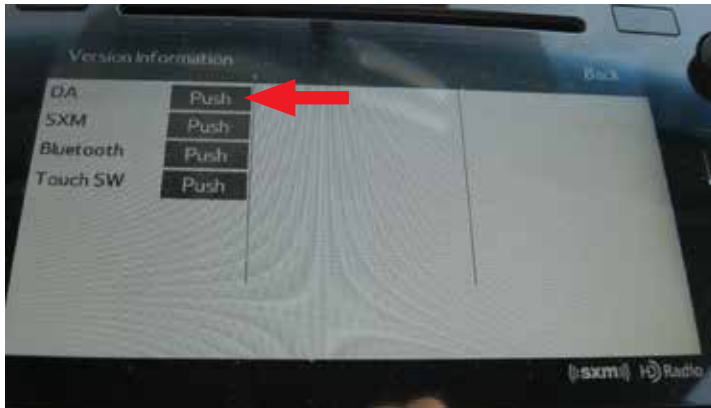
- Press “Version Information”

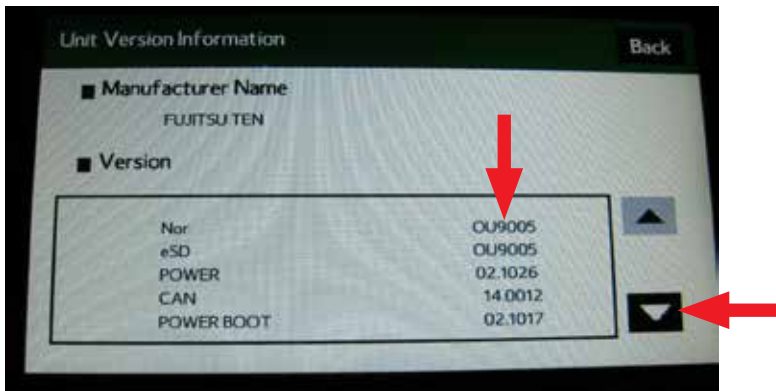
- Press “Push” next to DA

- Verify the current versions according to the “Version Check List” table shown on page 5. Use the down arrow to scroll to the bottom of the list for complete verification.
- If the software version is current (OU9007 for Legacy/ Outback OU9103 or higher for Impreza/ Crosstrek), press and **HOLD** the **HOME** button to exit the Diagnostic Mode to complete the procedure as no updates are necessary. If no updates are necessary then continue your diagnosis of the customer concern. If the Version ID numbers are prior to (lower than) those shown on the table below, proceed with the software update procedure beginning with **Step 3** on page 9.

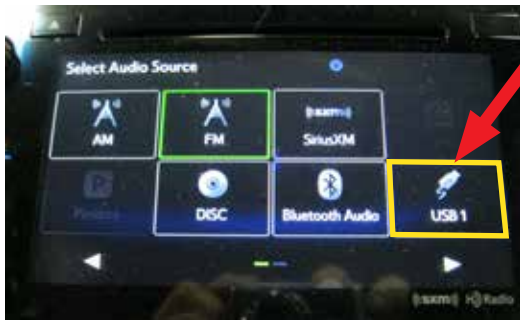
After the flash drive is recognized, the USB icon will illuminate.

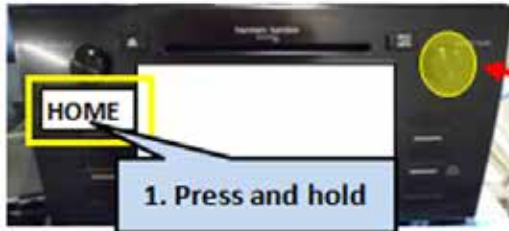
- Once the USB icon is illuminated, switch the unit into “Diagnosis Mode” by pressing and holding the HOME button while pressing the “AUDIO/TUNE” button 5 (five) times.

2. Press "AUDIO/TUNE" button 5 times

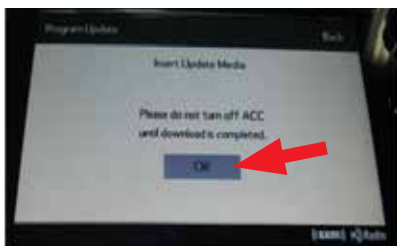
Wait for “OK” to activate
(turn black)

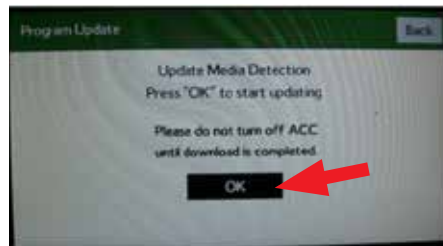
Press “OK”

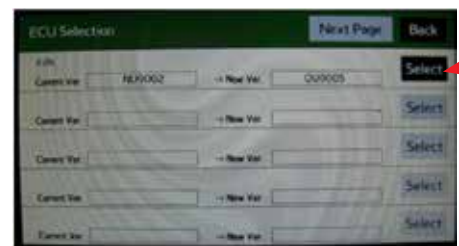
Press “SELECT”

NOTE: The “OK” button will not activate if the wrong software is on the flash drive. Please reload the proper files and start from the beginning of **Step 3**.

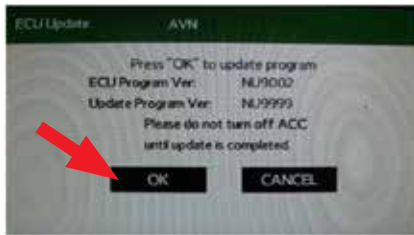
Press "OK"

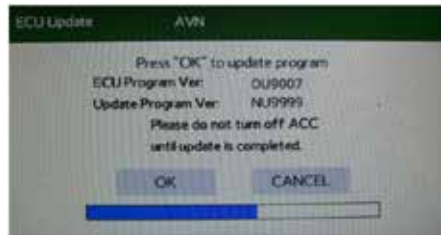
Once the updating starts, the status bar will run twice before "OK" illuminates (approximately 5 minutes).

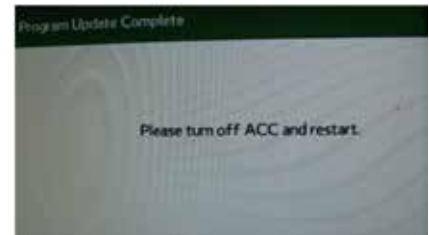
Turn off ACC

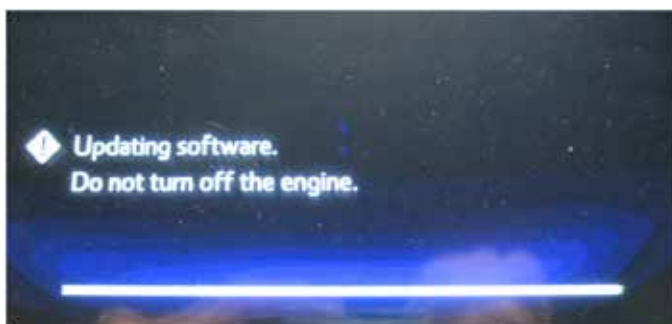
- Once the update completes successfully, turn the ACC off, **WAIT 30 SECONDS** then turn it back on again.
- After the unit boots back up, the "Updating software" screen and its status bar will be displayed. This update takes about 5 minutes to complete.

When the Software Update completes, the unit will restart automatically. Once the opening screen is displayed, remove the flash drive from the USB port and turn the ACC off.

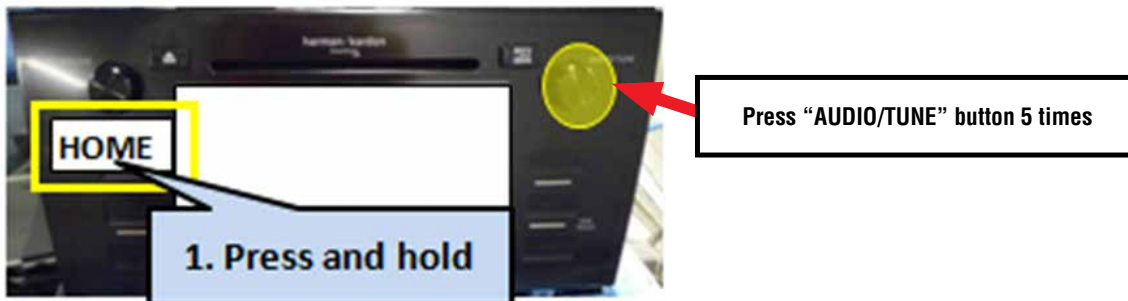
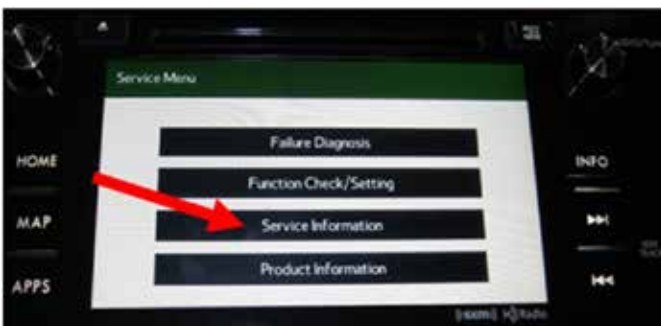
- Switch the unit into “Diagnosis Mode” by pressing and holding the HOME button while pressing the “AUDIO/TUNE” button 5 (five) times.

As mentioned earlier on page 4, once the update software installations are complete, the Version Check procedure must be performed again to confirm the updates have been installed successfully.

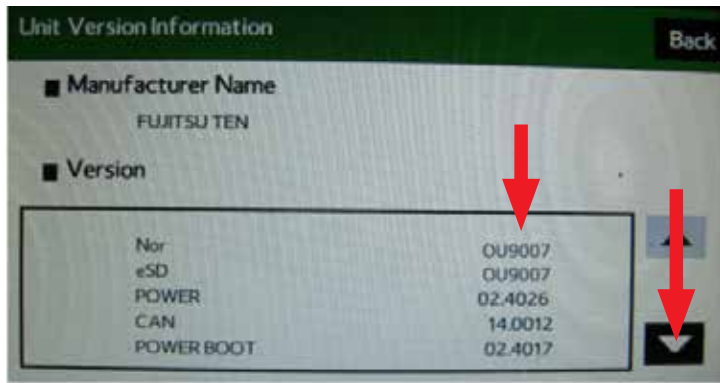
- Press “Push” next to DA

- Verify the current versions according to the “Version Check List” table shown on page 5. Use the down arrow to scroll to the bottom of the list for complete verification.

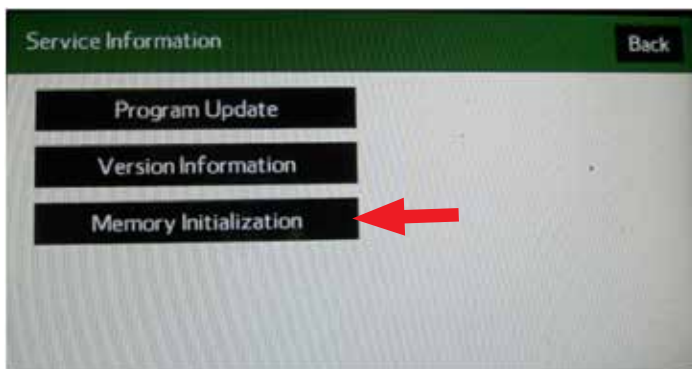
After confirming both software updates have been installed successfully, the Memory Clear procedure must be performed to complete the update procedure. After pressing “Back”, the following screen will be displayed:

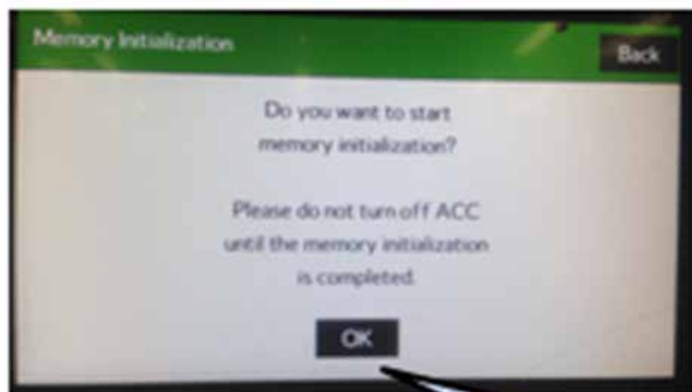
- Press “Memory Initialization”

Press and Hold

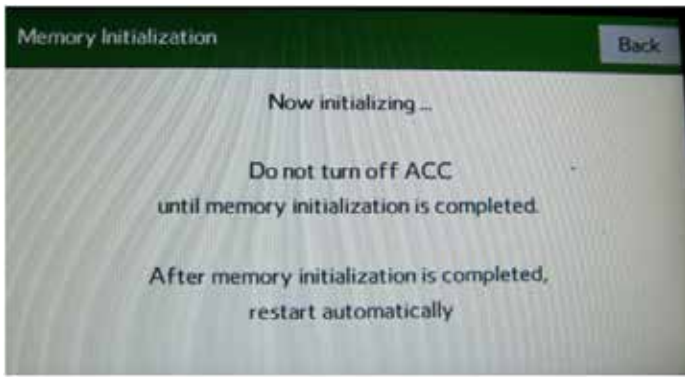
- Press and hold the “OK” button until the screen shown below is displayed (5 to 10 seconds).

This screen will be displayed for about 1 minute while the unit restarts. After restart, the Loading screen and its status bar will be displayed. After the status bar completes, the Main Menu screen will be displayed. To complete the updating procedure, you must go through the series of Initial Setup screens, reset the radio station presets and re-pair any mobile devices (where applicable).
