## SERVICE BULLETIN

**APPLICABILITY:** 2015MY Legacy, Outback, Impreza and XV Crosstrek Models with Fujitsu-Ten (F10) Navigation System

**NUMBER:** 15-182-15R

**SUBJECT:** Procedures for Updating the Head Unit Operating Software

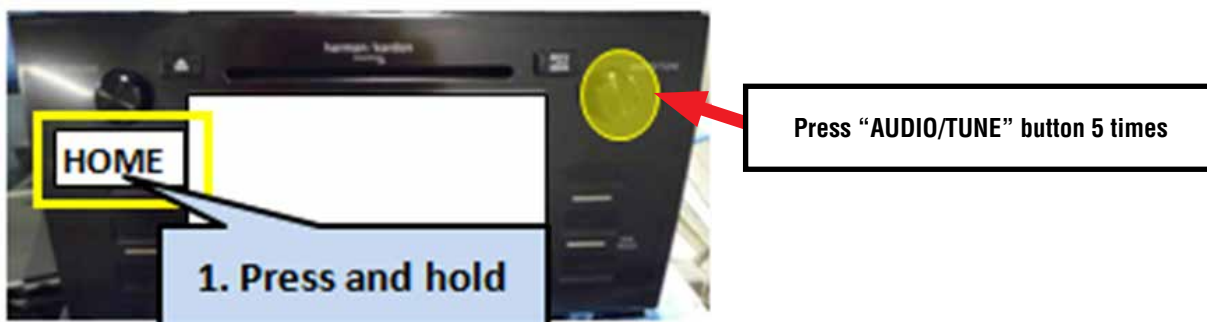
- Switch the unit into “Diagnosis Mode” by pressing and holding the HOME button while pressing the “AUDIO/TUNE” button 5 (five) times.

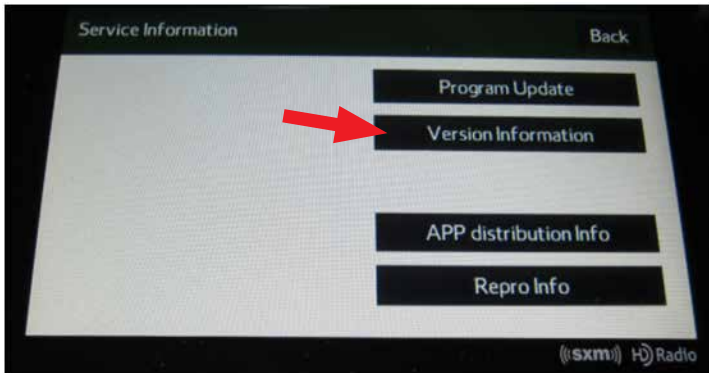
- Press “Service Information”

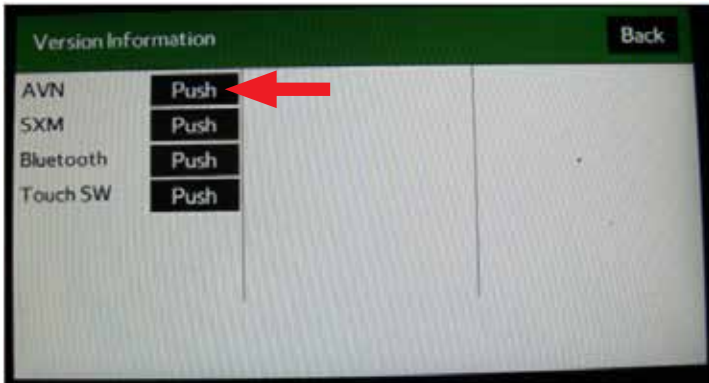
- Press “Version Information”

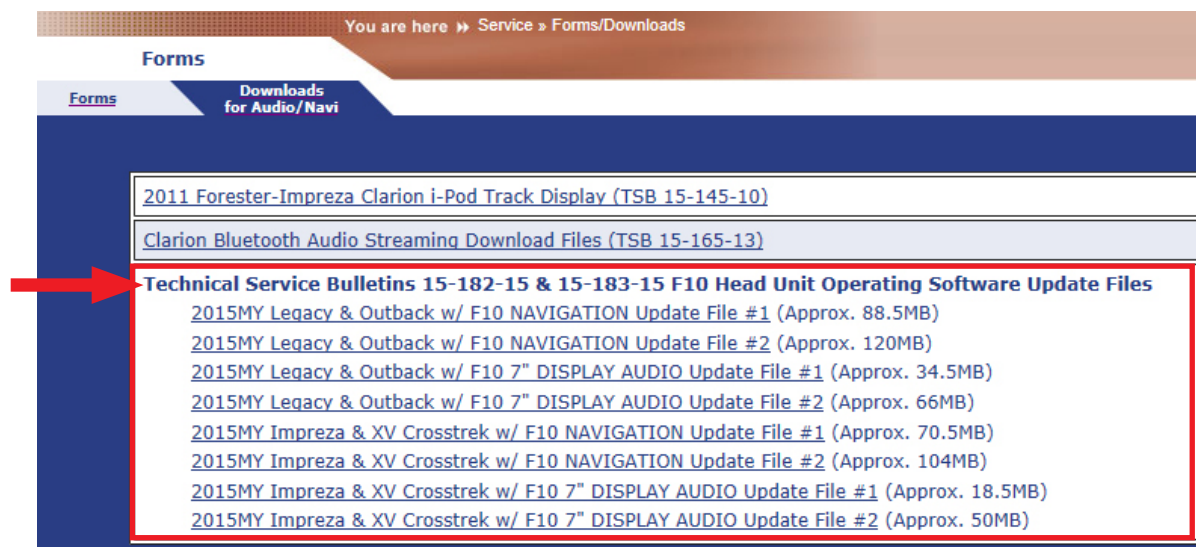
The Subarunet page shown above will display and contains links to the update files **1 & 2** for each model head unit.

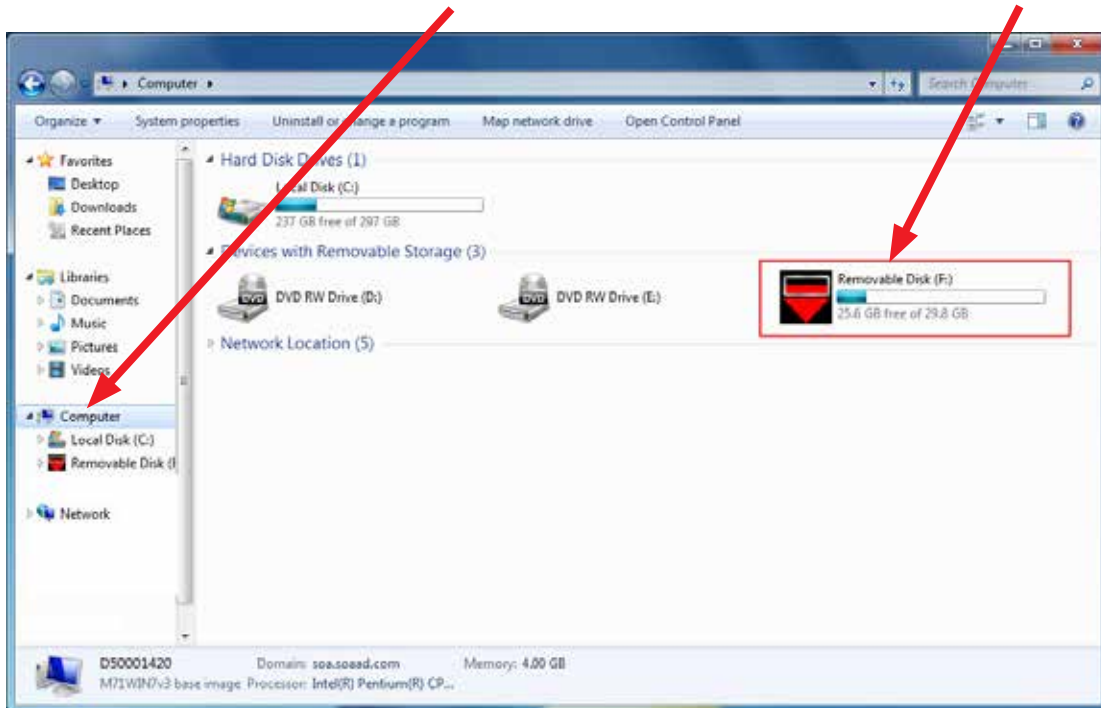
- In the next window, choose the **Computer** section on the left. Locate “**Removable Disk**”

**NOTE:** Always confirm the device you are formatting is the USB Flash Drive. This drive may have various names assigned to it by the manufacturer of the device and may not reflect the drive name given in this example.

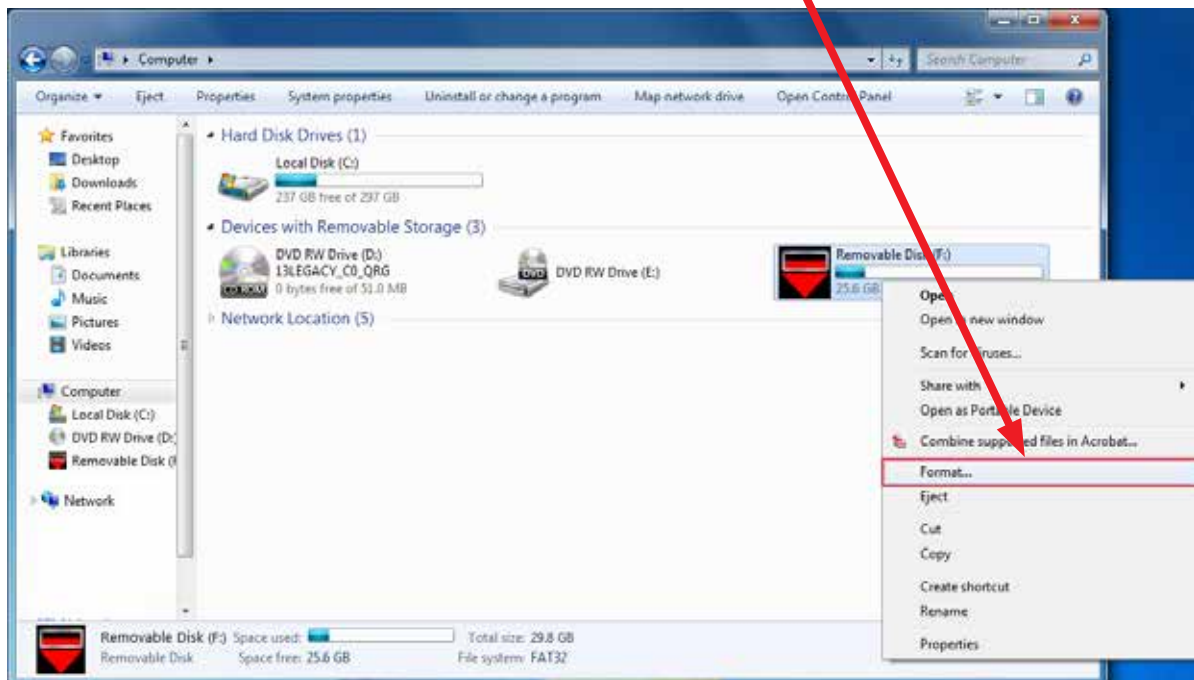
- Right click the picture for “**Removable Disk**” then select “**Format**”.

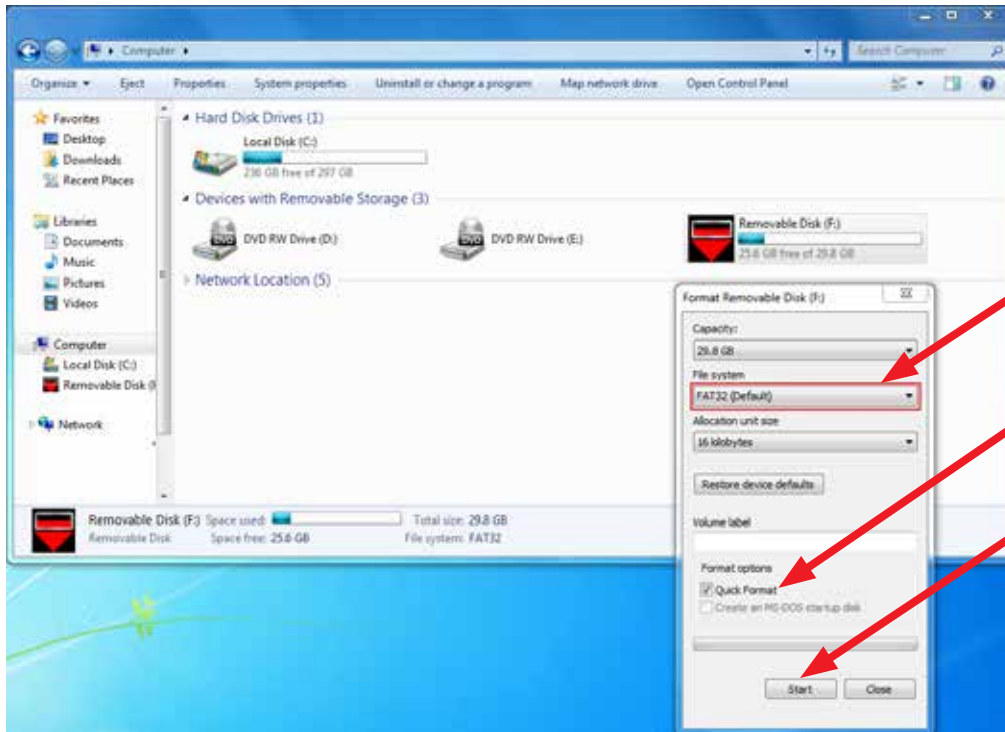
- When the “Format” dialog box appears, make sure that the option labeled “File System” is set to **FAT32** and the **Quick Format** box is checked as well. Then, click the “**Start**” button.

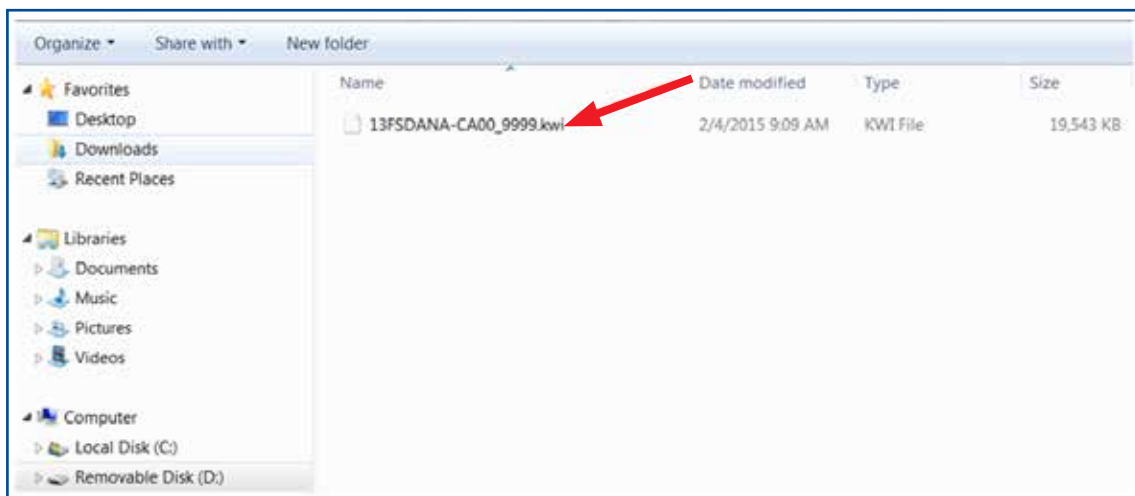
- Confirm the file (and flash drive) is ready to use by going back to Start > Computer (or My Documents on the SDS Toughbook) and double clicking on “Removable Disk” to display the drive’s contents as shown in the example below. There should only be **one** file displayed. All of the updates will have a “.kwi” extension at the end of their file name. If OK, proceed with **Step 4: Update Software Installation** below.

**REMINDER:** there can only be **ONE** file stored on the flash drive or the update procedure will not work. If you see more than one file stored, start over by re-formatting the flash drive again then reloading the update file.

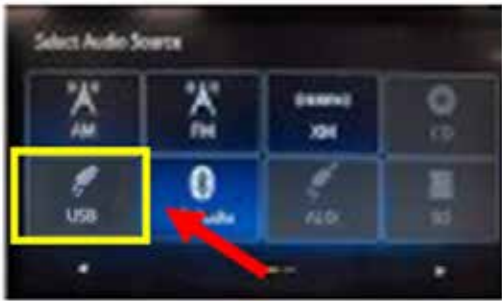
After the flash drive is recognized, the USB icon will illuminate.

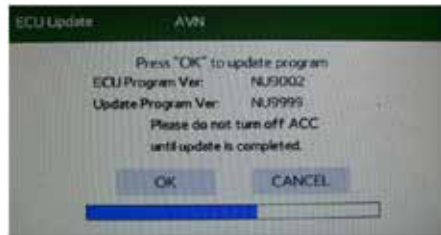
Once the updating starts, the status bar will run twice before "OK" illuminates (approximately 5 minutes).

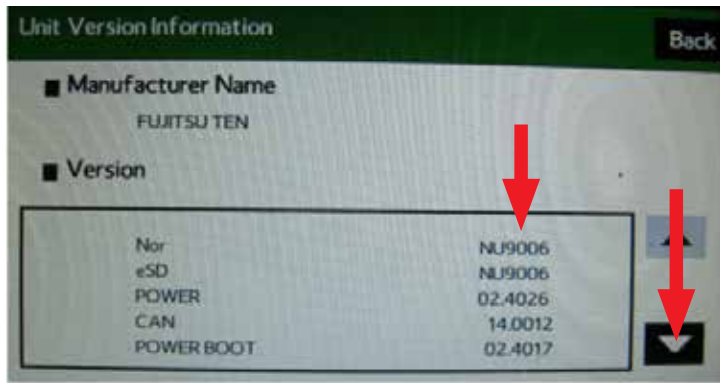
- Press “Push” next to AVN

- Verify the current versions according to the “Version Check List” table shown on page 5. Use the down arrow to scroll to the bottom of the list for complete verification.

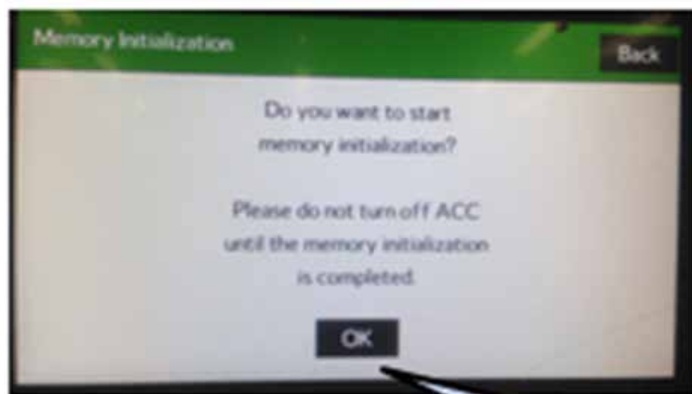
- Press “Memory Initialization”
