Service Action: Replace the Thermostat (F10)

F10 (5 Series Sedan)

With the N20 engine

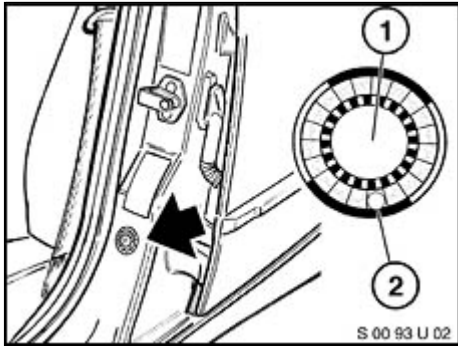
LABEL INSTRUCTIONS

This Service Action has been assigned code number **720**. After the vehicle has been checked and/or corrected, obtain a label (SD 92-453) and:

- A. Emboss your BMW center warranty number in the middle of the label (1);
- B. Punch out code number **720** (2), printed on the label; and
- C. Affix the label to the B-pillar as shown.
