Service Action: Program Control Units (SCR)

F02 (7 Series Sedan)

With the N57T diesel engine

With the N47T diesel engine

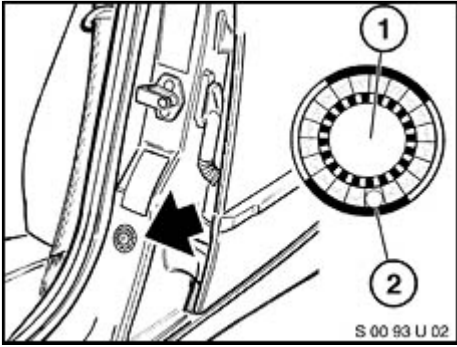
<p>This Service Action has been assigned code number 730. After the vehicle has been checked and/or corrected, obtain a label (SD 92-464) and:</p> <ol style="list-style-type: none"> Emboss your BMW center warranty number in the middle of the label (1); Punch out code number 730 (2), printed on the label; and Affix the label to the B-pillar as shown.
--	--

If the vehicle already has a label from a previous Service Action/Recall Campaign, affix the new label next to the old one. Do not affix one label on top of another one, because a number from an underlying label could appear in the punched-out hole of the new label.
