Service Action: Program Variable Damper Control (VDC) Unit

F15 (X5)

SITUATION

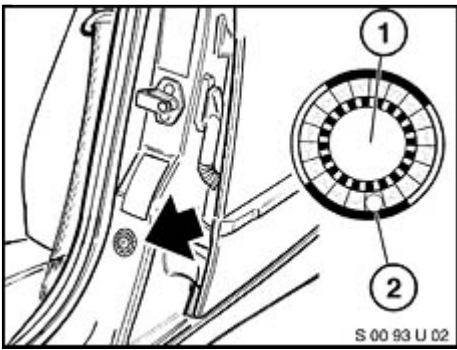
LABEL INSTRUCTIONS

<p>This Service Action has been assigned code number 725. After the vehicle has been checked and/or corrected, obtain a label (SD 92-464) and:</p> <ol style="list-style-type: none"> Emboss your BMW center warranty number in the middle of the label (1); Punch out code number 725 (2), printed on the label; and Affix the label to the B-pillar as shown.
--	--

First check if a Service Action label with a code number **725** is already attached to the B-pillar.

If the vehicle already has a label from a previous Service Action/Recall Campaign, affix the new label next to the old one. Do not affix one label on top of another one because a number from an underlying label could appear in the punched-out hole of the new label.
