Service Action: Program Variable Damper Control (VDC) unit

F15 (X5)

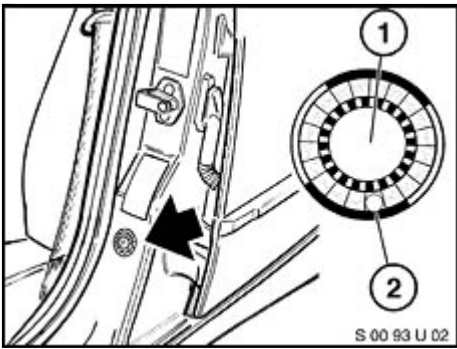
LABEL INSTRUCTIONS

<p>This Service Action has been assigned code number 726. After the vehicle has been checked and/or corrected, obtain a label (SD 92-464) and:</p> <ul style="list-style-type: none"> A. Emboss your BMW center warranty number in the middle of the label (1); B. Punch out code number 726 (2), printed on the label; and C. Affix the label to the B-pillar as shown.
--	---

If the vehicle already has a label from a previous Service Action/Recall Campaign, affix the new label next to the old one. Do not affix one label on top of another one because a number from an underlying label could appear in the punched-out hole of the new label.

First check if a Service Action label with a code number **726** is already attached to the B-pillar.
