Service Action: Replace the Thermostat

F30 (3 Series Sedan)

With the N26 engine

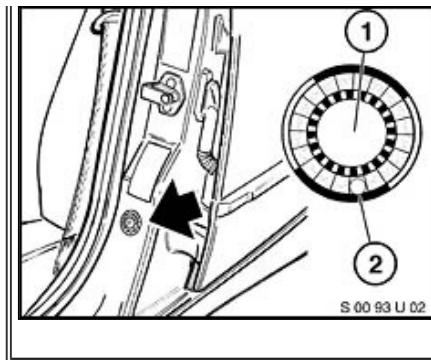
This Service Action has been assigned code number **719**. After the vehicle has been checked and/or corrected, obtain a label (SD 92-453) and:

- A. Emboss your BMW center warranty number in the middle of the label (1);
- B. Punch out code number **719** (2), printed on the label; and
- C. Affix the label to the B-pillar as shown.

First check if a Service Action label with a code number **719** is already attached to the B-pillar.

If a code number **719** has been punched out, the Campaign has already been performed and no further action is necessary.
